***MELODY LAKE
DAM REPAIRS
ASSOCIATION VOLUNTEERS
MAKE THE DIFFERENCE***

**THE DAM IS A CLASS C, HIGH HAZARD DAM
CONSTRUCTED OF DRY, LAID UP NATIVE
STONE, SIMILAR TO A FARMERS STONE WALL.
THE DAM IS APPROX. 27'H X 10'W (TOP) X
26'W (BASE) AND 120'L. THE DAM IS A
GRAVITY TYPE DAM WITH NO KEY AND RELIES
ON IT'S MASSIVE WEIGHT TO PROVIDE
STABILITY AND PREVENT SLIDING.**

**IN OCTOBER, 1980, MELODY LAKE DAM
WAS INSPECTED BY DEC AND THE ARMY
CORP OF ENGINEERS AS PART OF THE
NATIONAL DAM INSPECTION PROGRAM
AND SEVERAL DEFICIENCIES WERE FOUND
AND ORDERED TO BE CORRECTED.
ALTHOUGH THERE WAS NO IMMEDIATE
DANGER, IF REPAIRS WERE NOT MADE,
THE DAM COULD BE ORDERED TO BE
BREACHED.**

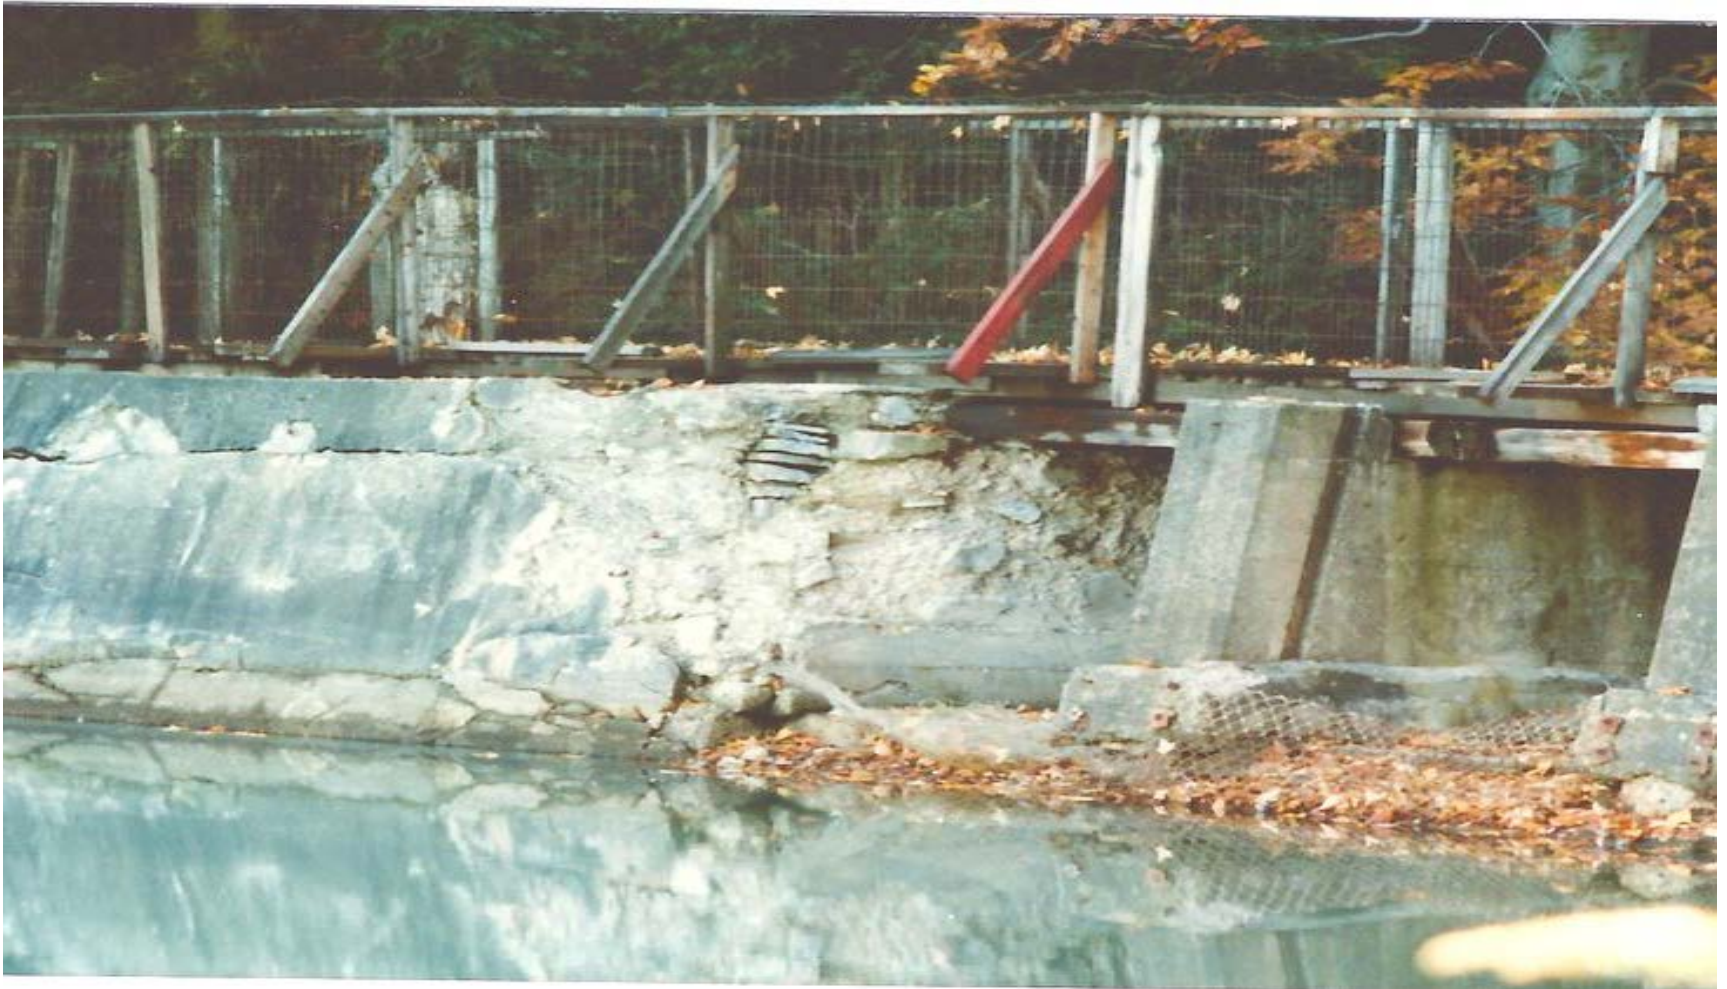
- 1. INADEQUATE SPILLWAY CAPACITY**
- 2. DETERIORATED CONCRETE OF UPSTREAM FACE OF DAM**
- 3. VOIDS UNDER BRIDGE PIERS**
- 4. DISPLACED STONE ON DOWNSTREAM FACE**
- 5. NO OPERABLE DRAIN**
- 6. SUBSTANTIAL LEAKAGE**
- 7. NO EMERGENCY ACTION PLAN**
- 8. LACK OF PRESCRIBED MAINTENANCE & OPERATION PROCEDURES**

Upstream face of dam

REMOVAL OF ALL DETERIOATED CONCRETE (SPILLWAY, PIERS, ETC.)

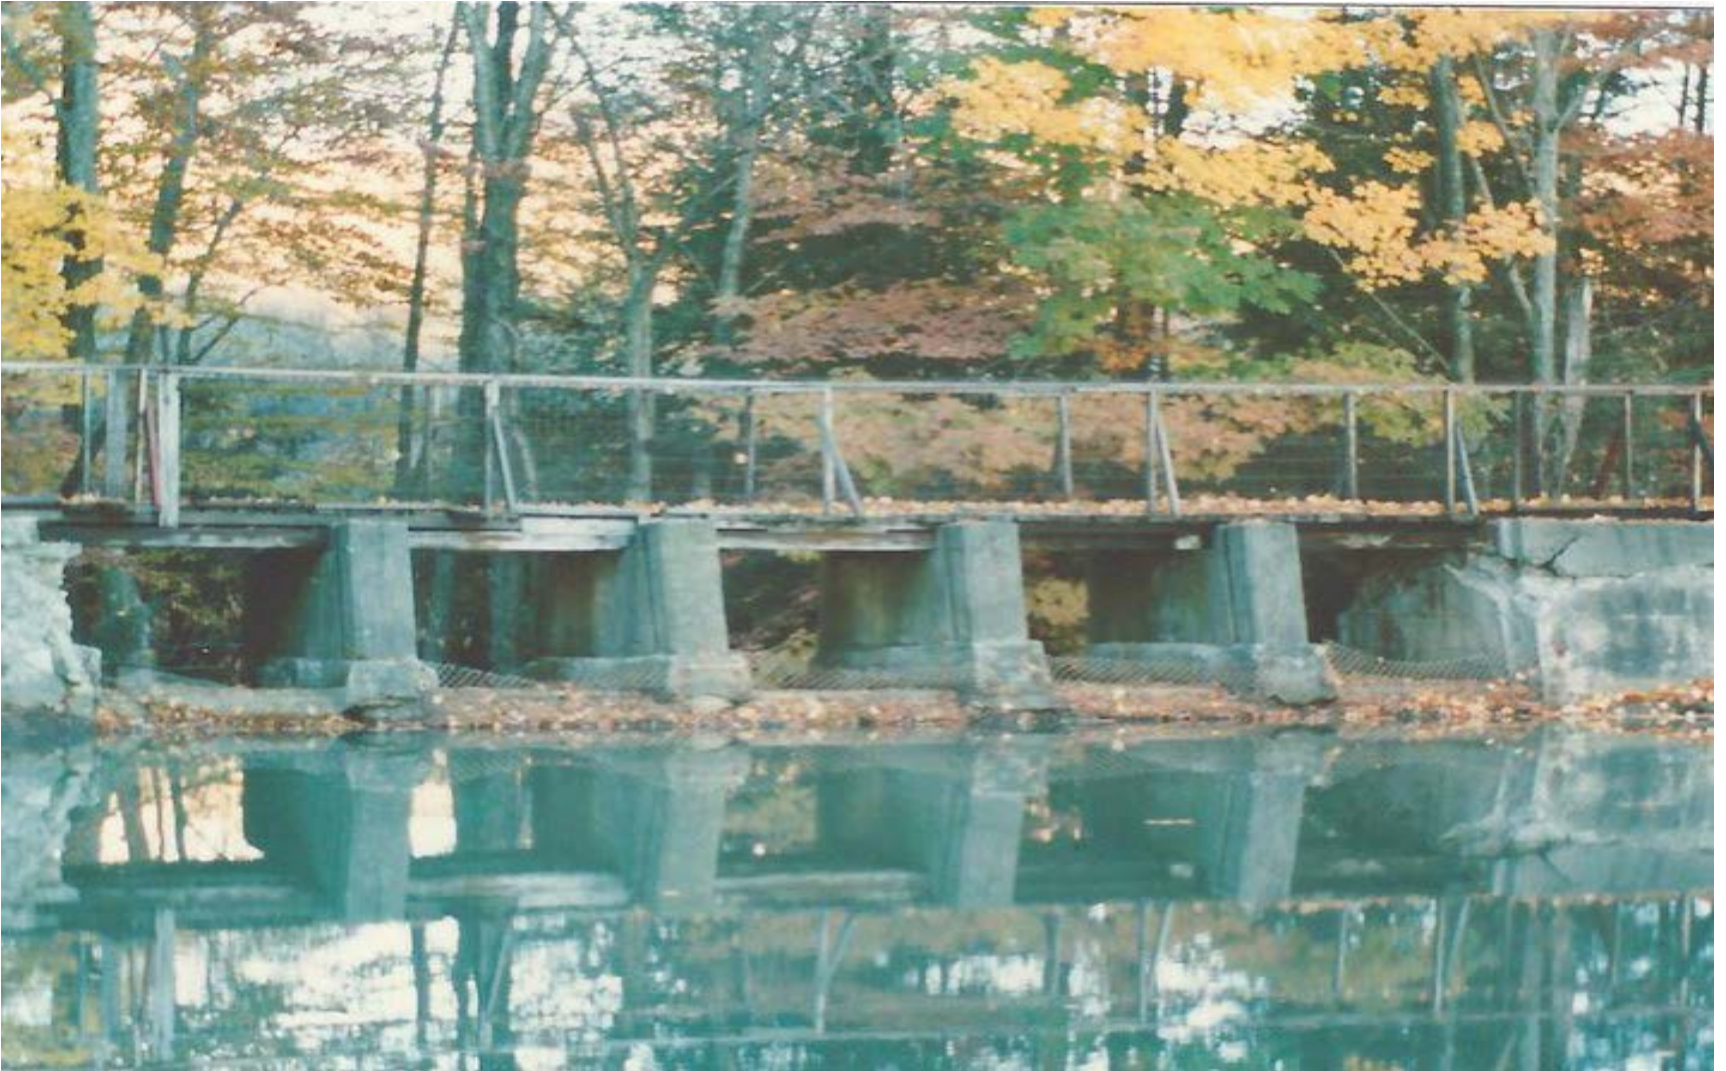
The main reason the dams have been called unsafe is that their spillways are too small to handle an accumulation of water from an unusually heavy storm without the lake water overflowing the top of the dam, Koch said.

Inadequate Spillway Capacity

MAKE THE EXISTING SPILLWAY ON THE DAM LARGER THEREBY ELIMINATING THE NEED FOR A LONG SWALE ACROSS PRIVATE PROPERTY. THIS WOULD ALSO ELIMINATE A LONGTERM MAINTENANCE ITEM.

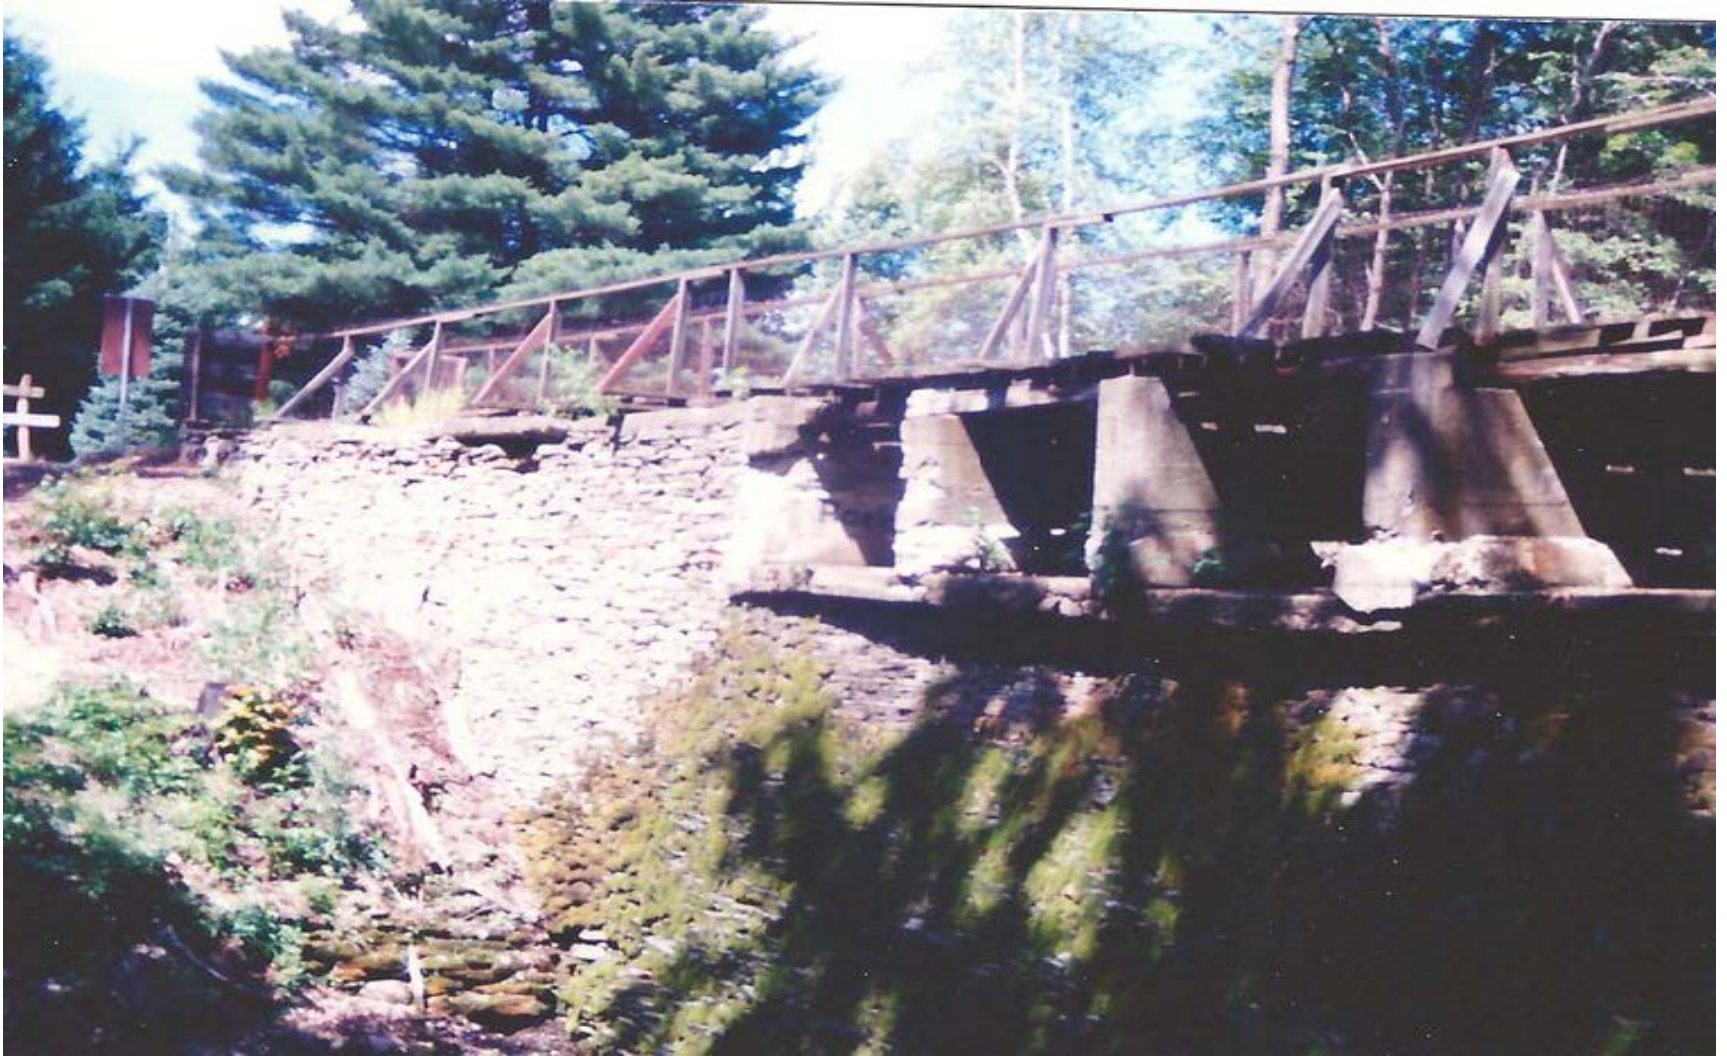
MISSING STONE AND DETERIORATED PIERS

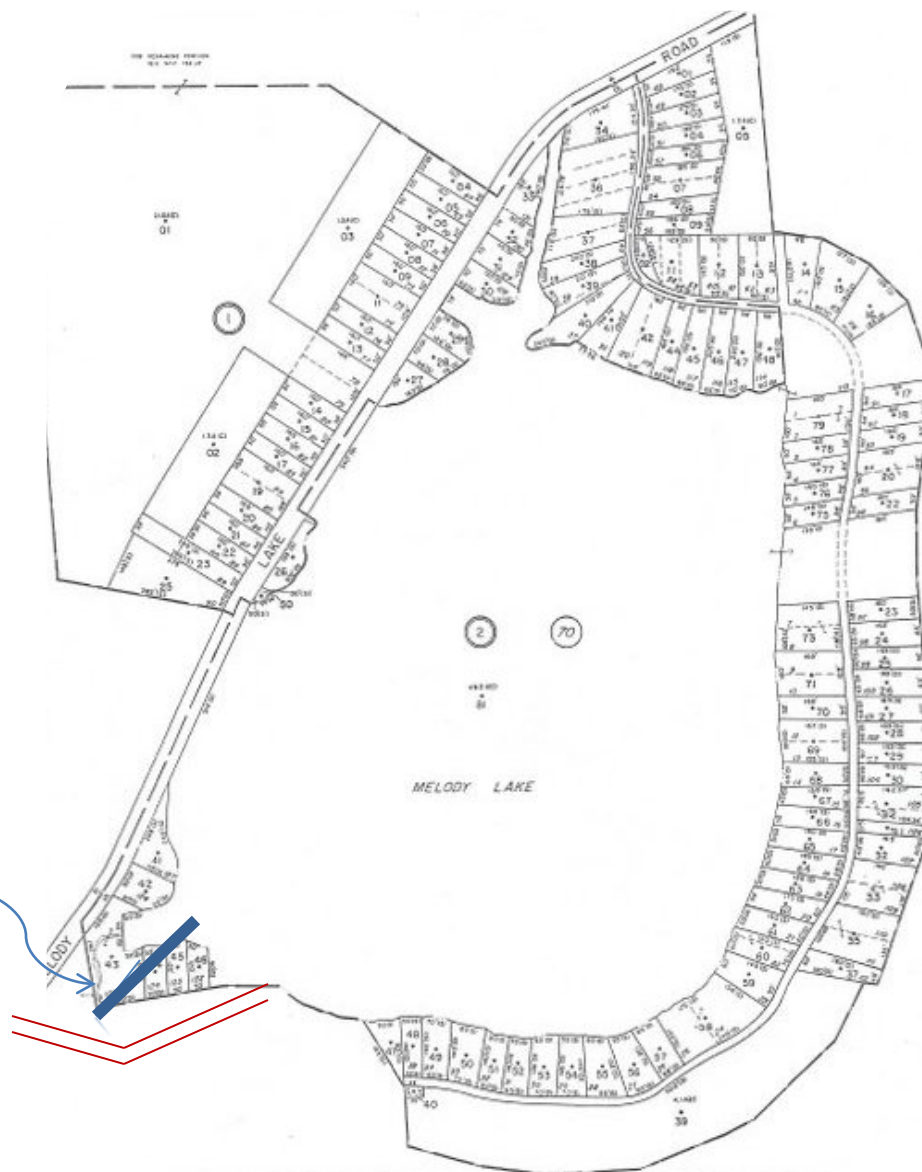
Proposed drain 12" x 250' x 2 = 500'

Proposed swale – 3'd x 45'w x 120'l

2 DRAIN PIPES ACROSS PRIVATE PROPERTY OF ASSOCIATION MEMBER AND AN OVERFLOW CHANNEL ACROSS NON MEMBER PRIVATE PROPERTY (BOTH OF THESE PROPOSALS HAD LIMITED ACCESS DUE TO THE DEAD END OF MELODY LANE)

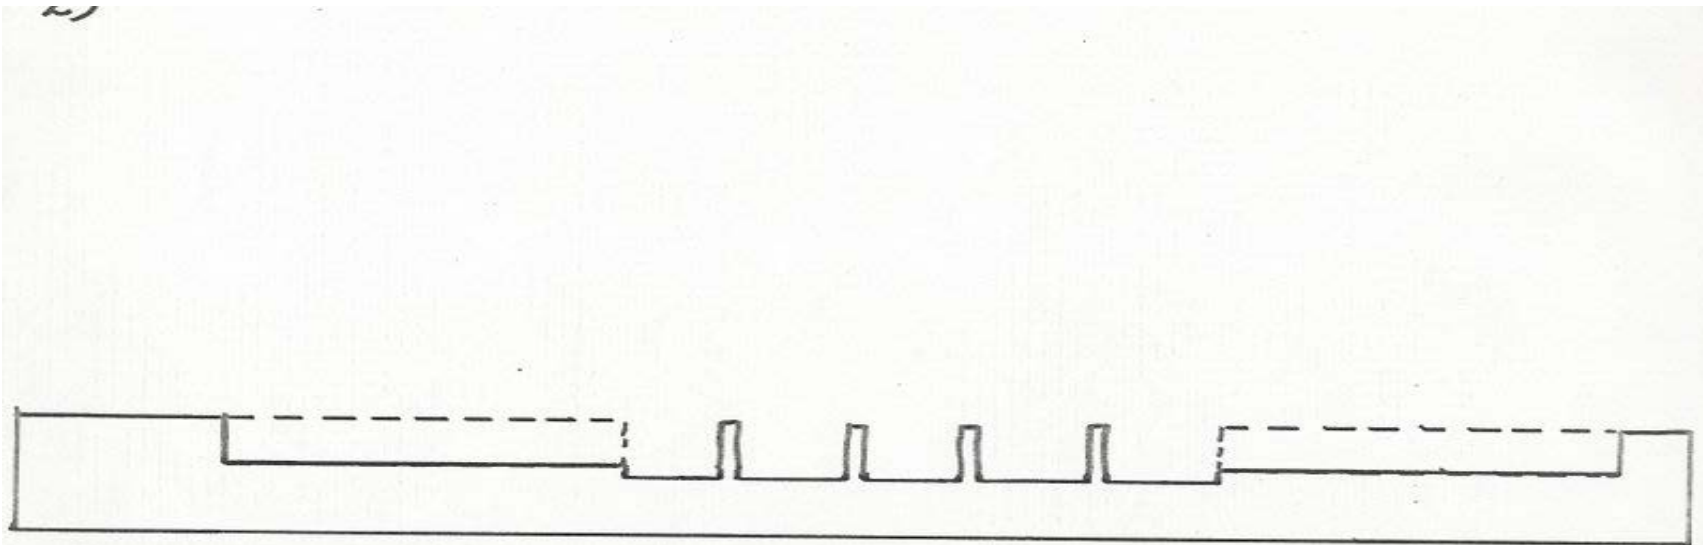
Proposal to remove 30' x 4' on both sides of the spillway

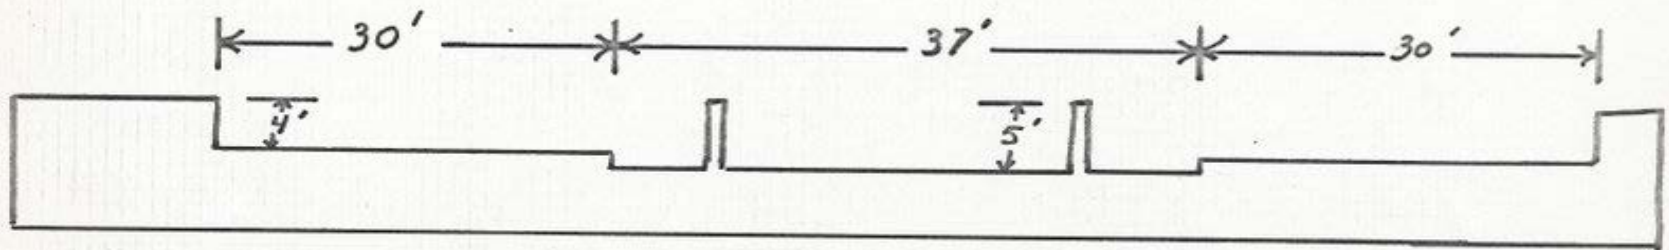
After removing both sections plus the removal of 2 piers
resulted in an additional 240 ft² for a total of 390 ft²
(an increase of 260%)

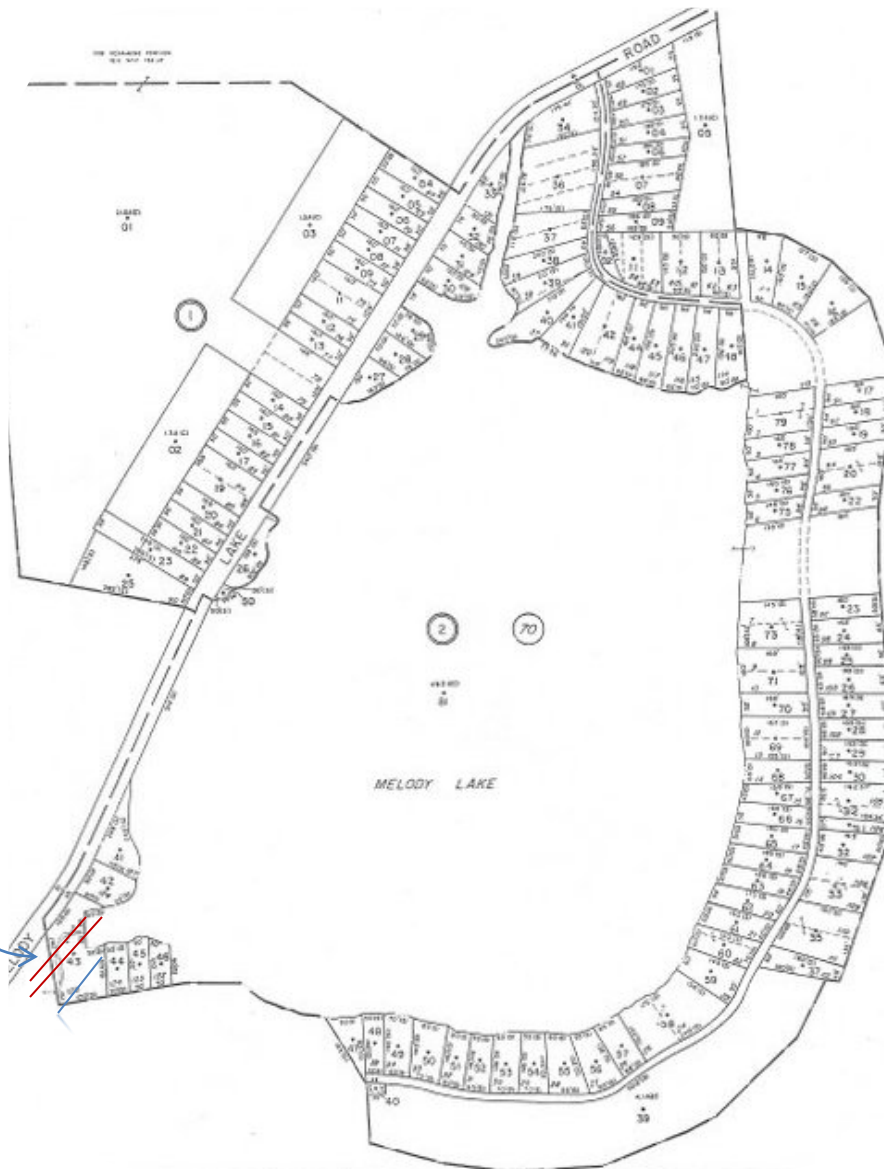
Proposed drain 12" x 250' x 2 = 500'

Final drain 12" x 110' x 2 = 220'

Proposed swale – 3'd x 45'w x 120'l

Final swale – 0'

MOVE THE LOCATION OF THE DRAIN PIPES TO THE OPPOSITE SIDE OF THE DAM WHERE THERE WAS BETTER ACCESS AND THE ASSOCIATION ALREADY HAD A DAM MAINTENANCE EASMENT.

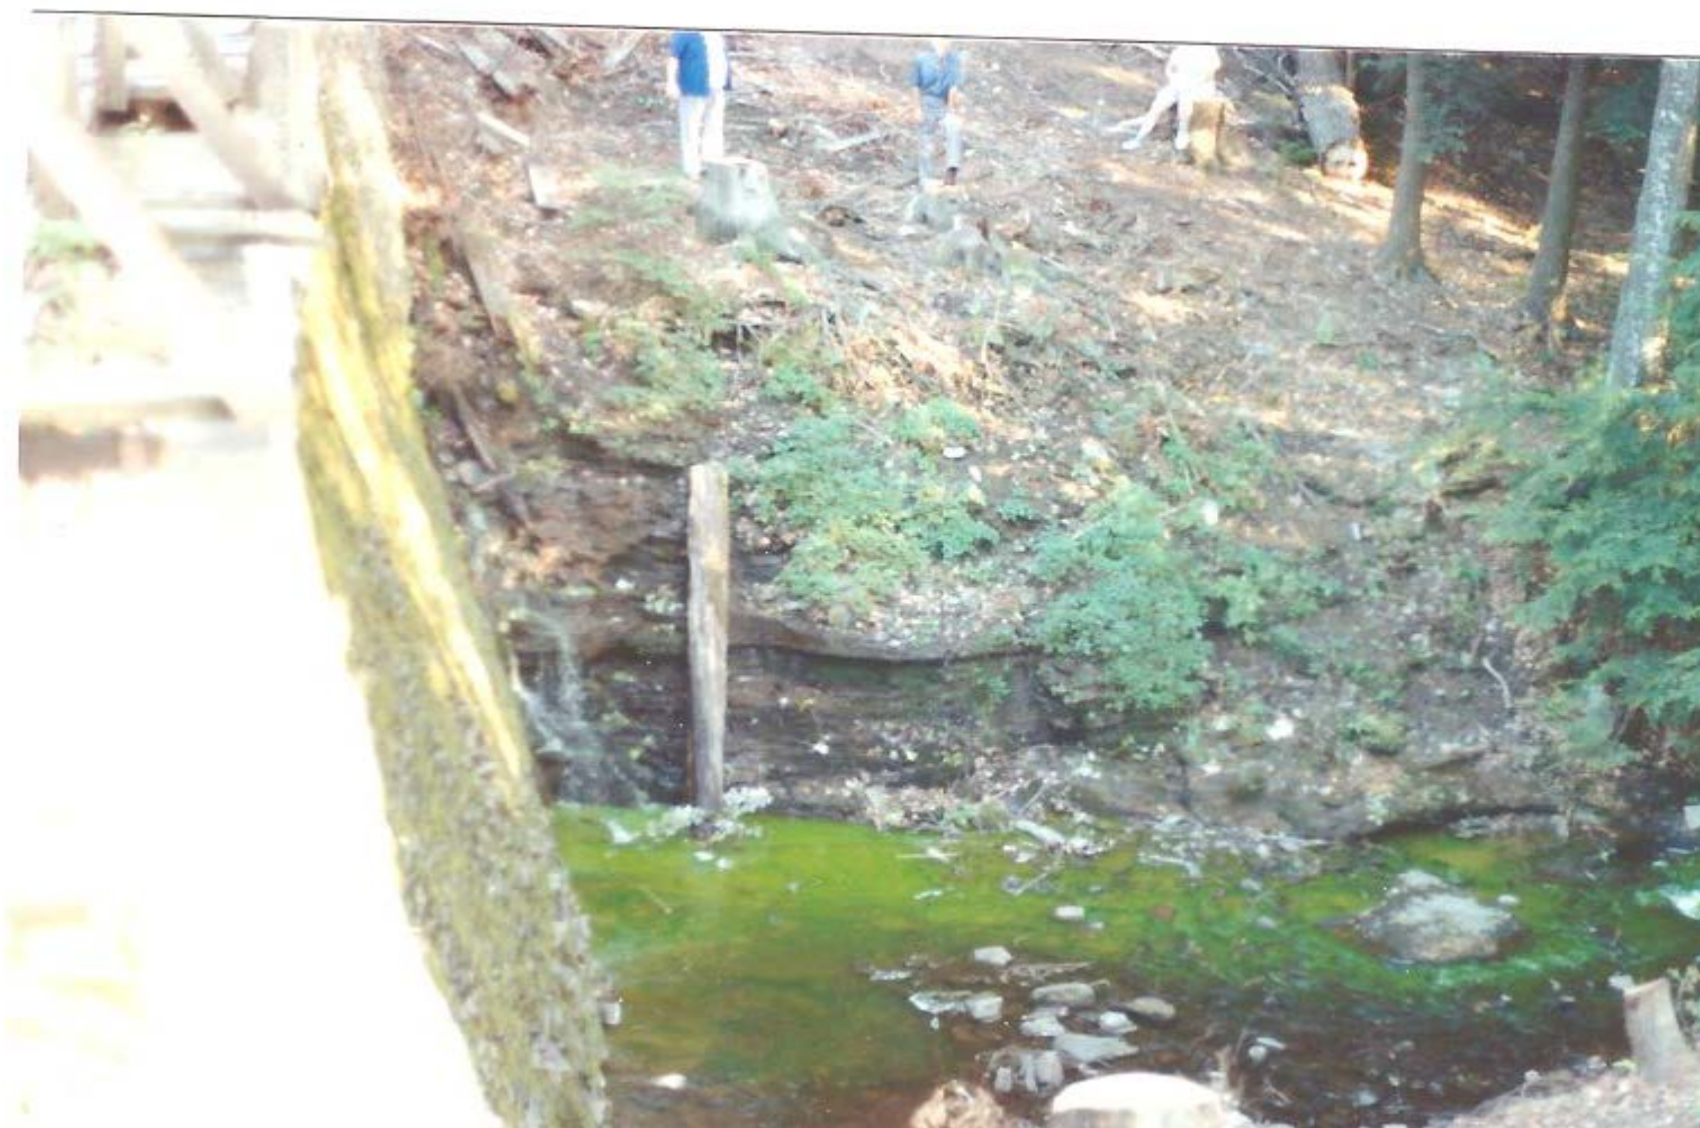
Dye was used to determine where the leakage was coming from

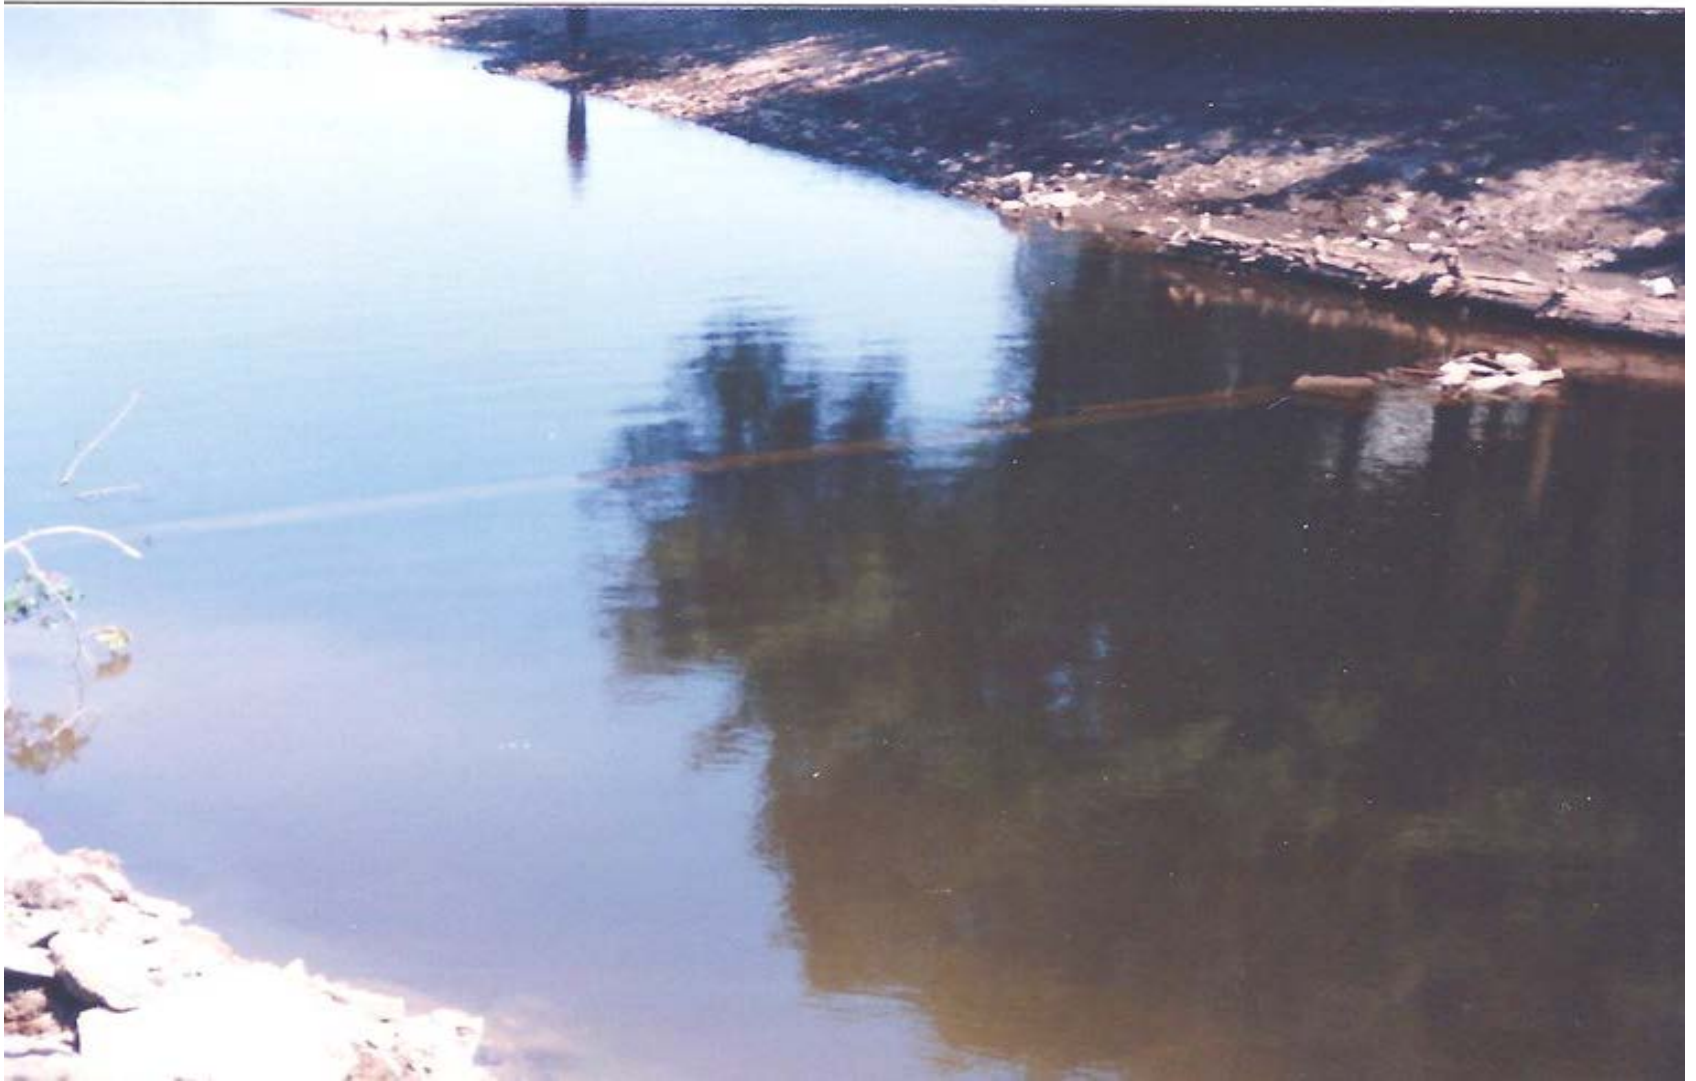
At this level, a wooden coffer dam which was constructed when the dam was built became visible

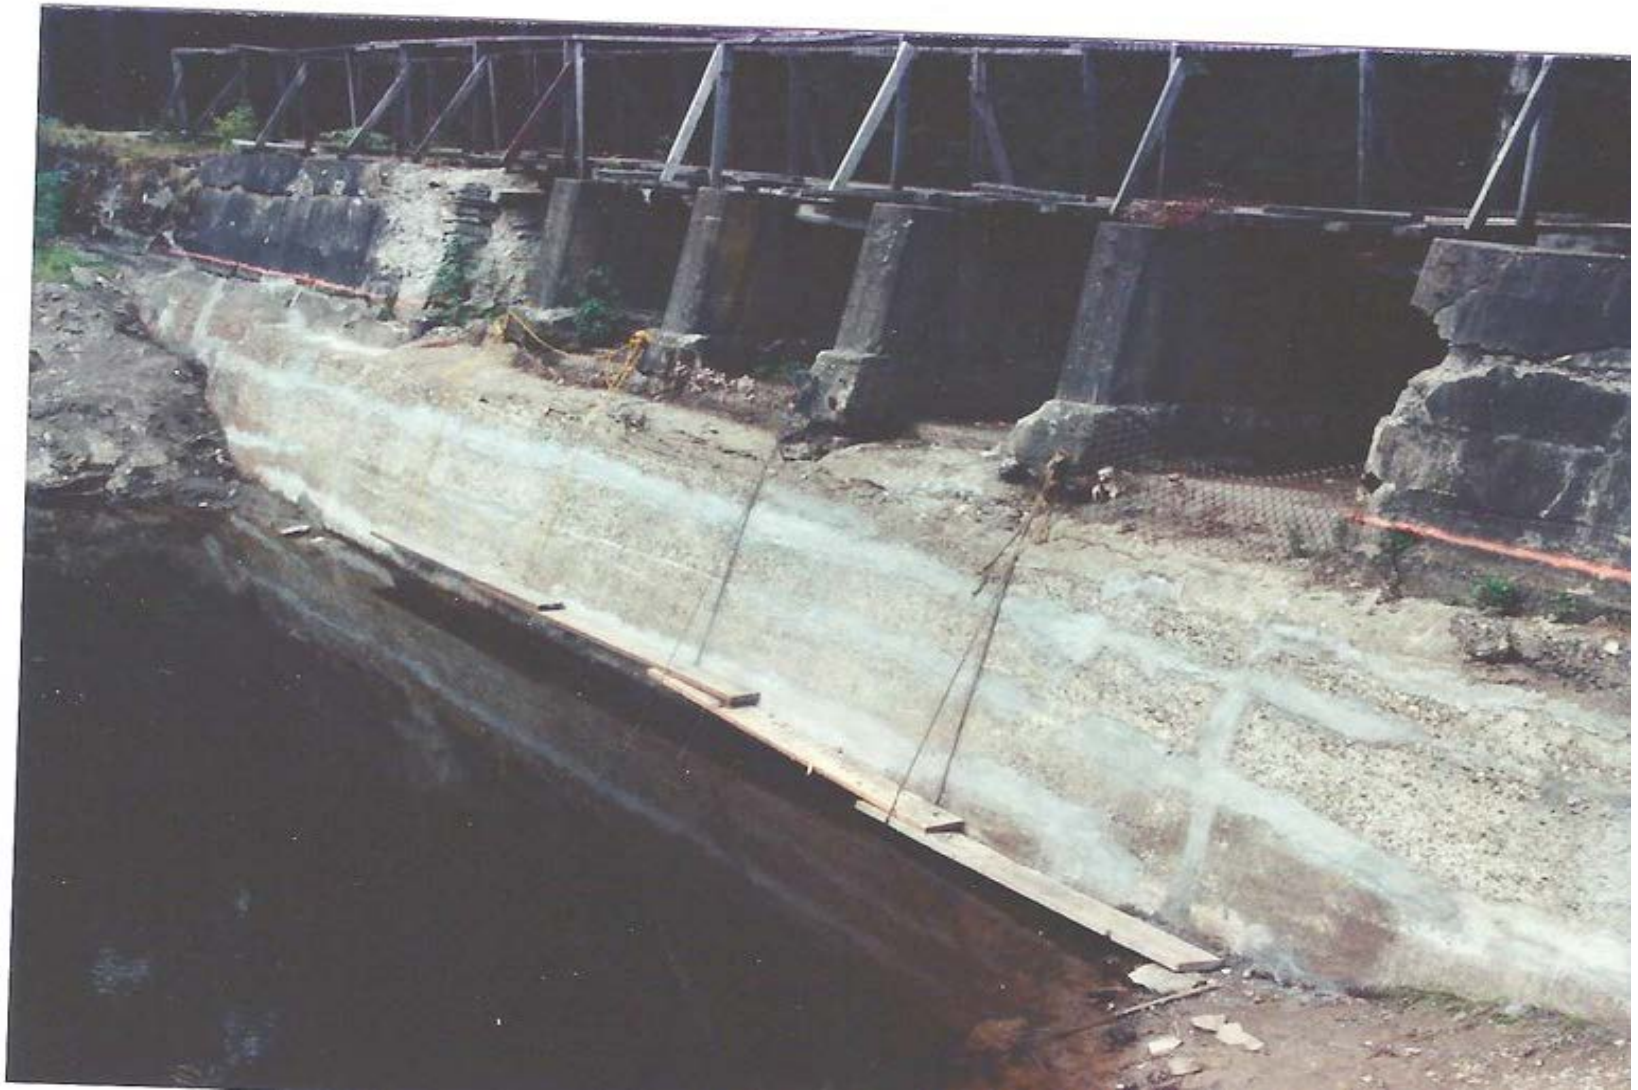
Cracks on the upstream face were patched with hydraulic cement

THE NEXT STEP WAS TO REMOVE THE WALKWAY AND START EXPANDING THE SPILLWAY. THIS WAS DONE BY ASSOCIATION MEMBERS. SMALL CRACKS IN THE CONCRETE FACE OF THE DAM WERE PATCHED WITH HYDRALIC CEMENT. LARGER REPAIRS WERE COMPLETED BY REMOVING OLD SECTIONS AND FORMING AND POURING NEW CONCRETE.

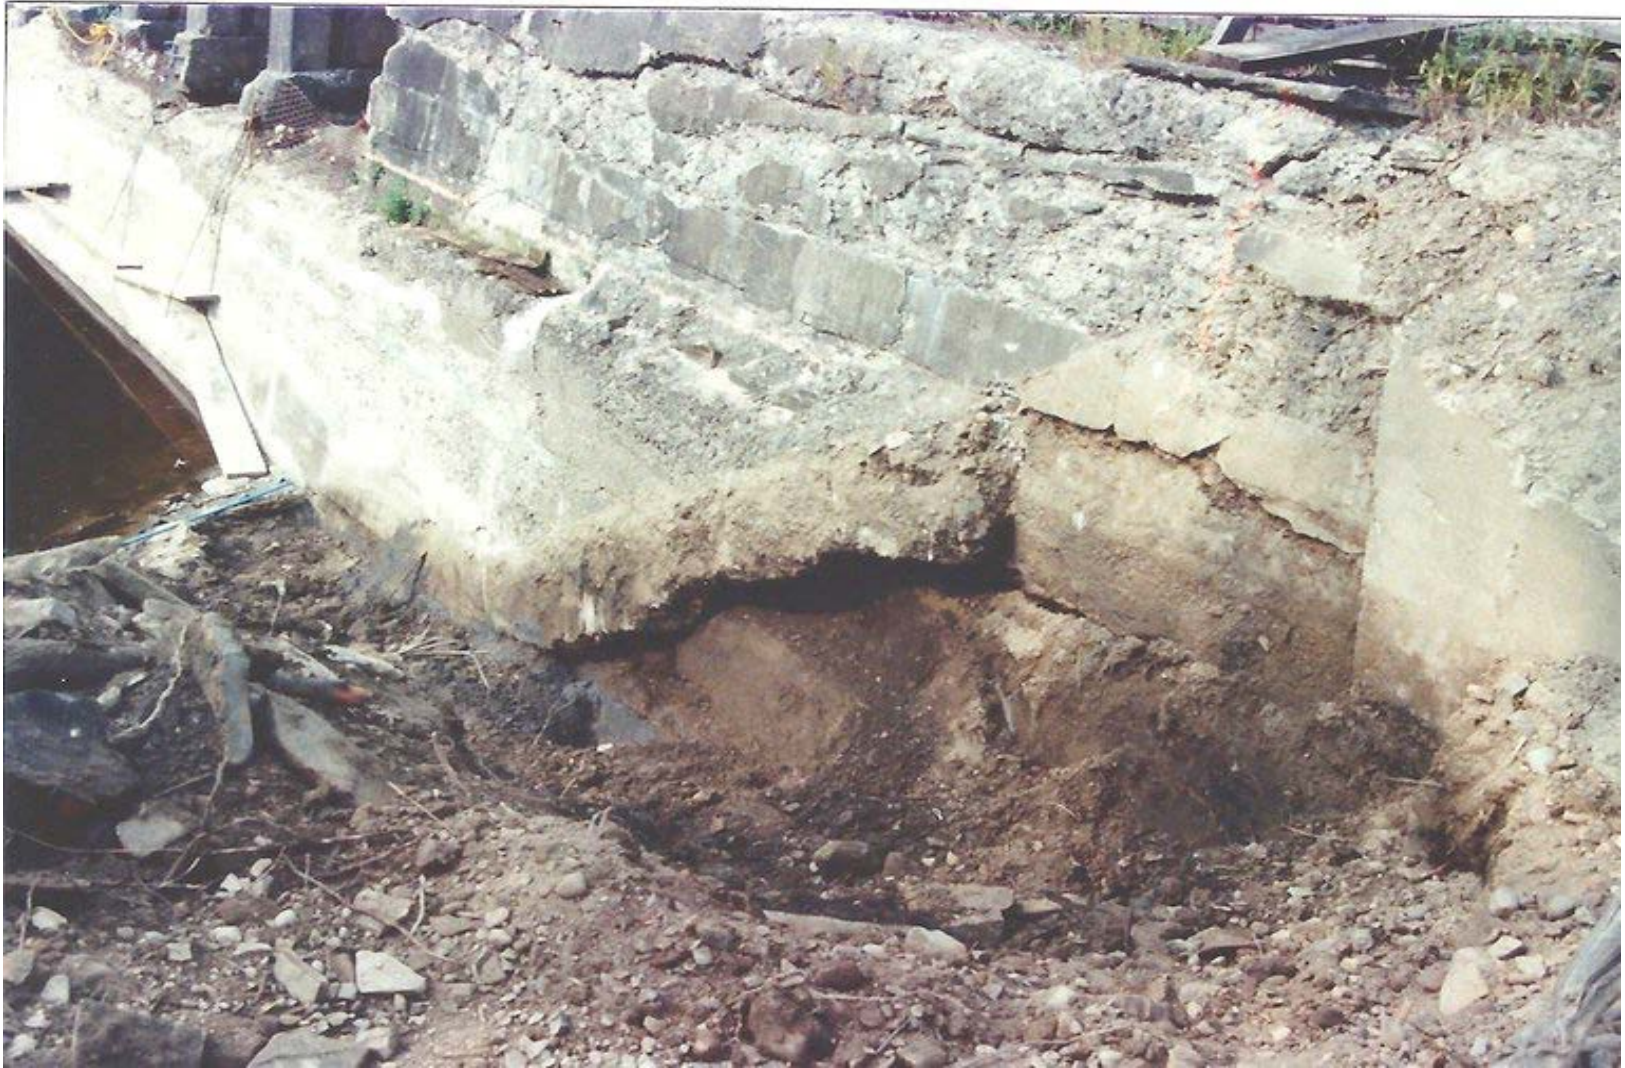
Larger sections were removed, formed and replaced

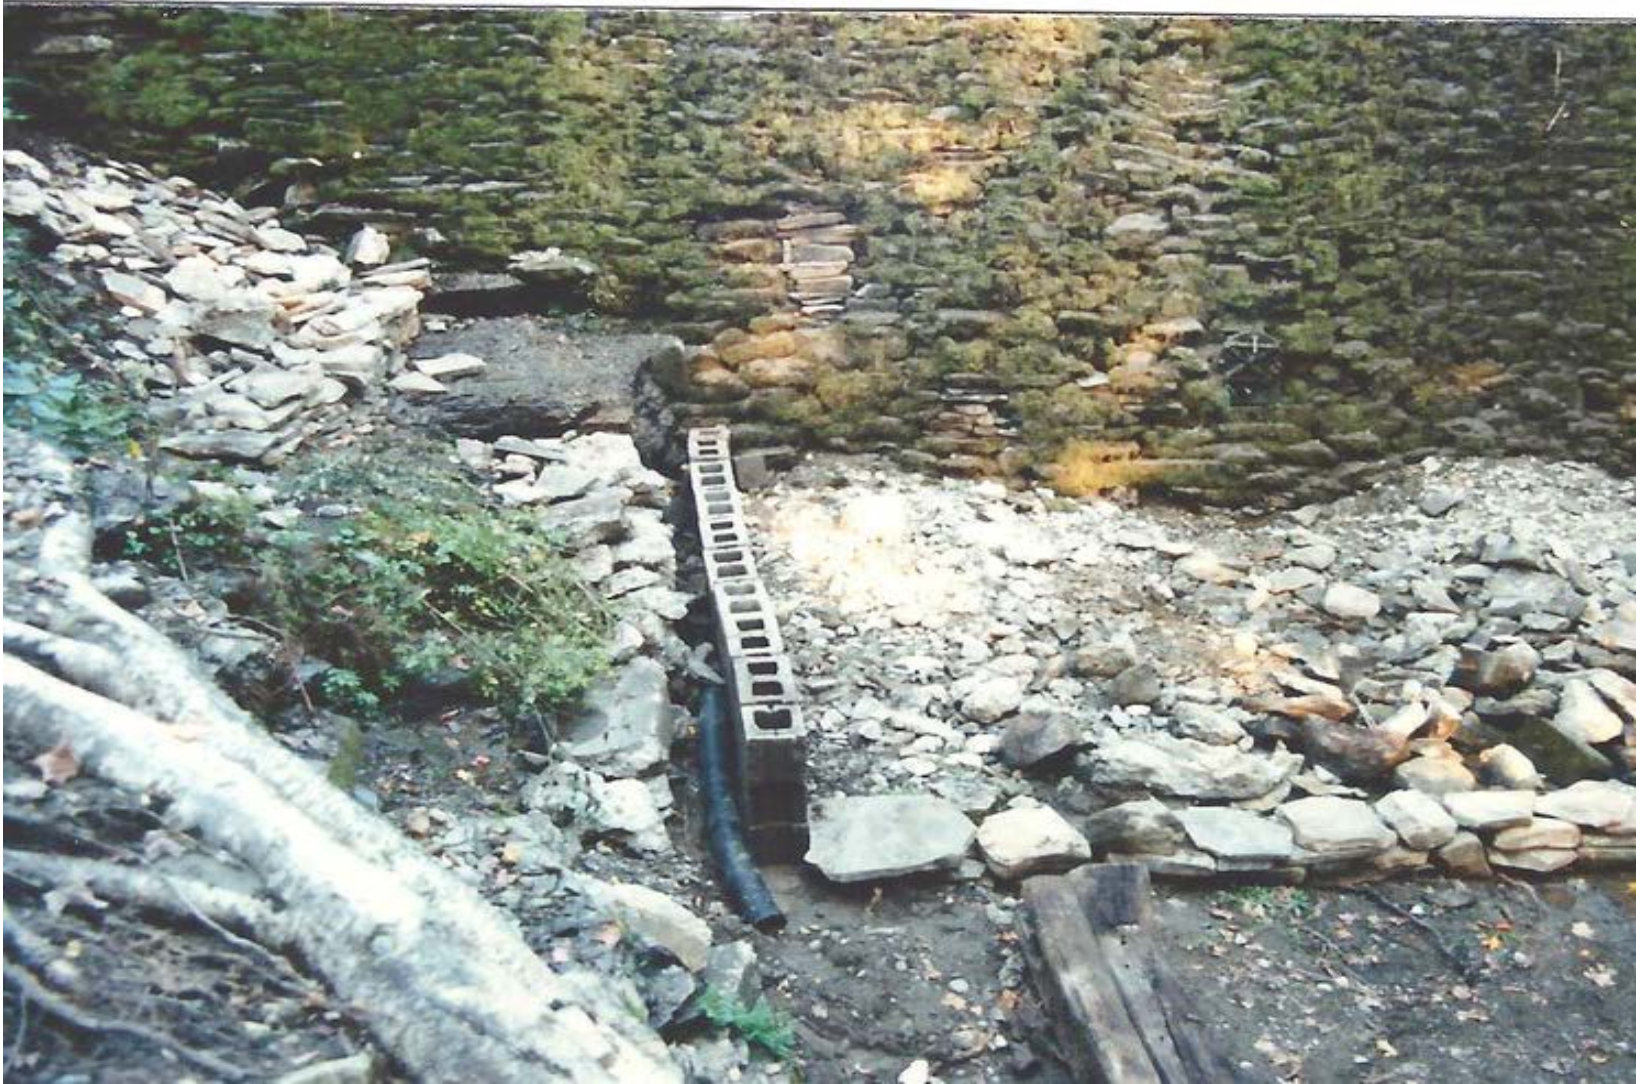
The stone that was removed for the larger spillway was placed at the downstream toe of the dam to reduce the possibility of sliding

SINCE THE DAM RELIES ON ITS MASSIVE WEIGHT FOR STABILITY, DEC REQUIRED THAT ALL STONE THAT WOULD BE REMOVED SHOULD BE PLACED IN A BUTTRESS AT THE DOWNSTREAM TOE OF THE DAM TO COMPENSATE FOR THE LOSS OF WEIGHT FROM EXPANDING THE SPILLWAY. (REMOVAL OF ABOUT 110 CU. FT)

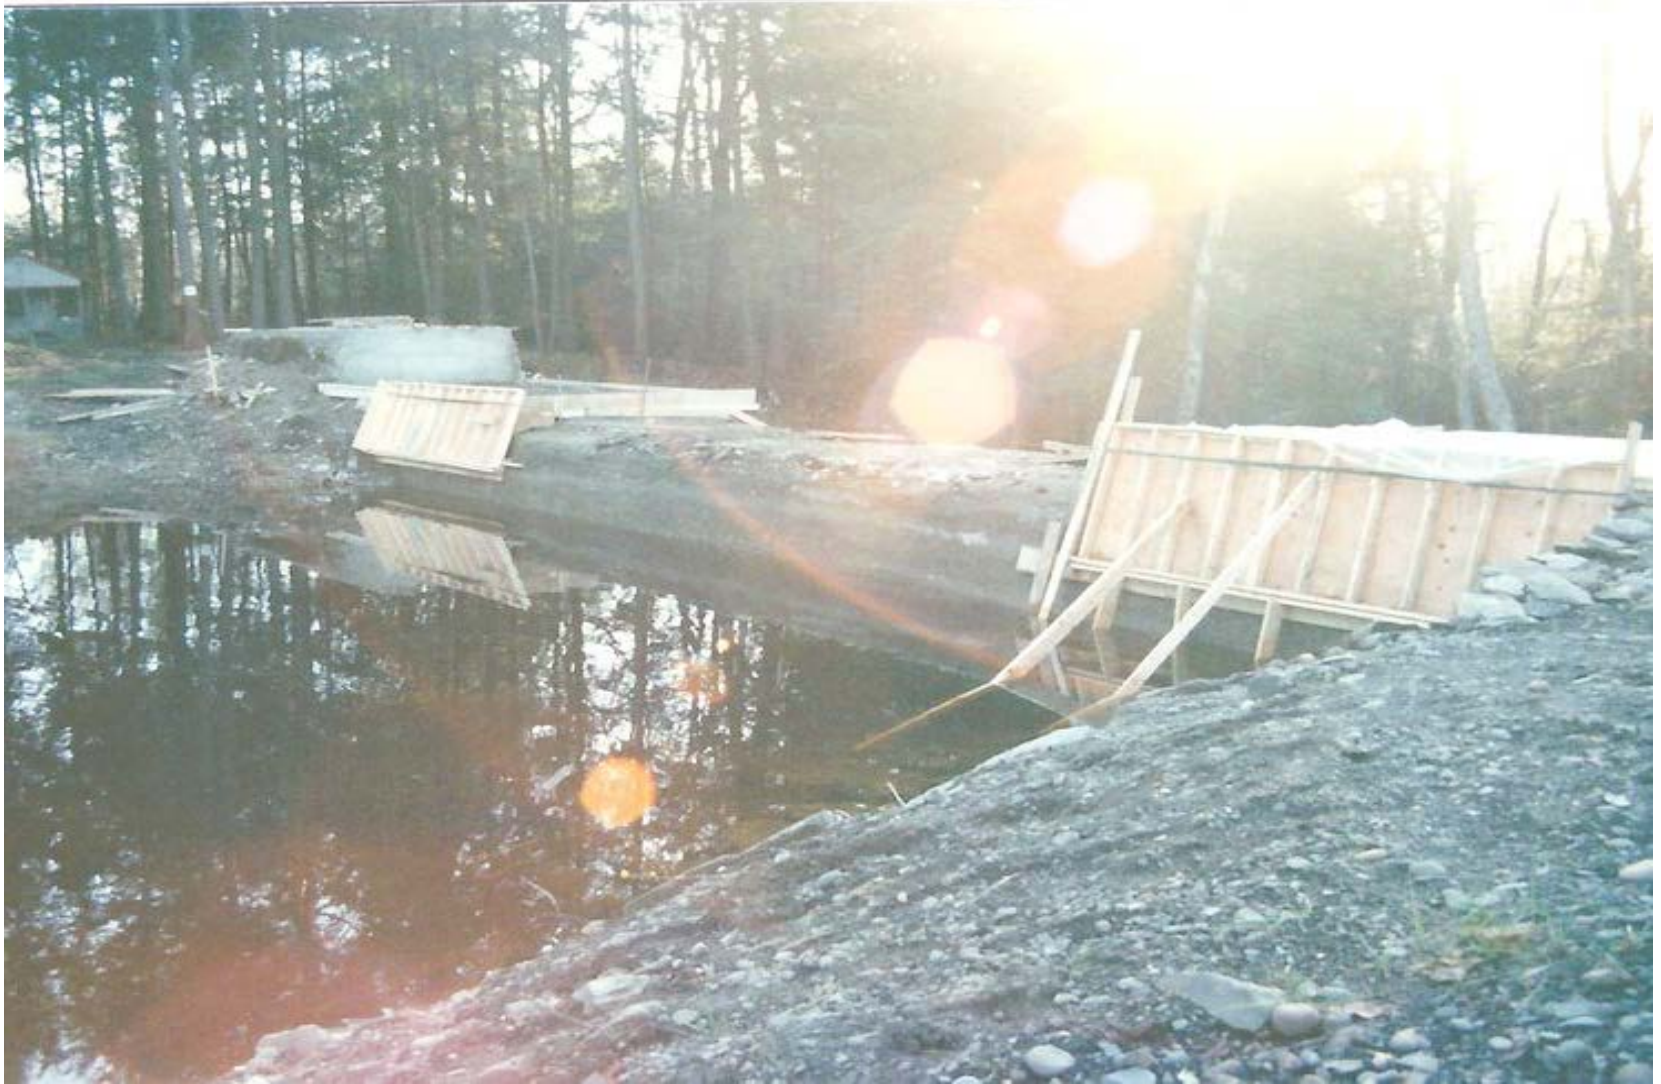
The larger concrete work such as spillway slabs and piers were contracted out for \$15,000 labor & material

IN THE FALL OF 1987, A CONTRACTOR WAS HIRED TO POUR THE CONCRETE SPILLWAY CAP AND PIERS WHICH WAS COMPLETED IN NOVEMBER. THE DRAINS WOULD REMAIN OPEN FOR THE WINTER TO KEEP WATER AND ICE OFF THE SPILLWAY
