# BEAVER POND MANAGEMENT AS A TOOL TO CONTROL ALGAE BLOOMS IN A SMALL, PRIVATE LAKE

Patrick Rose

# Summary

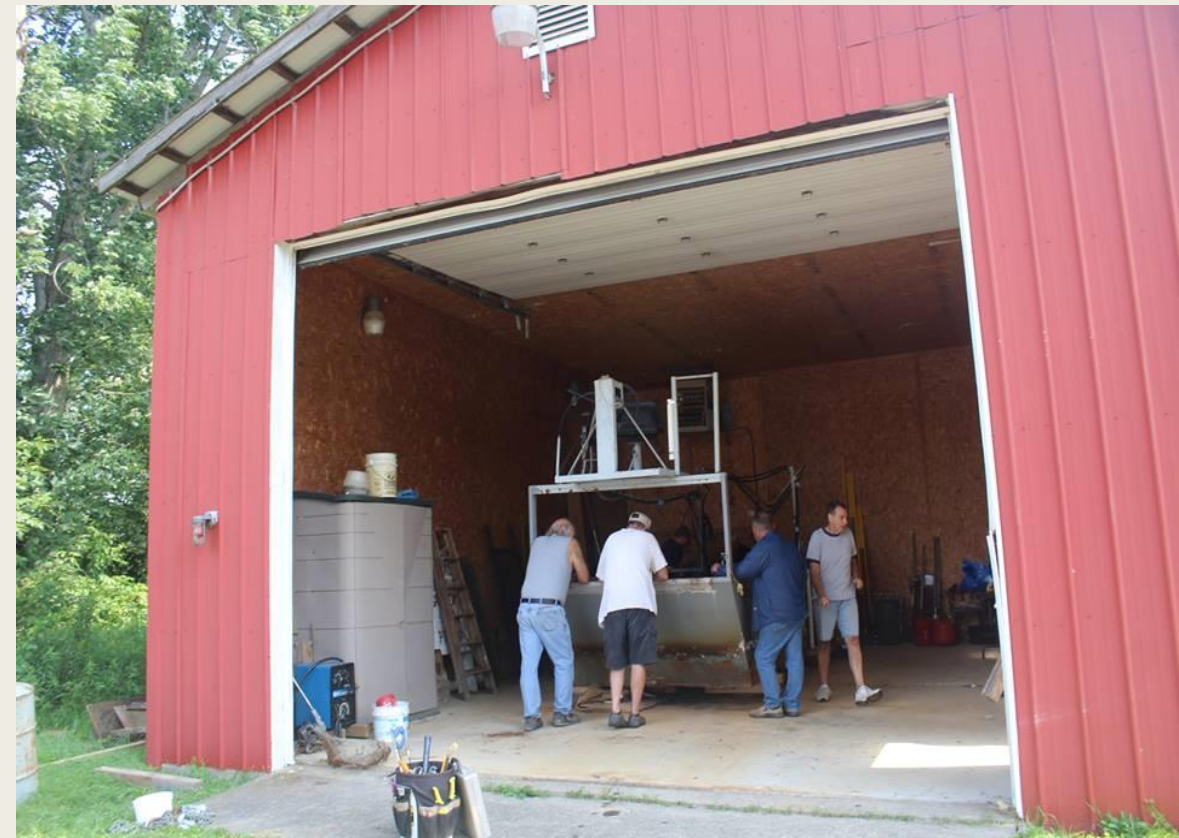
- PRLOA has been managing the lake since the 1960s
- Became concerned with excessive plant growth in the 1990s.
- Hired contractors in 1991 and 1992
- Built mechanical harvester in 1993
- Grass carp stocking began in 1994

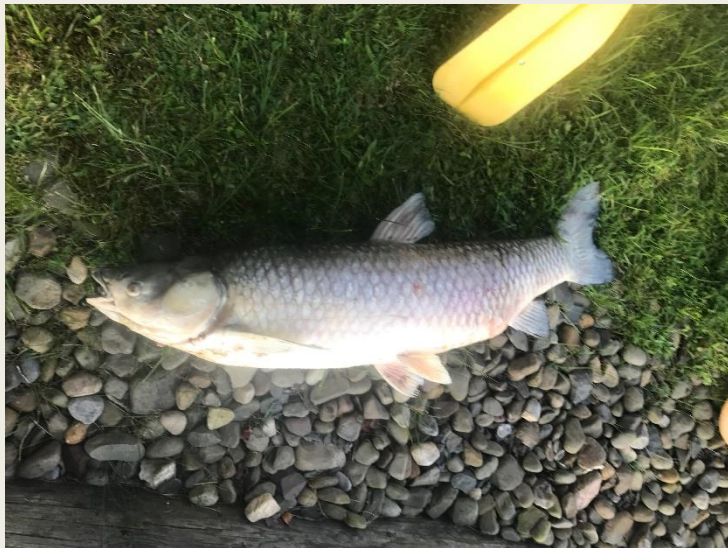
- 1,190 triploid grass carp stocked
- Targeting Eurasian watermilfoil
- Fish kill of ~150 grass carp in winter of 2016

Year	Number of Carp
1994	200
1997	250
2000	400
2005	100
2013	55
2014	100
2015	75

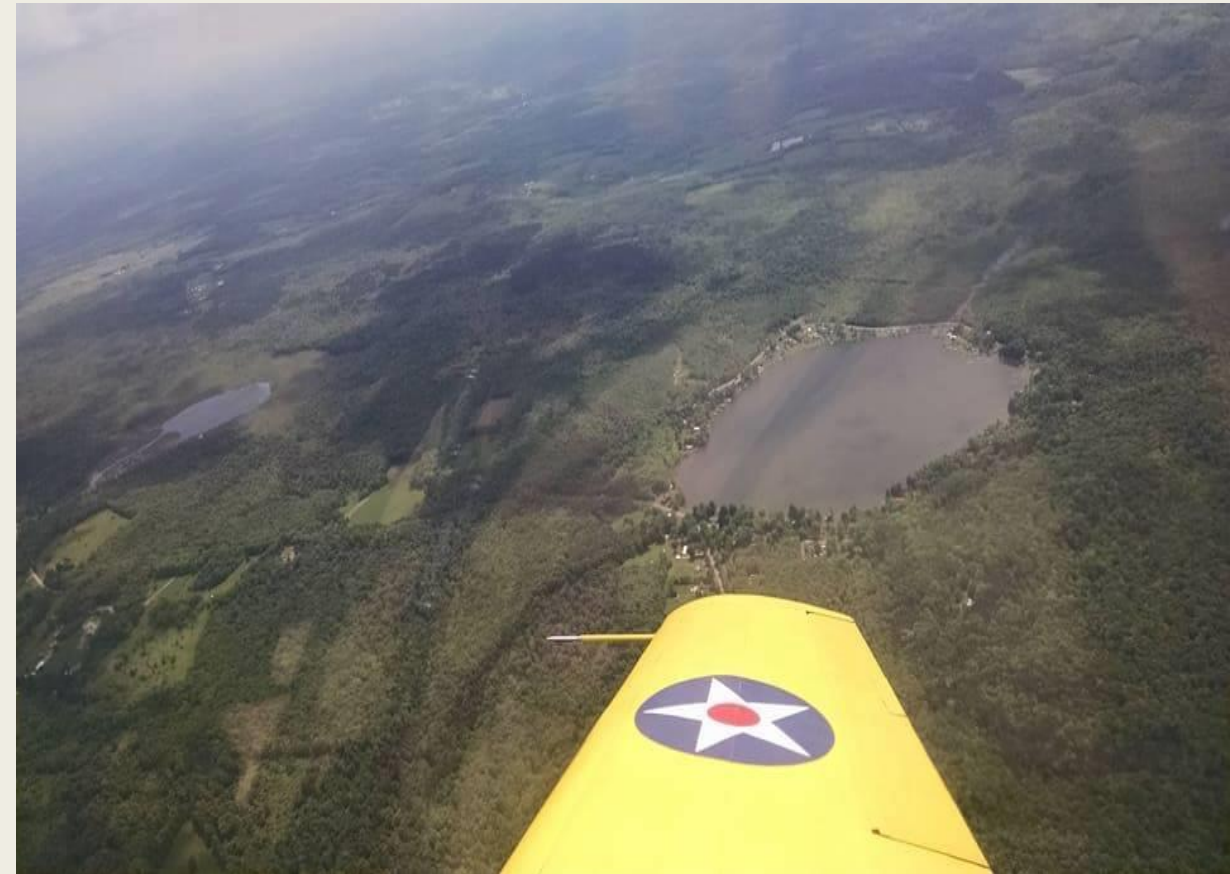
- Walked through watershed collecting water samples
- Total nitrogen, nitrate + nitrite, total phosphorus
- Most nitrogen samples below detection or low concentration
- Members of PRLOA suspected 2 beaver ponds may be source of nutrients

- Our nutrient data leads us to believe that the beaver ponds are a major source of phosphorus
- Water quality data and the location of Plymouth Reservoir at the top of a hill leads us to believe the lake is polymictic
- Extended periods of stratification could be causing the small hypolimnion to become anoxic
- Periods of hypolimnetic anoxia have the potential to activate and release phosphorus from the lake bottom

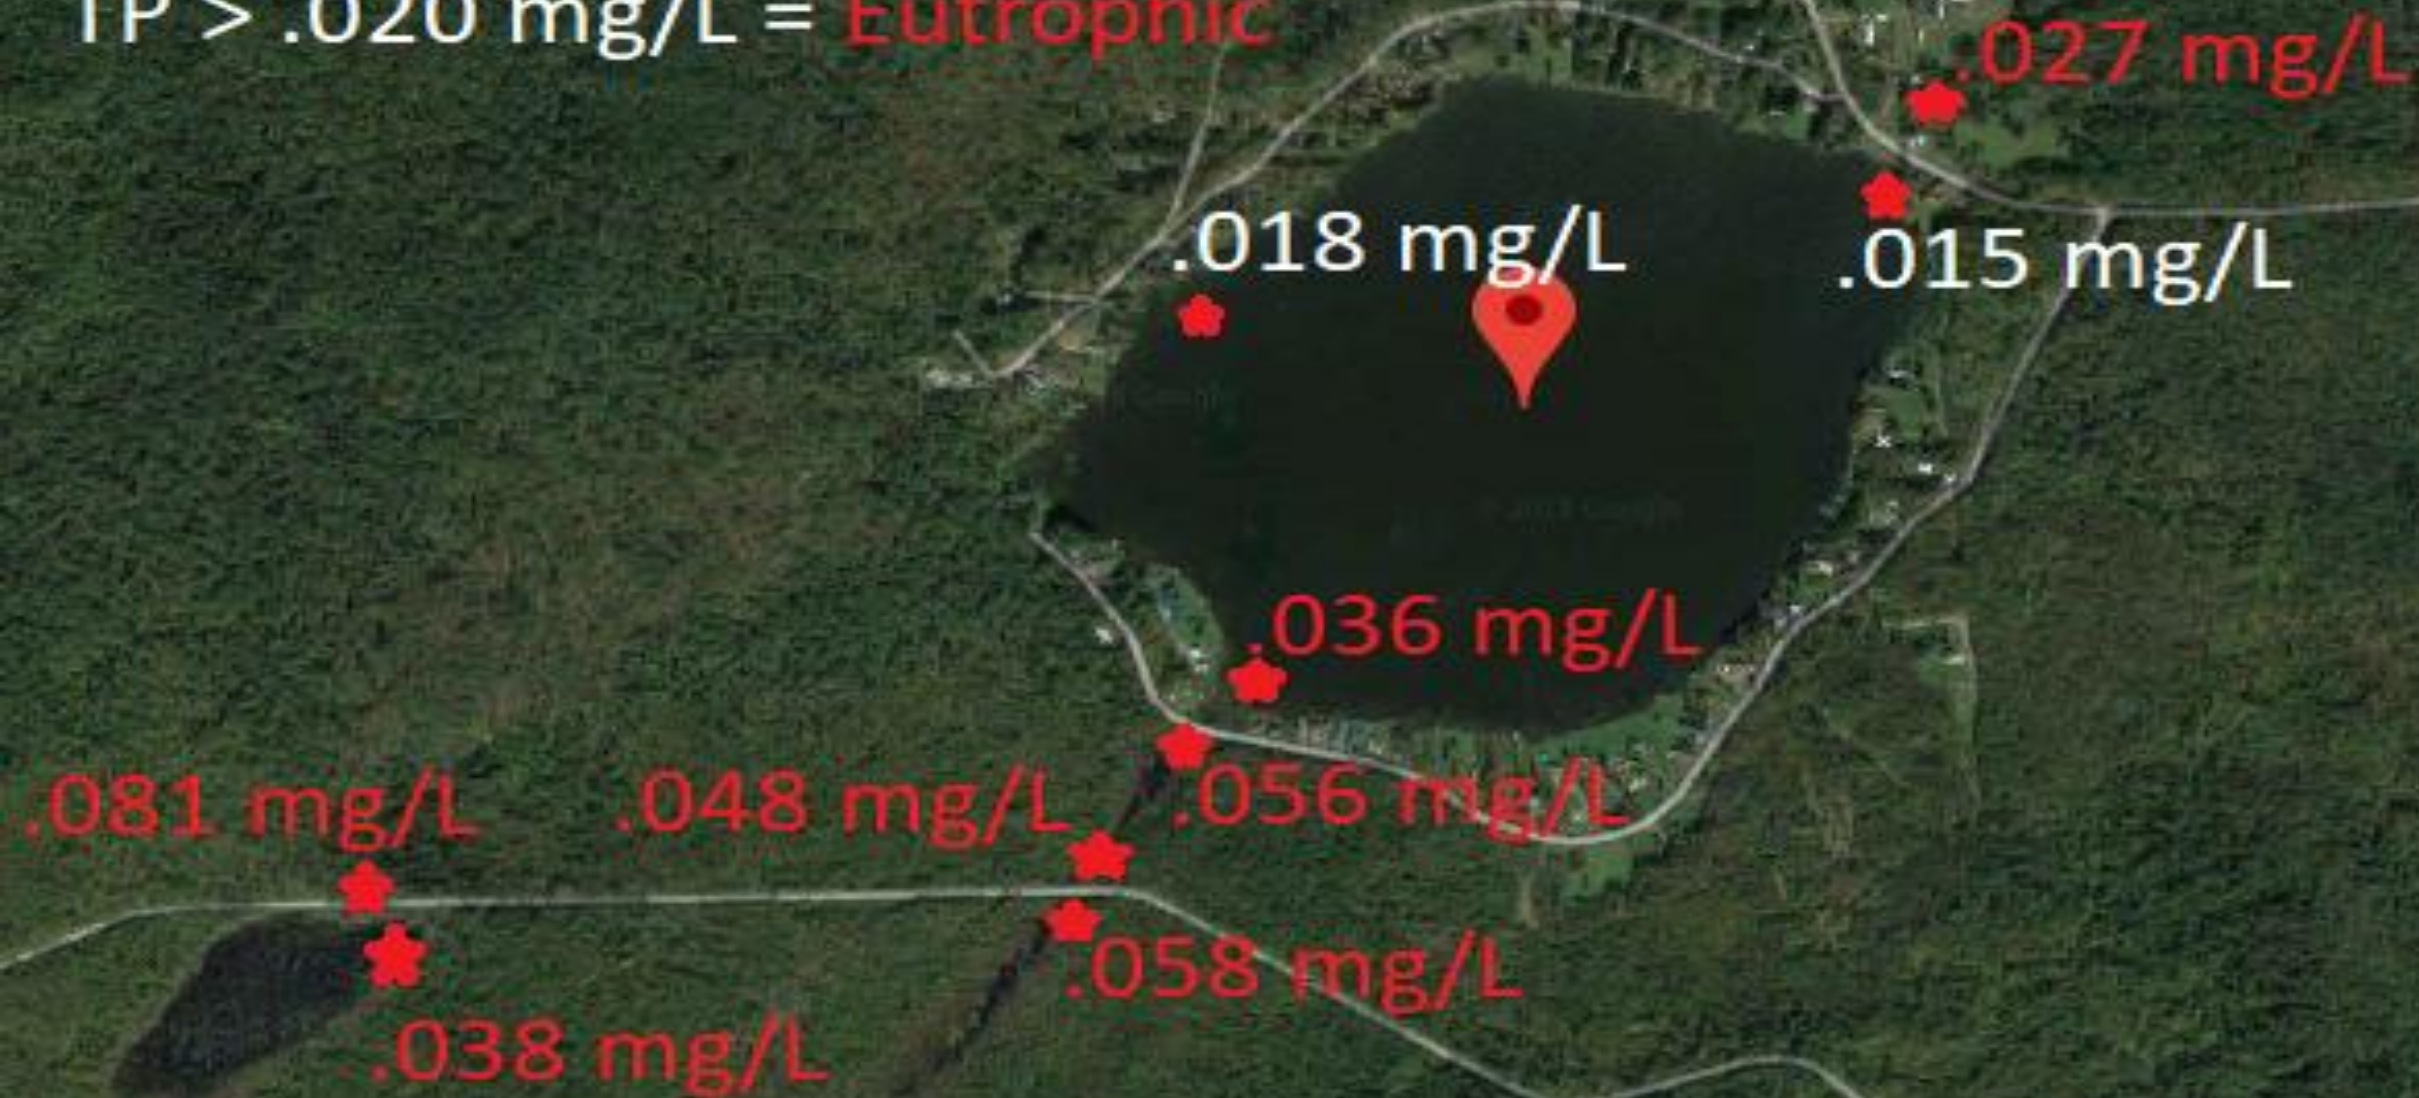
Total phosphorus

TP > .020 mg/L = Eutrophic

# Implications

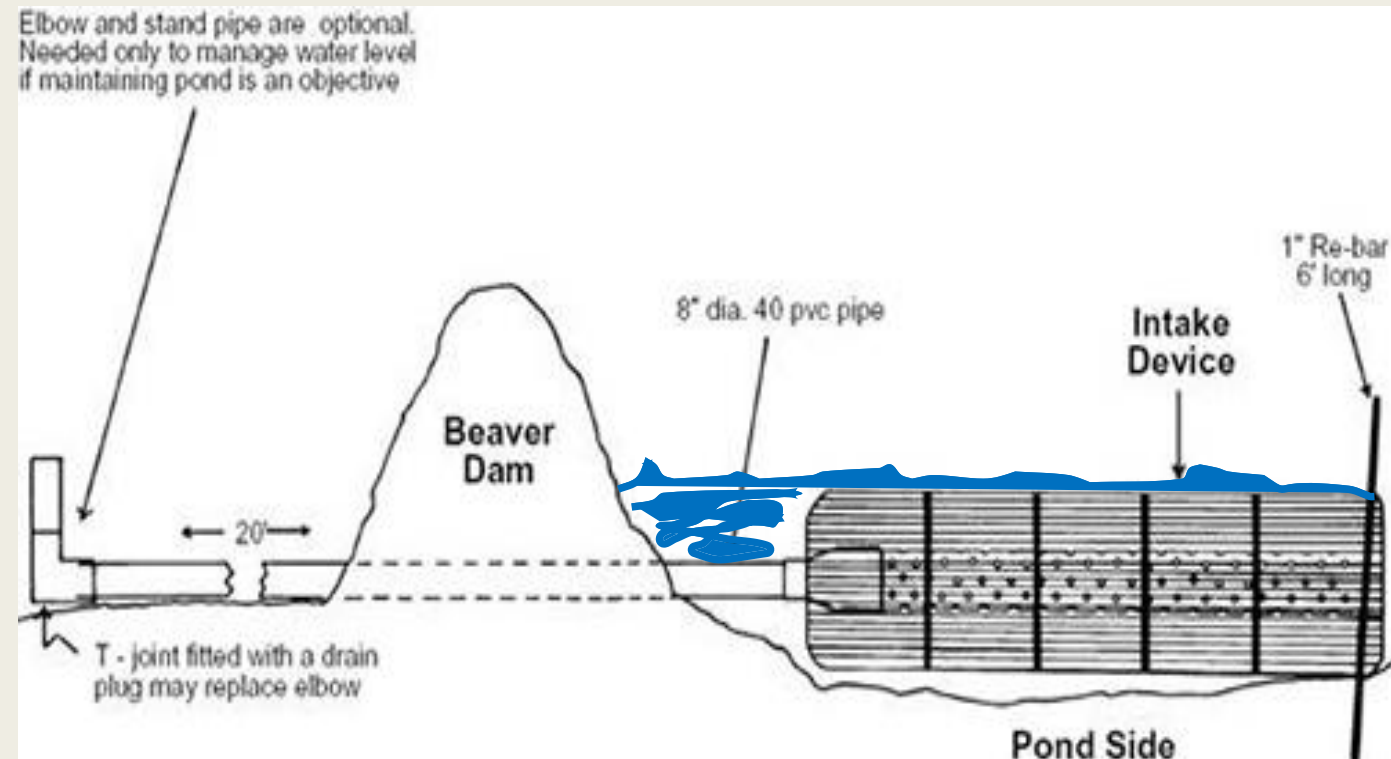
- Drainage system
  - *Ex: Clemson beaver pond leveler*
    - Beavers cannot detect water flow through the device
    - One device can handle ~3 acre feet/day

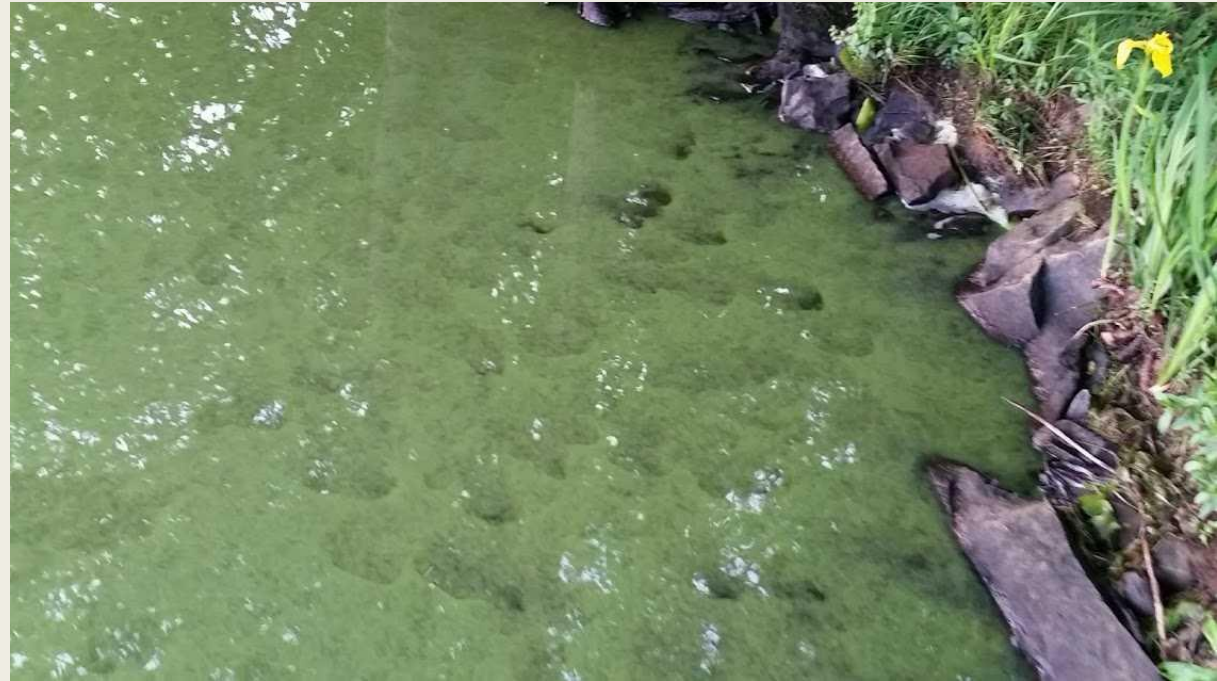
- Sequester nutrients and reduce runoff
- 2003 plant survey
  - *Broadleaf cattail*
  - *Eastern bur-reed*
- Target area: Two coves where beaver pond flow enters the lake
