Urban Watershed Renewal in Berry Brook, NH An Examination of Impervious Cover, Stream Restoration, and Ecosystem Resilience

Tom Ballestero, James Houle, Daniel Macadam 4 May 2019 Lake George, NY

Berry Brook Watershed Renewal Project

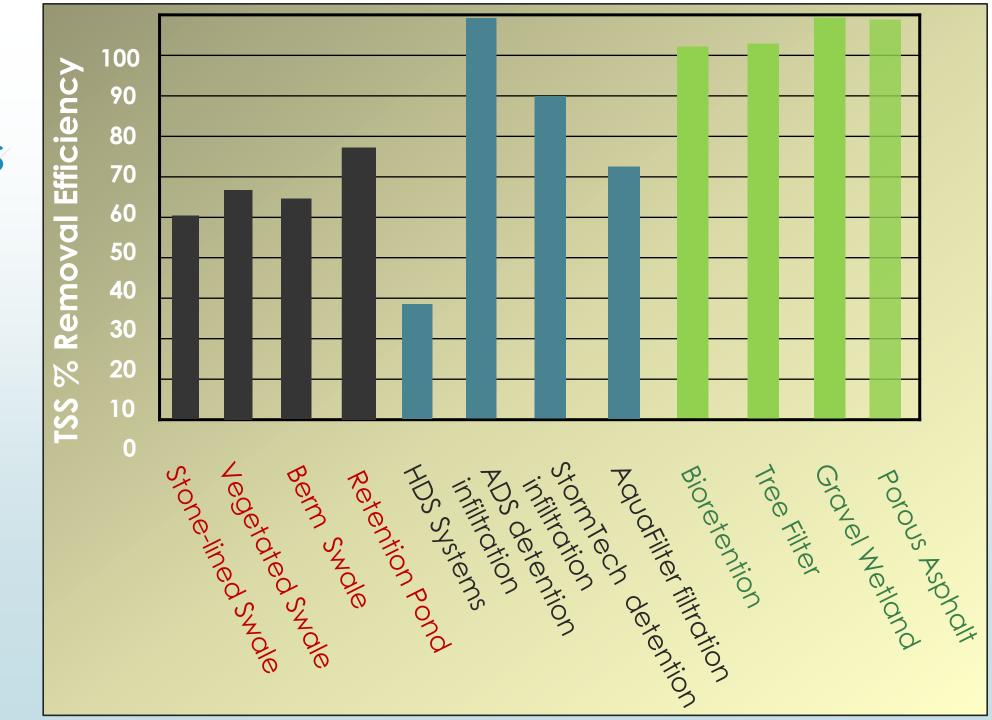
TSS Removal Efficiencies

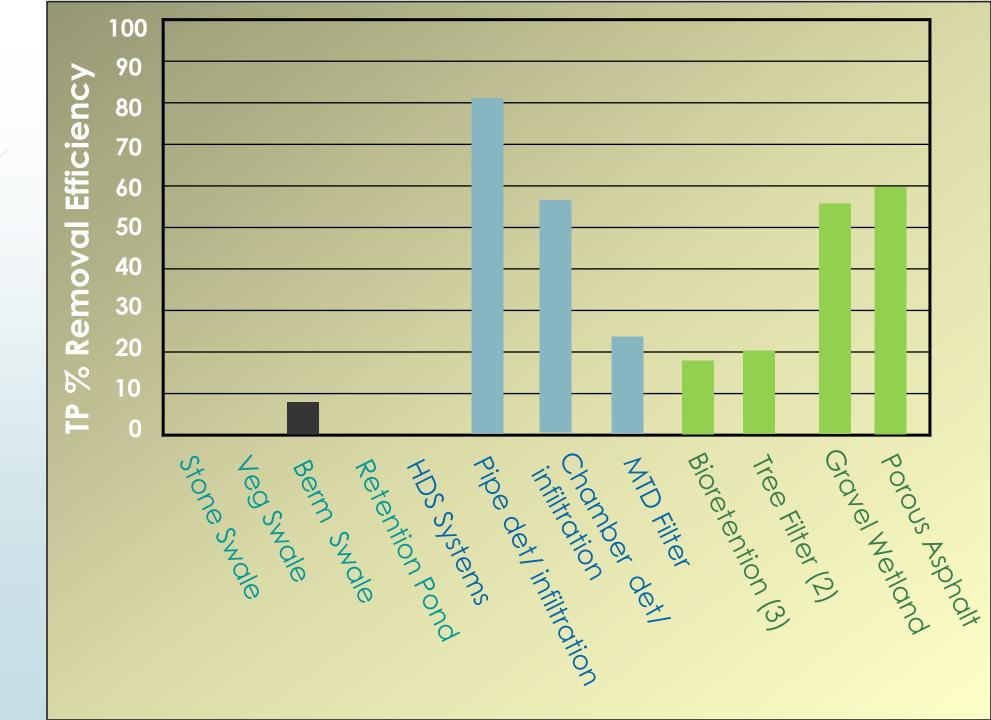
TP Removal Efficiencies

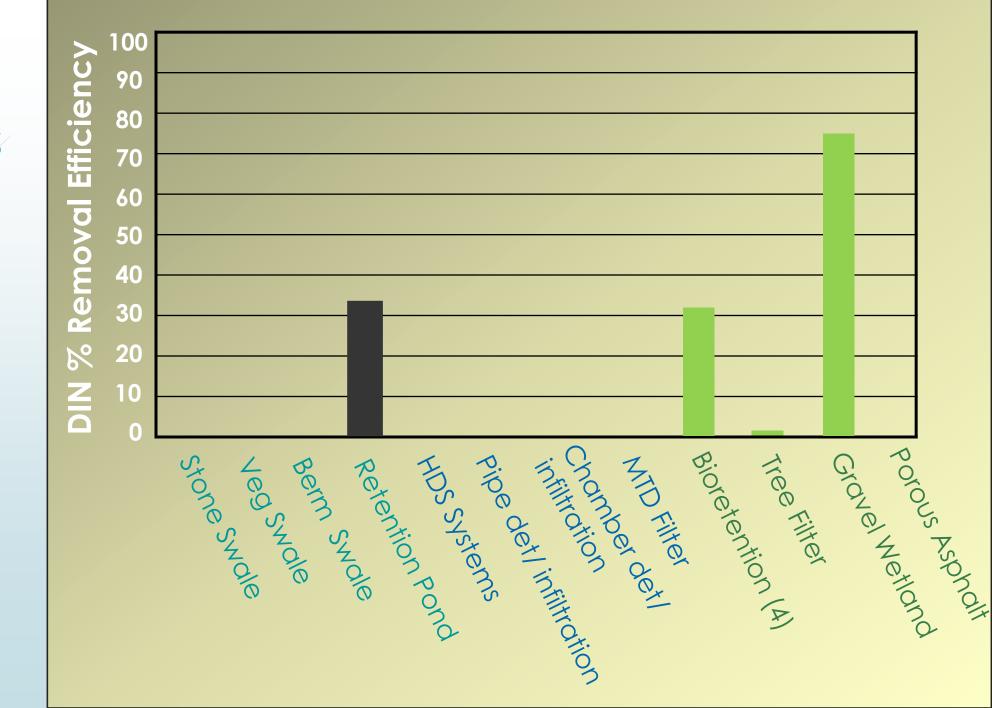
DIN Removal Efficiencies

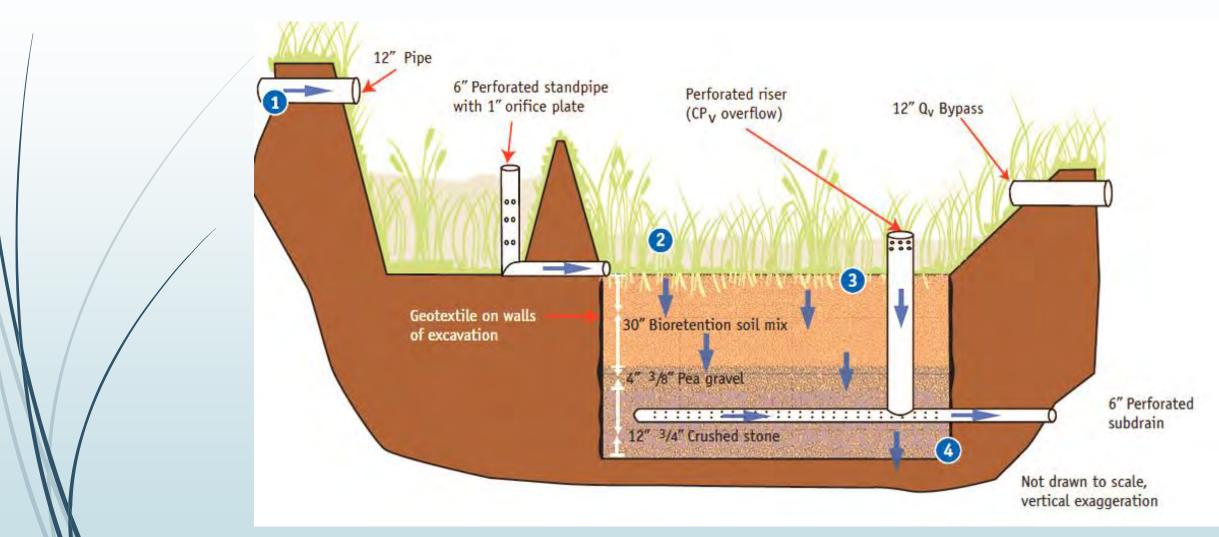
Introduction: Bioretention Filters

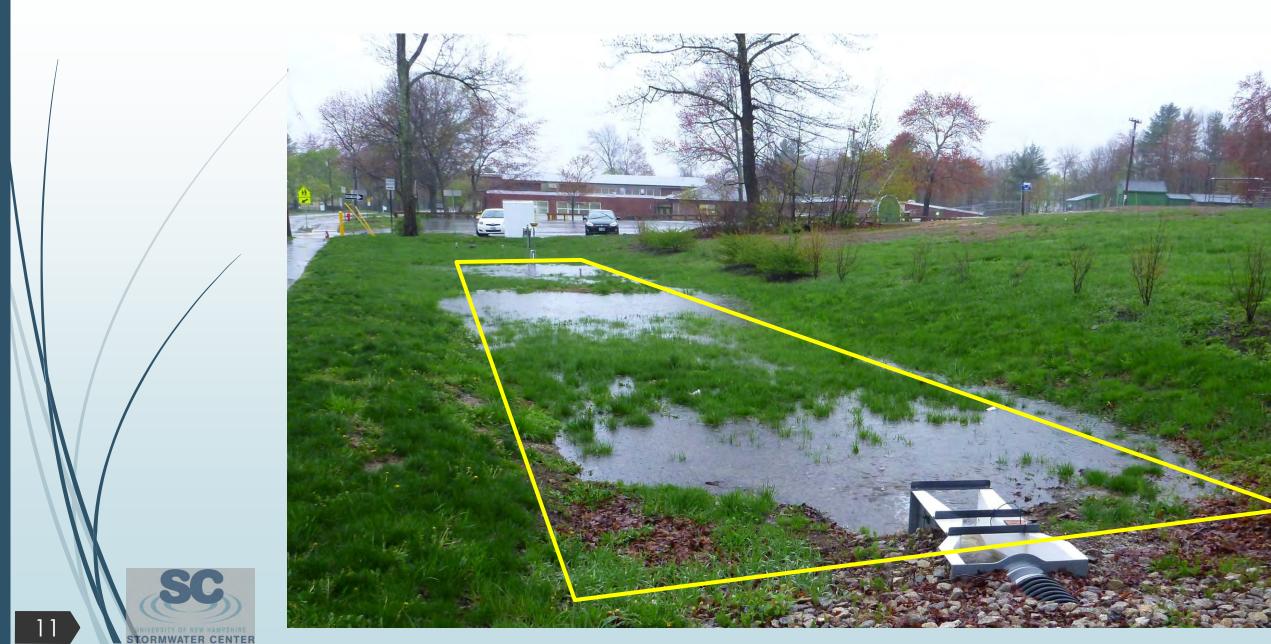
Site Study: Bioretention (during 1 in. storm)

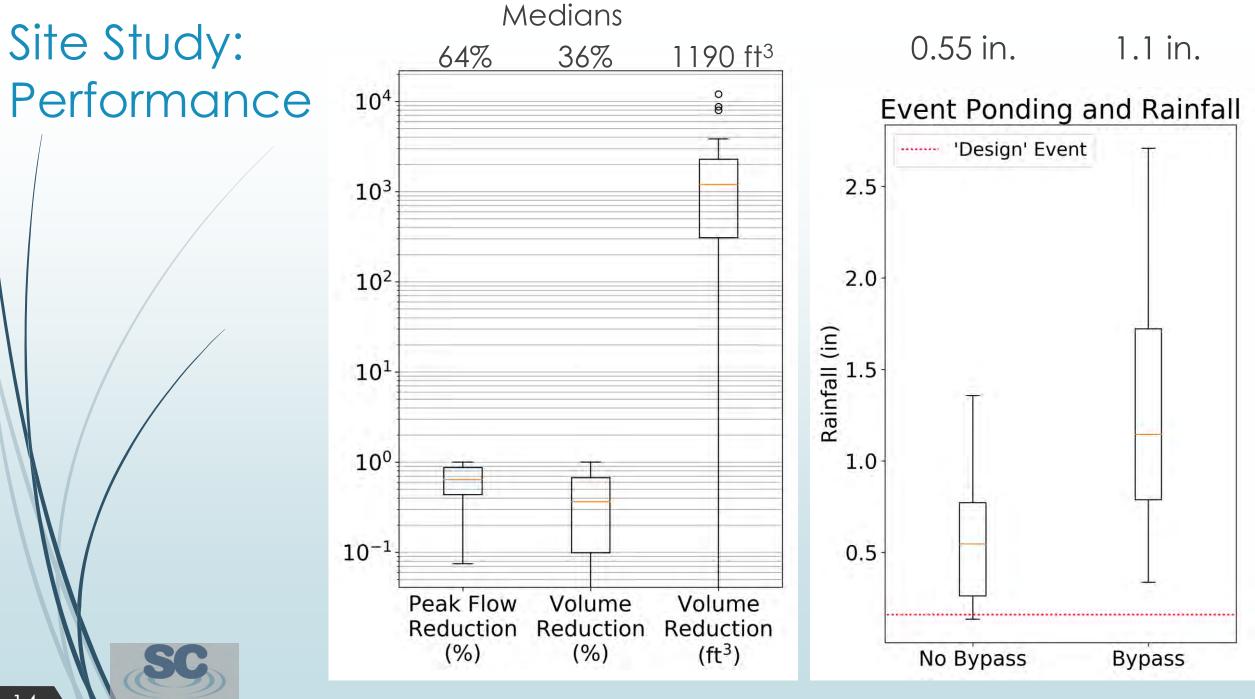
Site Study: Horne St., Dover, NH

- Watershed area 22 acres
- Subdivision of 1/3 ac. lots
- 38% impervious cover
- CN 60
- Time of concentration
 - Estimated with TR-55 Velocity method: 17 minutes
 - Median observed: 16.5 minutes
- Median observed lag time of 9 minutes
- Filter is 2,100 ft² (140 ft x 15 ft)
- Watershed to bioretention area ratio of 455:1
- Current design rainfall 0.16 inch

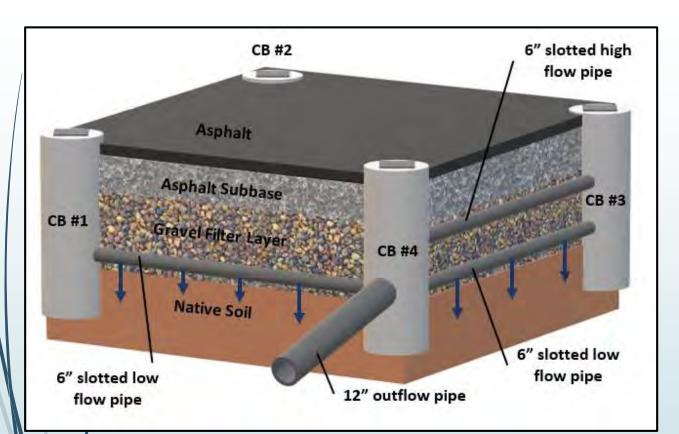
Grove St. System

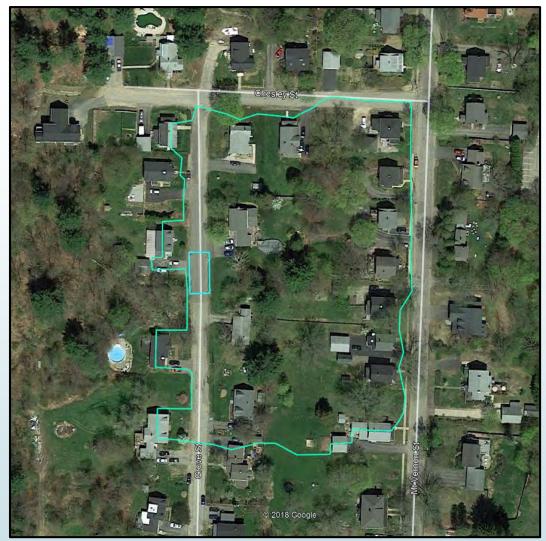
System Diagram

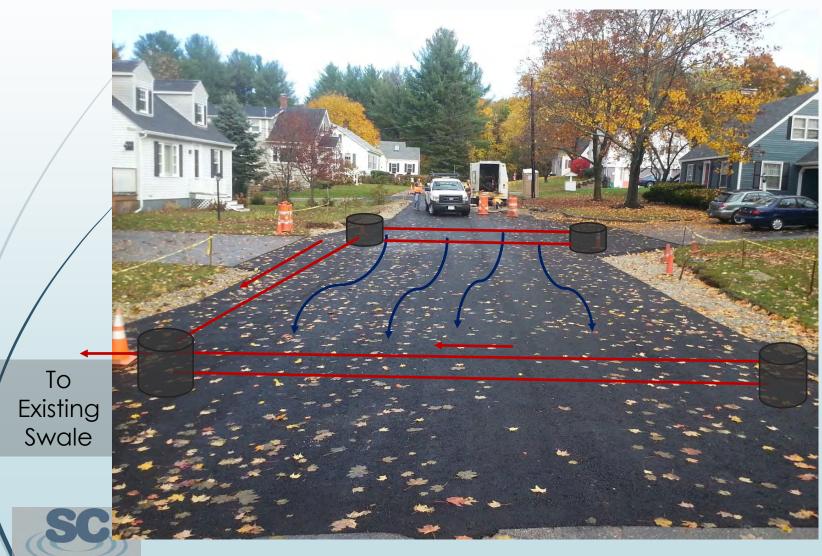
GI: Subsurface Gravel Filter

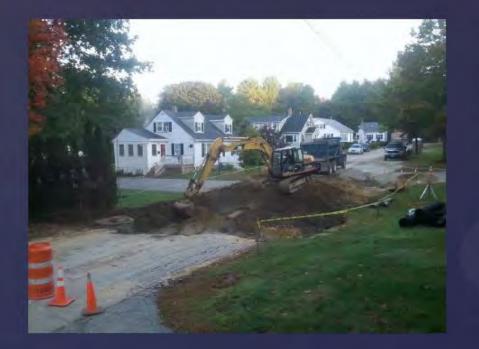
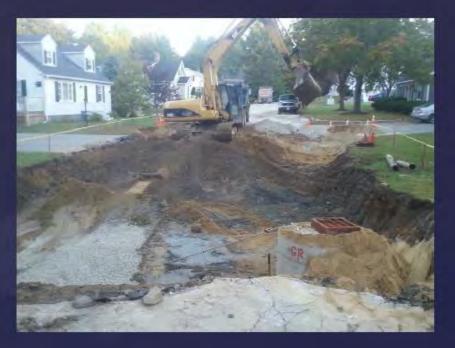
Excavation 90% complete

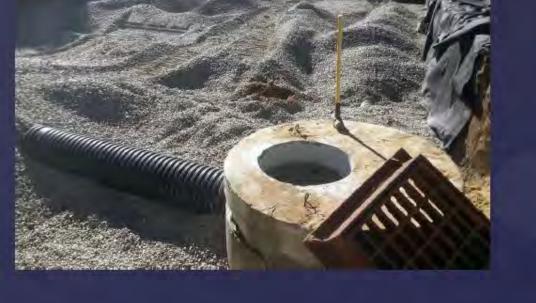
Pipe installation

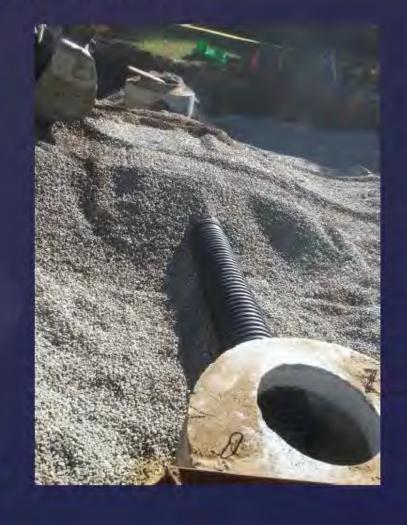
Pipe installation between CB#1 & CB#2

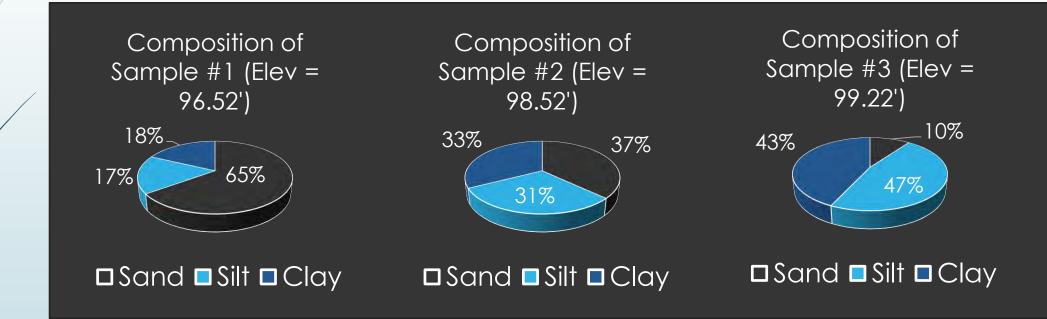
Grove St. Native Soil Composition

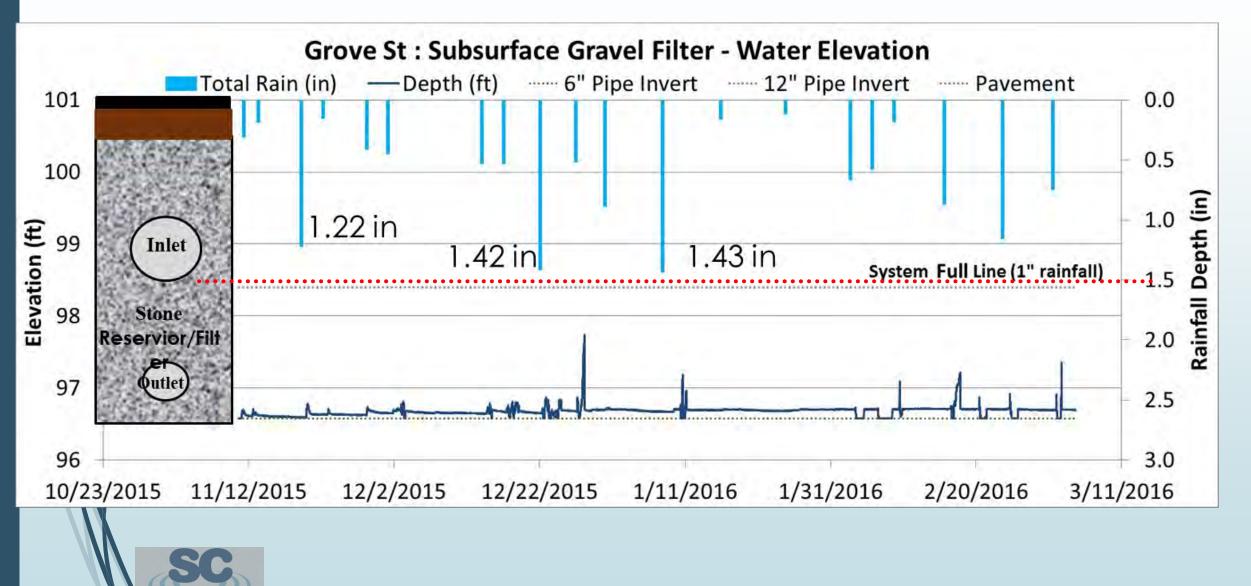
System Water Level History

- Cumulative runoff volume reduction of 84%
- Peak flow reduction of 88%
- System never completely filled
 - Maximum water depth of 1.94ft for 1.25-inch rain event on 4/6/2017

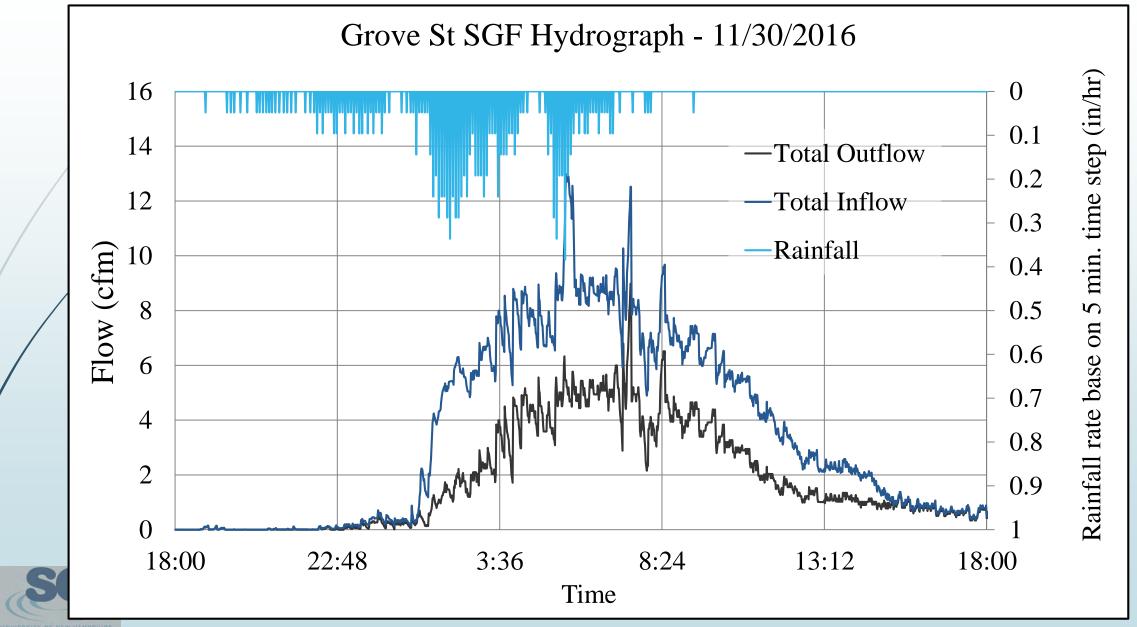
Develop Storm Hydrographs

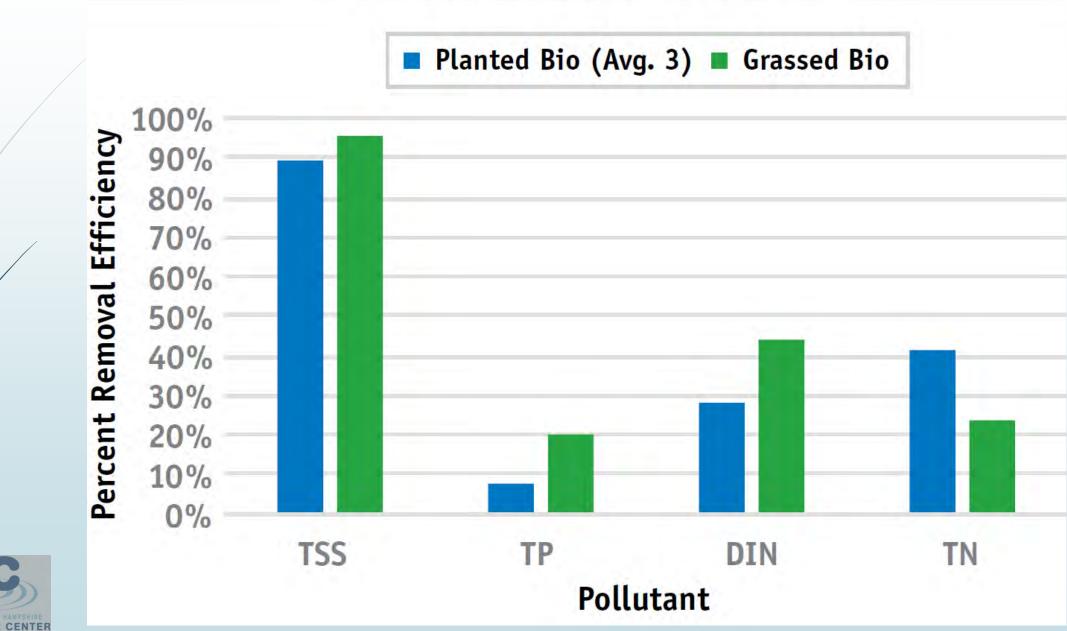
Comparison of Pollutant Removal Efficiency Planted vs Grassed Bioretention

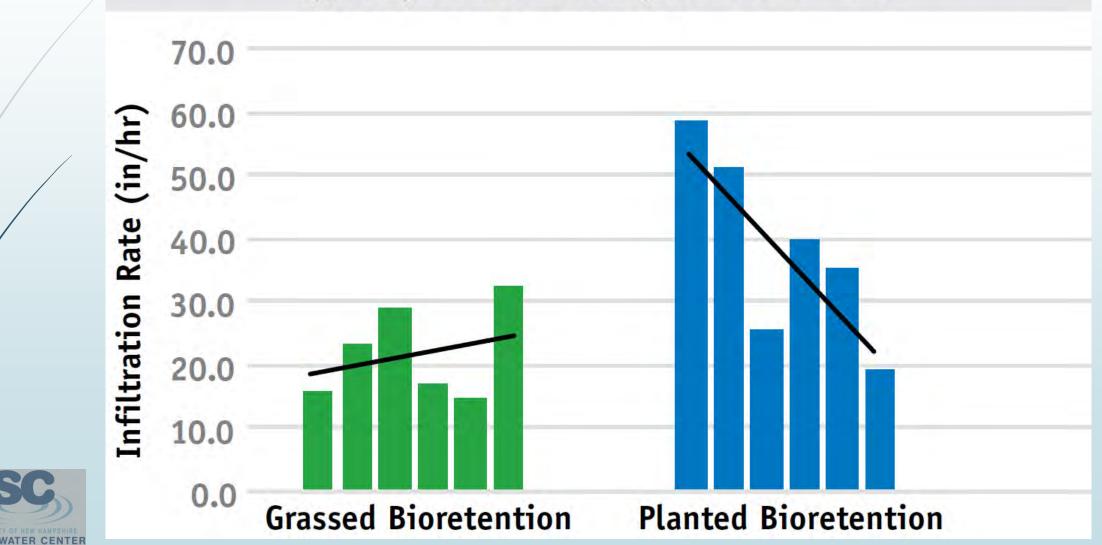
Grassed vs Planted Surface Infiltration Rates

Average Infiltration Rates of a Planted (blue) versus Grassed (green) Bioretention Systems Over Time

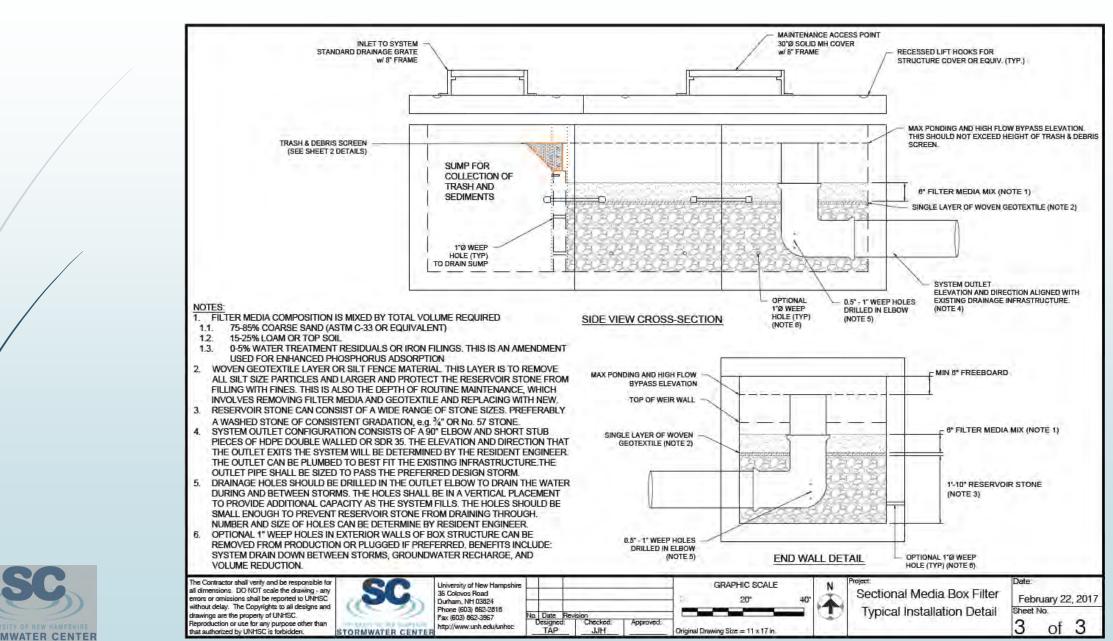
Sectional Media Box Filter Design – version 3

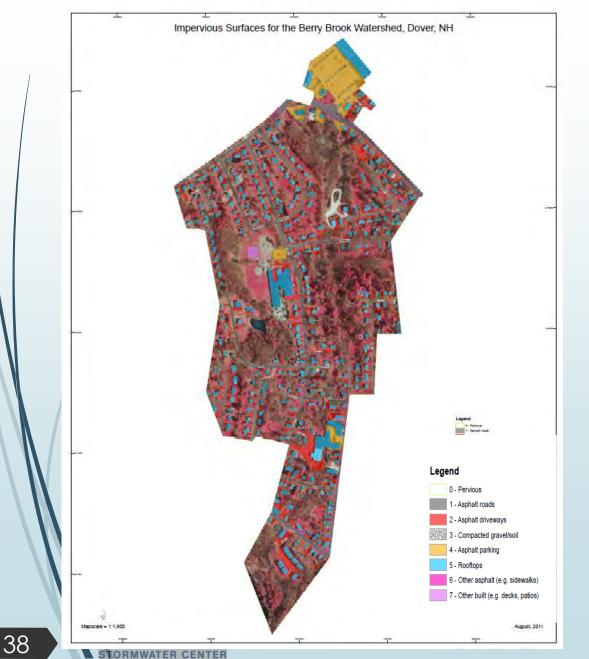
Berry Brook Watershed Overview Impervious Surfaces

Surface	Area (acres)
Total Watershed	185
Pervious	129.4
Asphalt Roads	14.3
Asphalt Driveways	12.4
Compacted Soil	1.0
Parking Lots	7.0
Rooftops	17.6
Other Asphalt	1.7
Other (decks, patios)	1.3
Impervious Total	55.3 (30%)

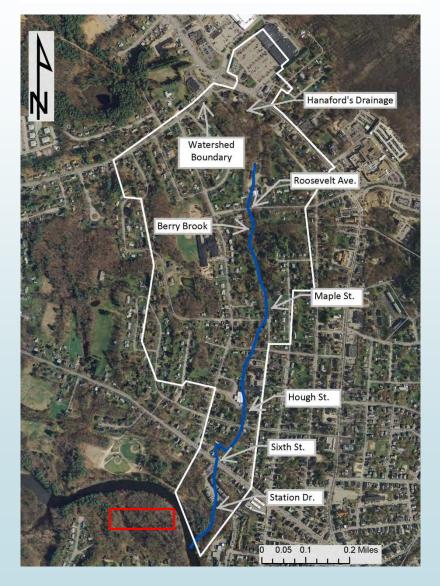
Berry Brook Watershed –Delineation and Monitoring Locations

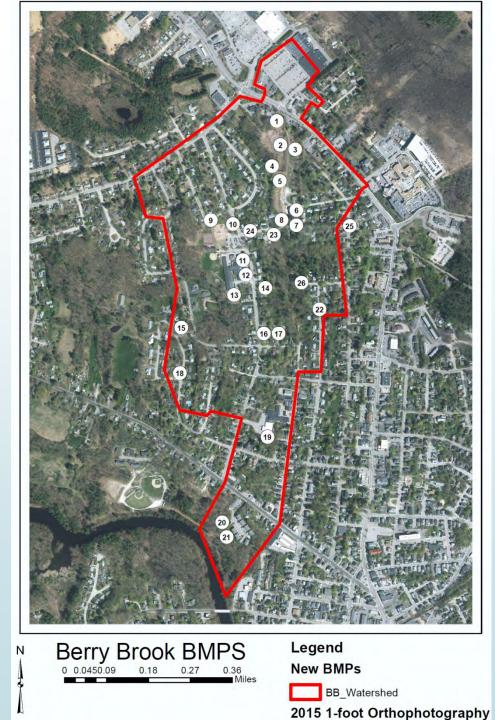
Retrofit Locations

Crescent Ave DA = 2.97 ac Treated IC = 1.5 ac (28.5%)

Glencrest Ave DA = 6.8ac Treated IC = 2.3 ac (33%)

Upper Horne Street DA = 12.2 ac Treated IC = 3.7 ac (31%) Gravel Wetland DA=11.0 ac, Treated IC = 9.55 ac (86.8%)

> Page Ave DA = 5.23 ac, Treated IC = 1.88 ac (36.0%)

Wetland Expansion ~0.6 acres

Lowell Ave DA = 2.6 ac Treated IC = ac (43%)

Stream Restoration
 ~800 ft, including C, A
 and Aa - channel

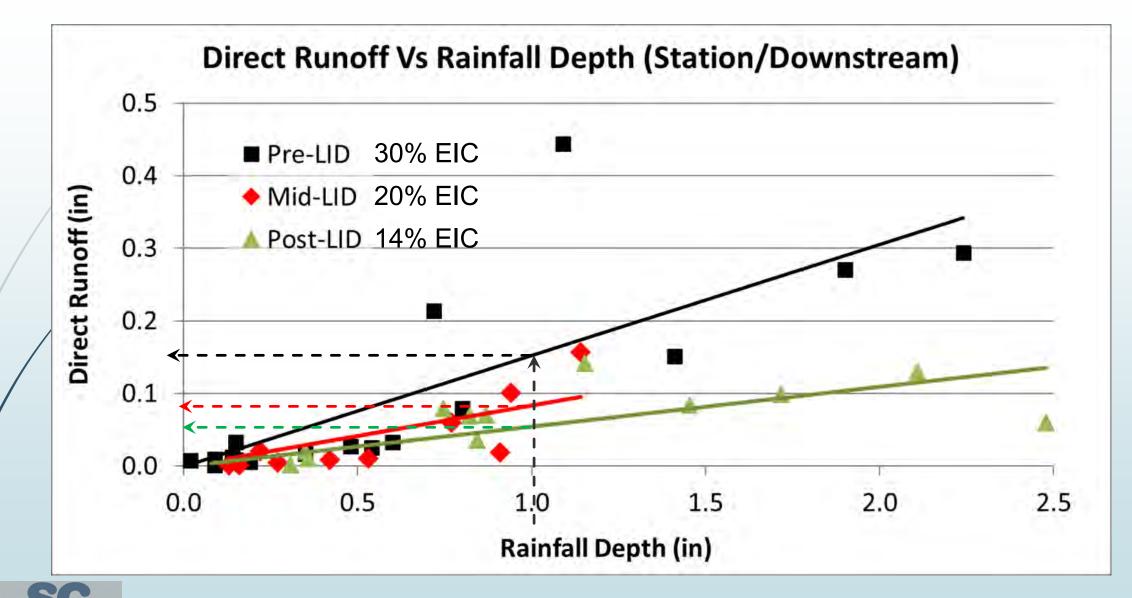
Reducing Runoff Volume

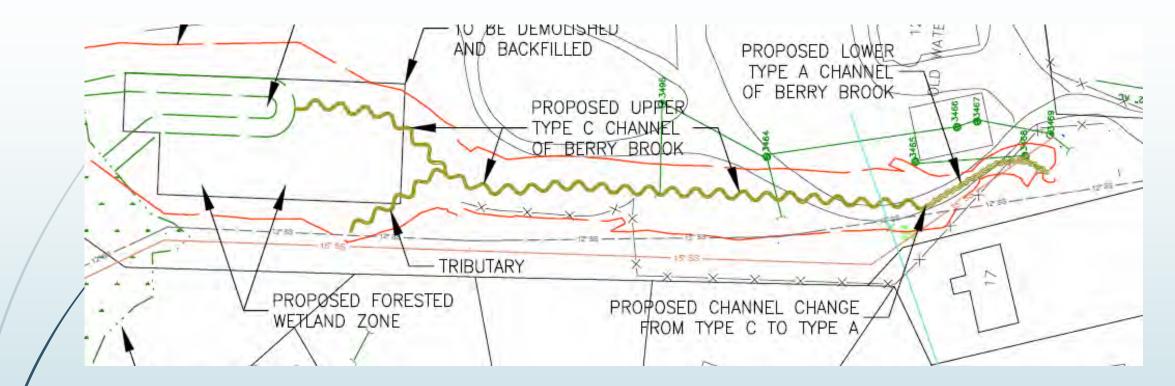
Initial Design

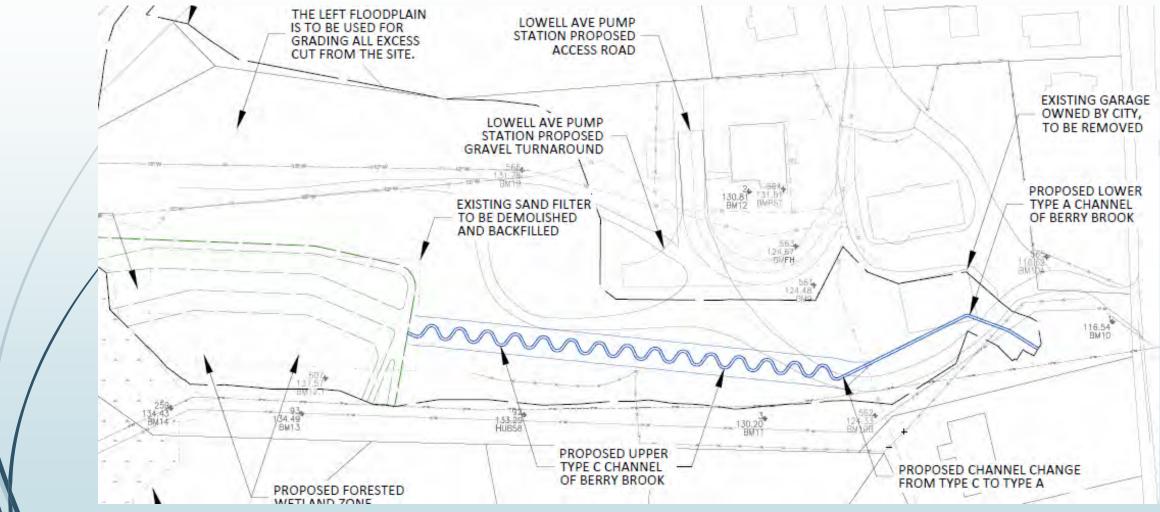
Expanded Wetlands, Shrinking Stream

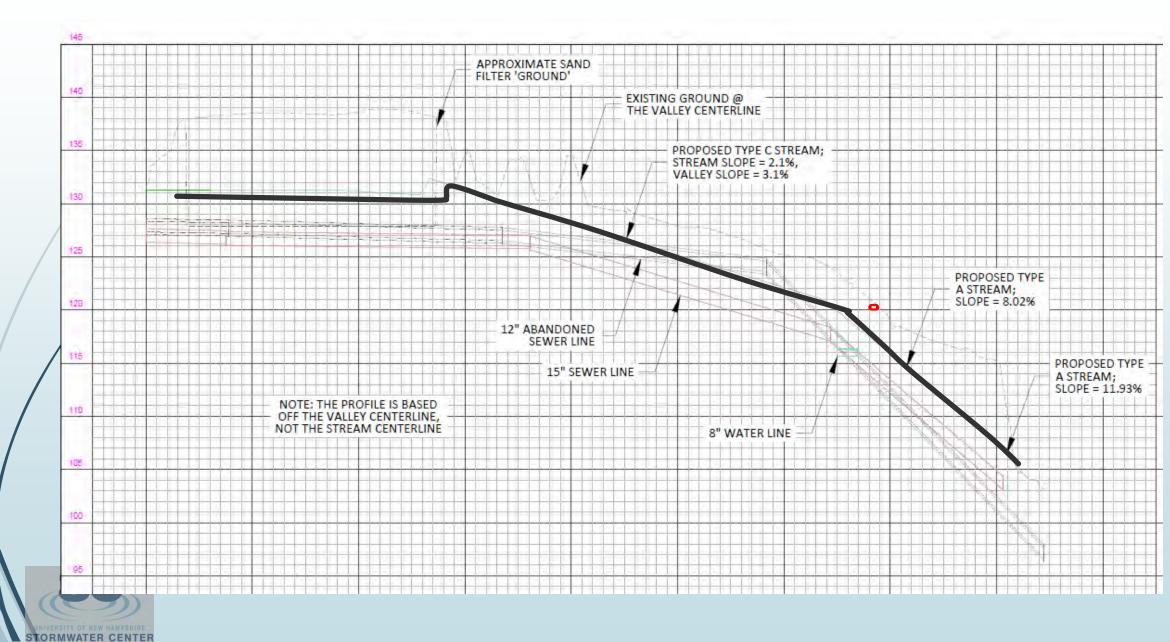
Design Profile

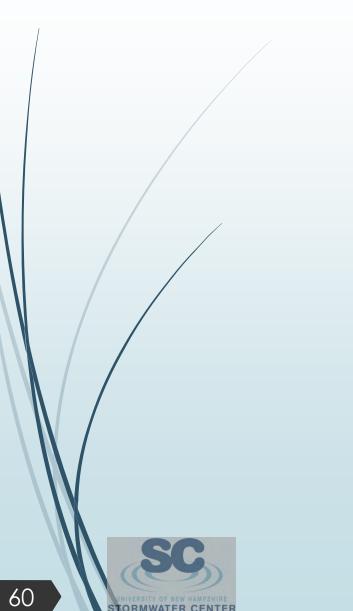
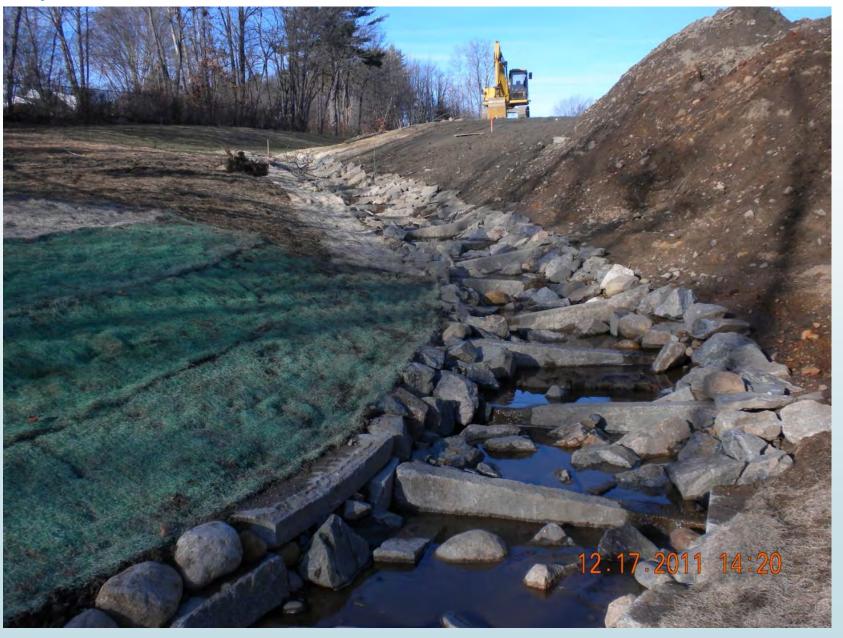
Construct Aa Step-Pools

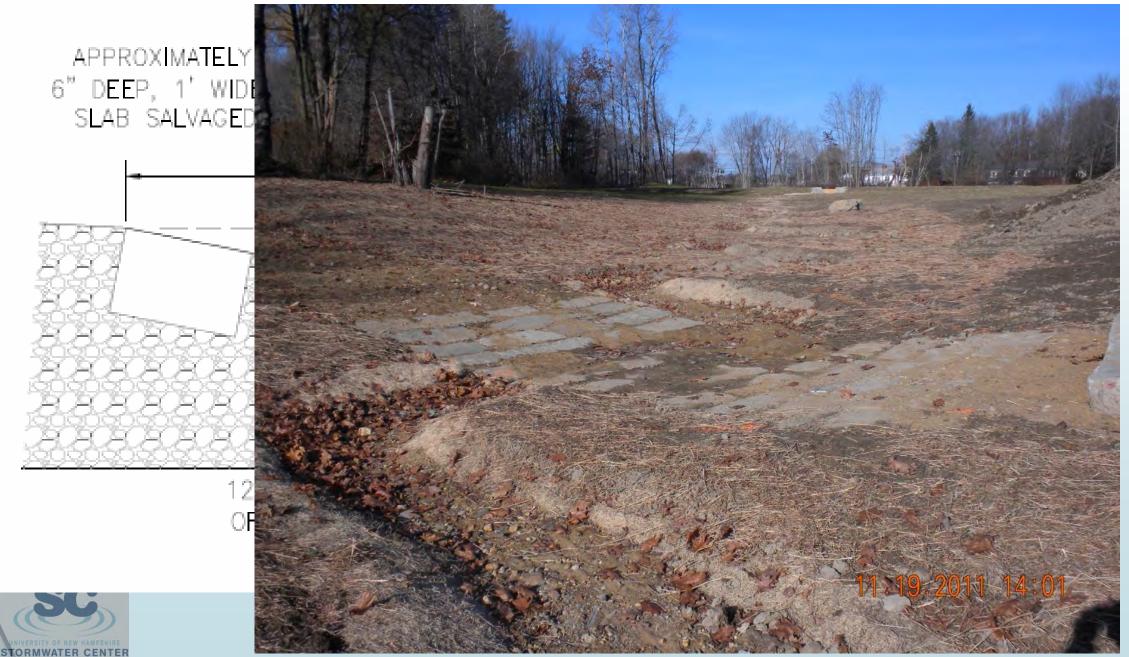
At-Grade Stream Crossing

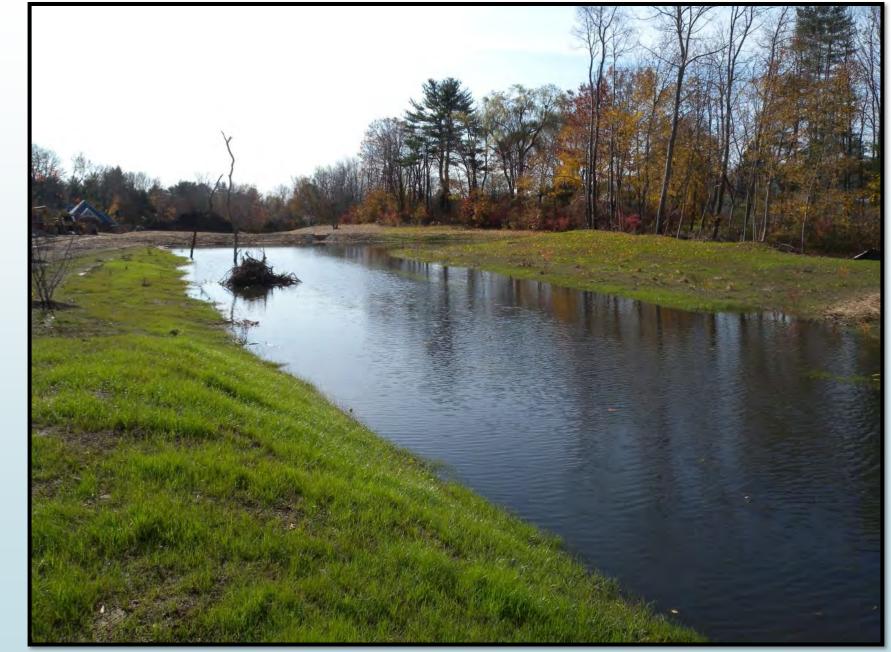
Created Wetland

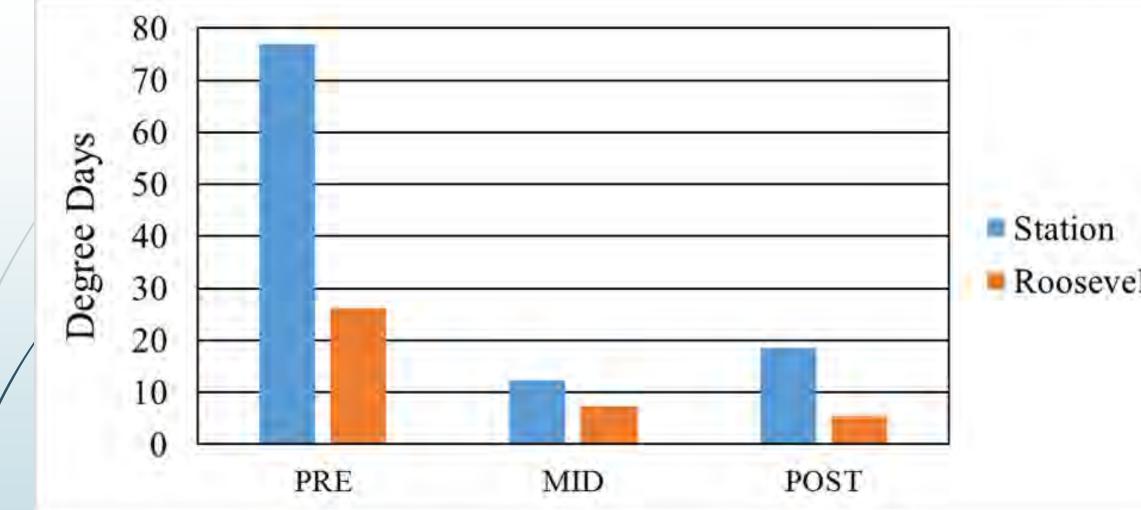
Summer Cooling

One degree day is a day when the average stream temperature is one degree Fahrenheit above 65 degrees F. This is important as the temperature that a Brook Trout begins to feel heat stress is 65 °F. Therefore a day with an average daily stream temperature of 71 degrees would represent 6 degree days.

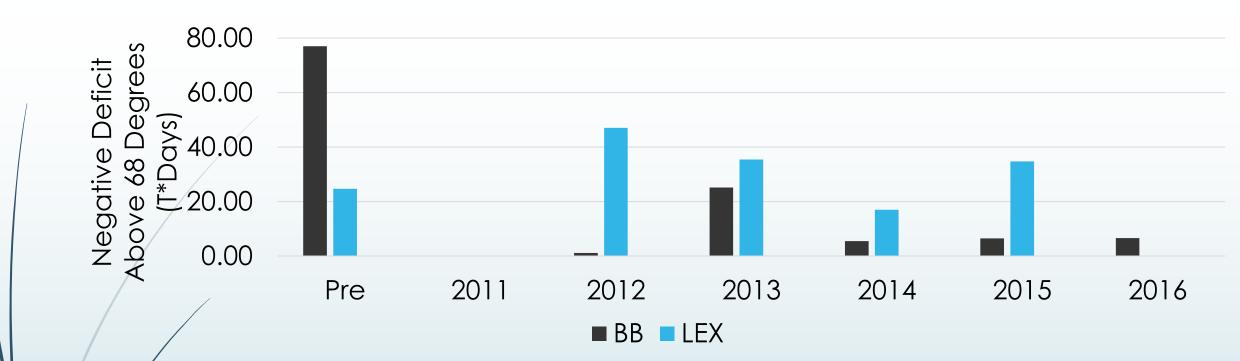
Thermal Response
