New York State Parks, Recreation and Historic Preservation

Lake Welch Watershed Management and HAB Mitigation Efforts

May 4, 2024

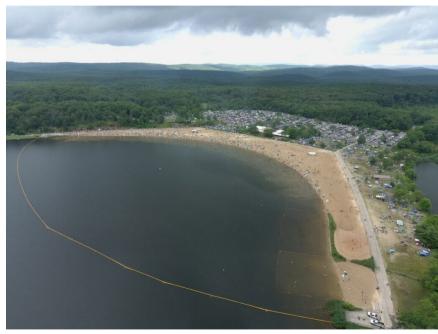
2023 Short Term Mitigation Stratgies

Ultrasonic Devices April- Sept

Boom

May - October

Algaecide

June
