Occupies a glacially scoured valley

Constructing historic land use – land cover patterns for the Honeoye Lake watershed and exploring their relationship to modern lake condition.

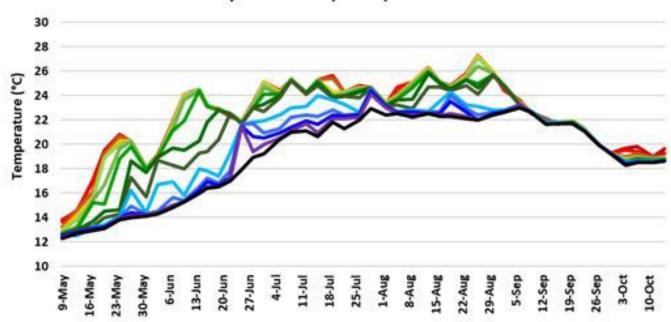
Honeoye Lake Deep Temperature 2021

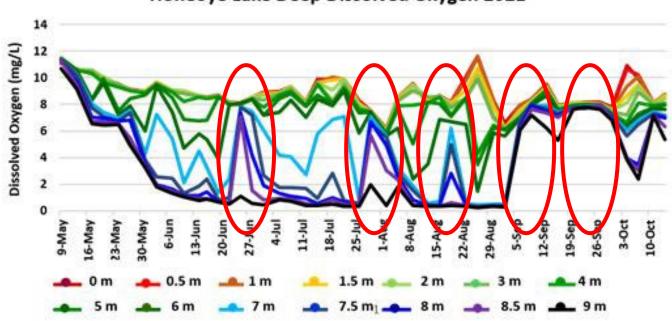
Honeoye Lake Deep Dissolved Oxygen 2021

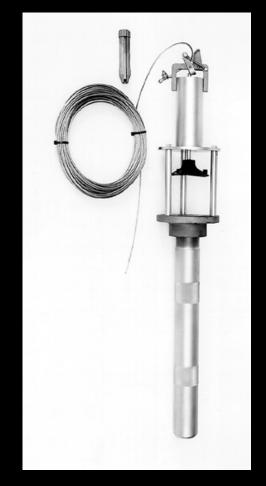
sediment corer

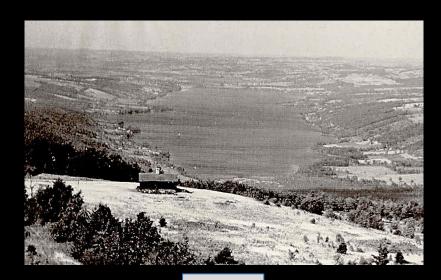
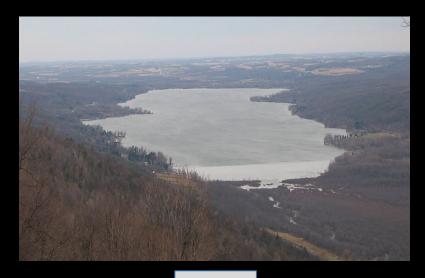
1940 2006

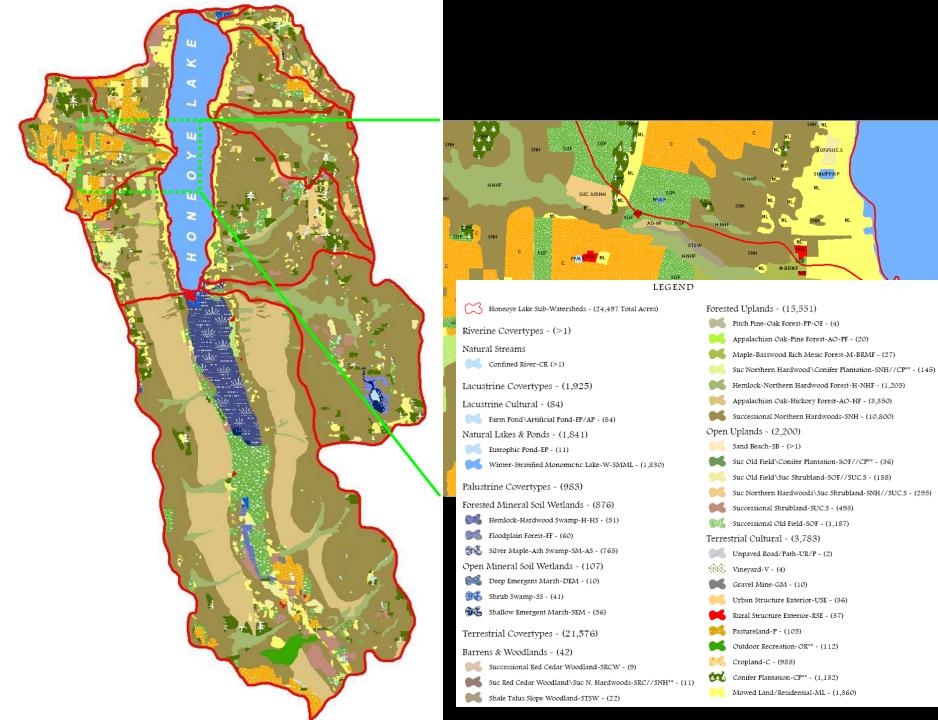
Modern Watershed

- 4 major systems: riverine, lacustrine, palustrine and terrestrial
- 10 subsystems: natural and cultural categories
- 38 community cover types and numerous linear and point features
- 5 natural communities have significant NY-NHP state-wide ranking: discontinuous cold polymictic lake, floodplain forest, silver maple-ash swamp, shale talus slope woodland, and maplebasswood rich mesic forest

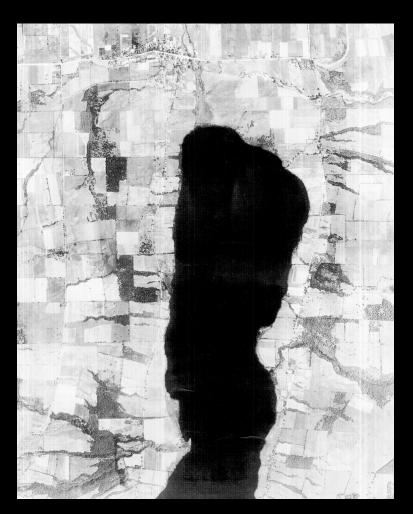
North end of Honeoye Lake in 1929
