Suozzo, Doty & Associates

2026 NYSFOLA Annual Conference
May 8-9, 2026

Case Studies of Septic System Impacts on Surface Water Quality

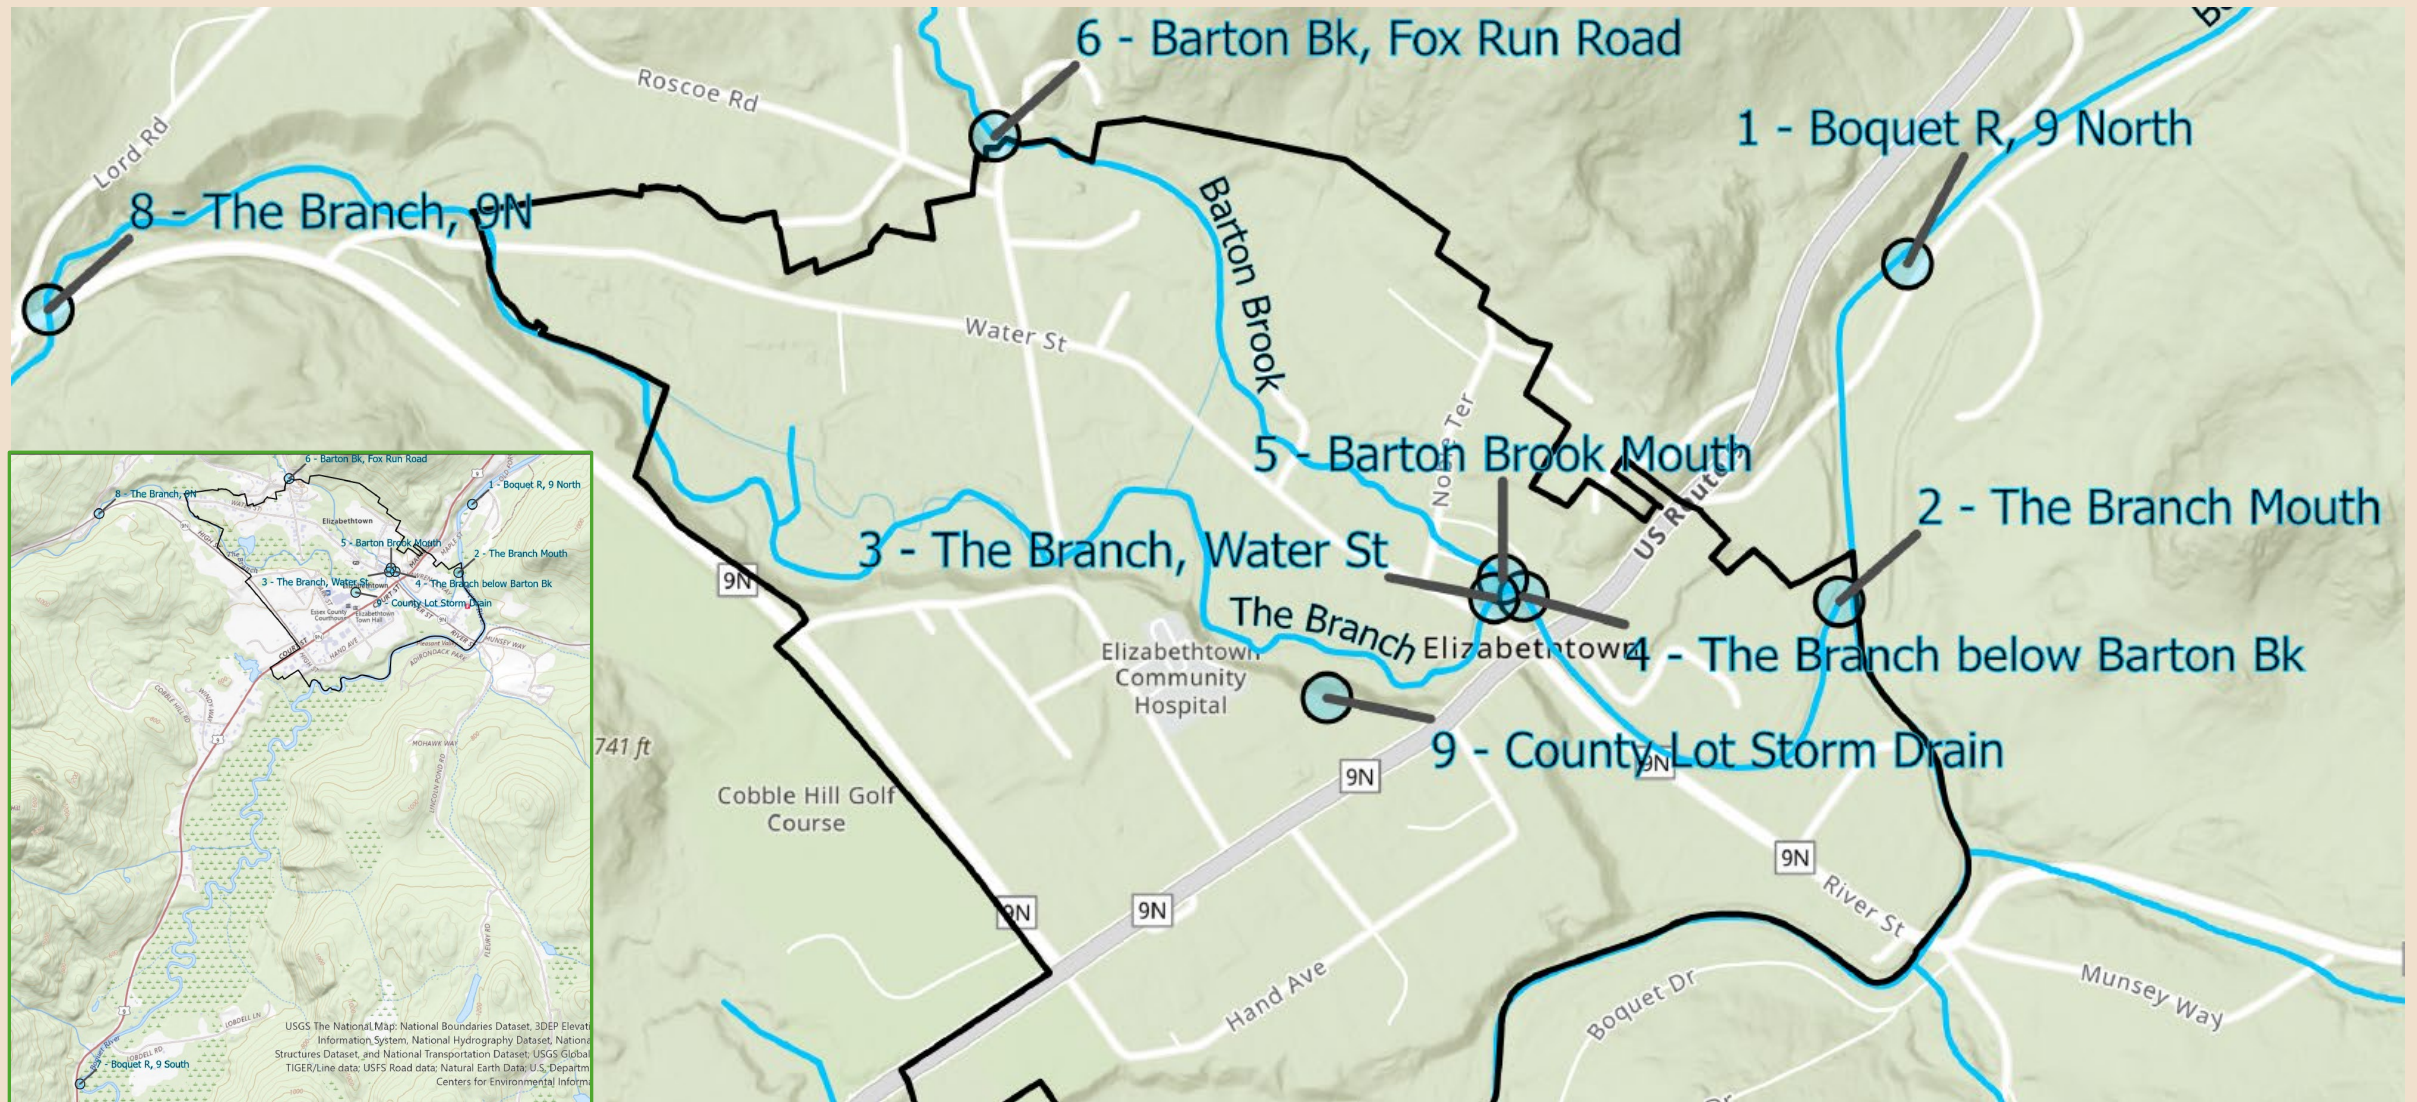
Water Quality Monitoring: Station Locations

- Eight stations on The Branch, Barton Brook and Boquet River above and below Hamlet
- Designed to detect septic system leachate
- Sampling May through November
- Weekly Sampling September through October
- Bacteriological Testing
 - Fecal coliform, E. coli
- Water Chemistry
 - pH, temperature, alkalinity, conductivity, chloride
 - total phosphorus, dissolved phosphorus, nitrate-nitrite, ammonia, total Kjeldahl nitrogen, total nitrogen
- Microbial Source Tracing
 - Human associated bacteroidetes
- Dye Testing

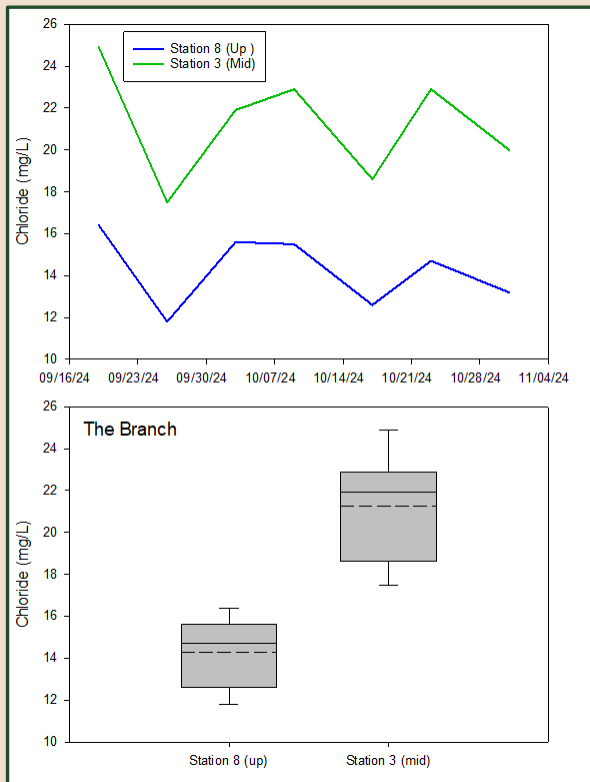
- Fecal coliform bacteria higher downstream compared to upstream
- E. coli bacteria higher downstream compared to upstream
- Chloride higher downstream compared to upstream
- Conductivity higher downstream compared to upstream
- Nitrate-nitrite higher downstream compared to upstream

Water Quality Results – The Branch

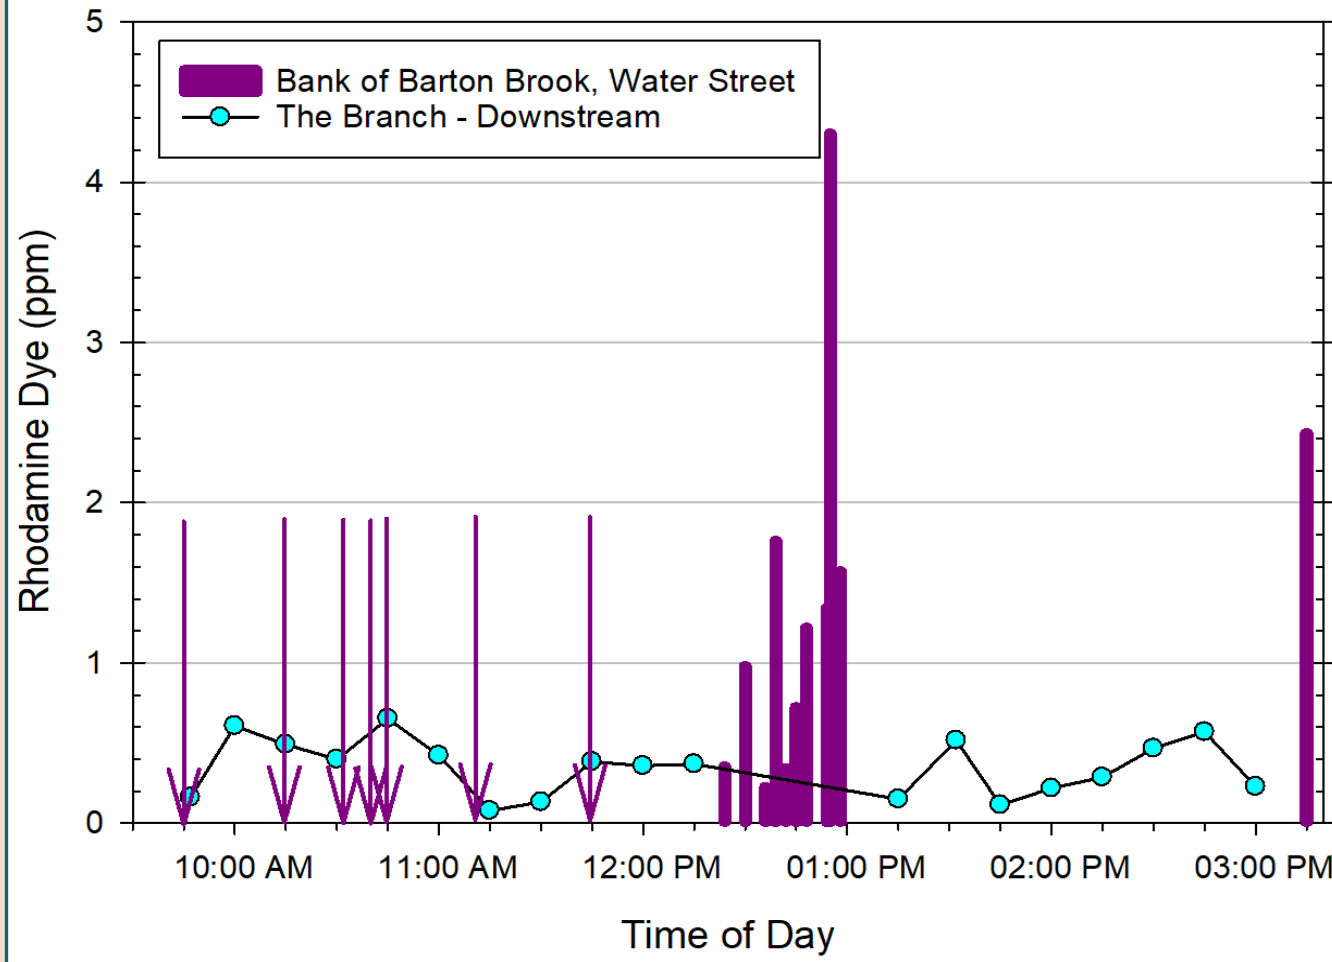
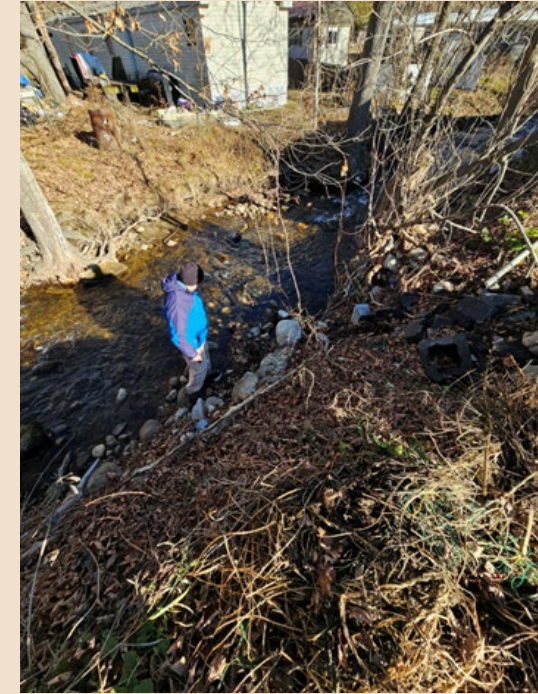
Elizabethtown Dye Testing
11/25/2024

Bank Readings (ppm)	Background (ppm)
0.983	0.387
1.764	0.274
0.727	0.396
1.221	0.322
1.344	0.356
4.307	0.228
1.573	0.347
2.437

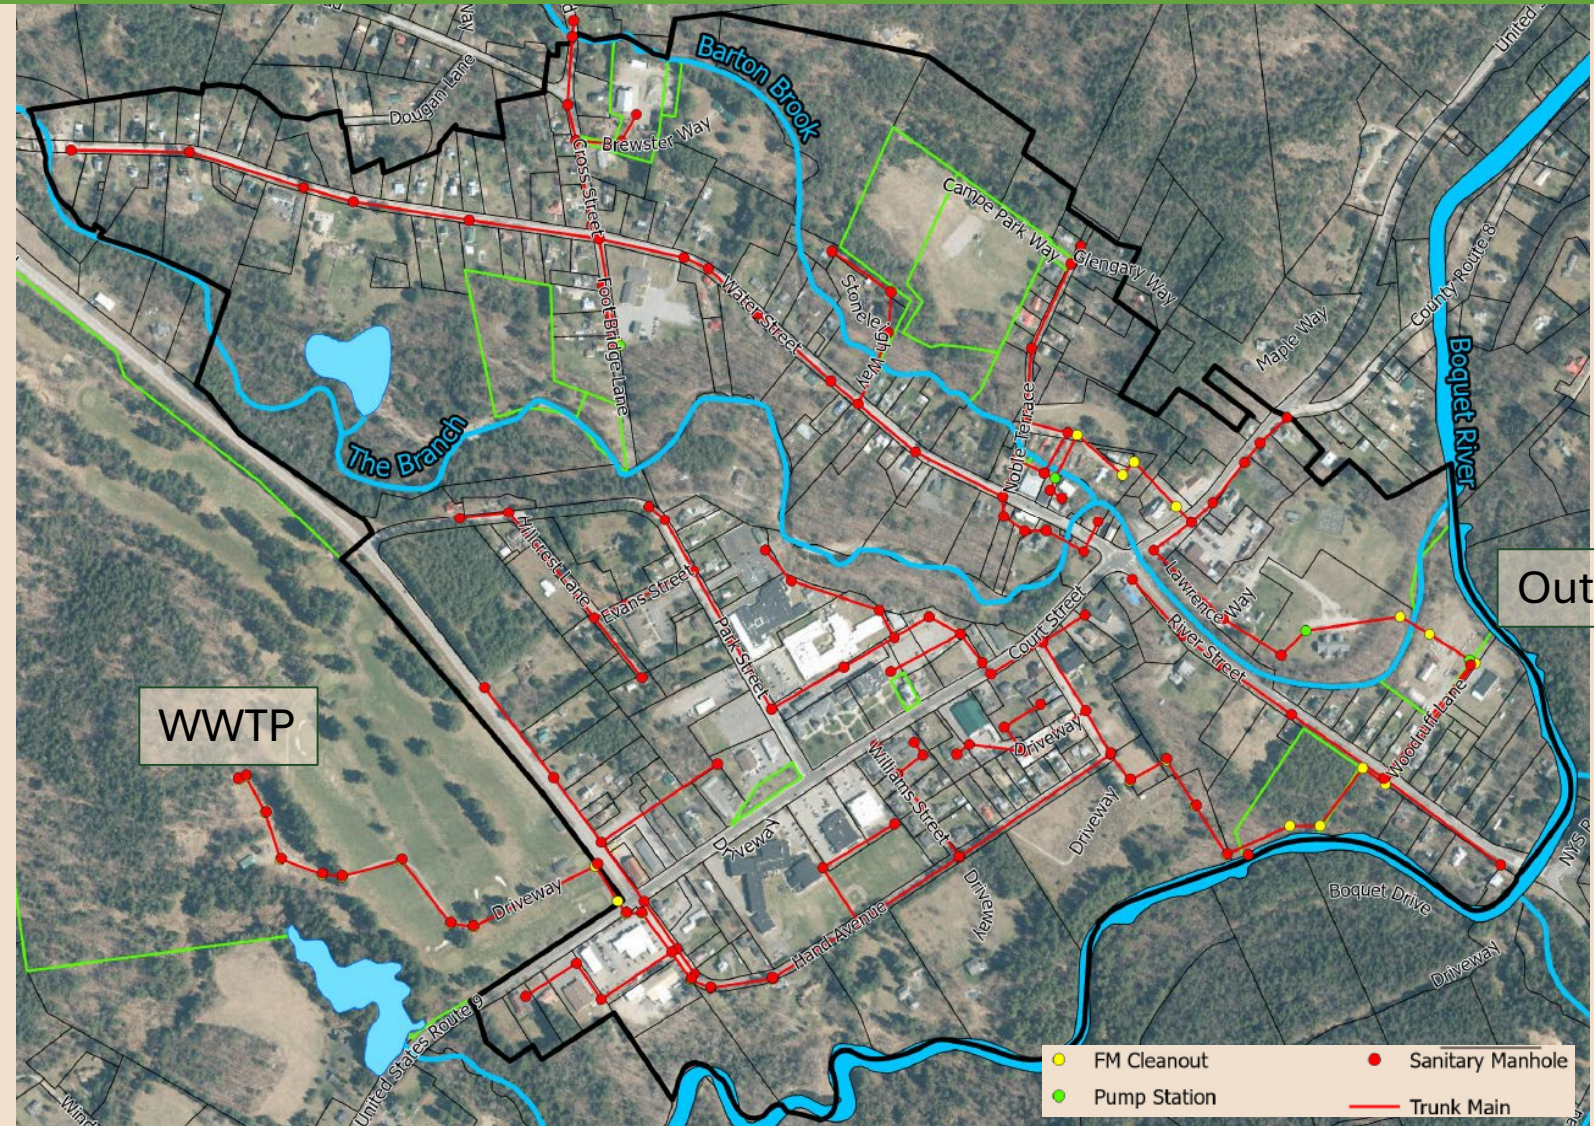
The Solution: Wastewater Collection & Treatment System

- Gravity Mains
 - 4.2 miles of 8-inch PVC
 - 0.8 miles of 12-inch PVC
 - 1.0 mile of 12-inch effluent line
- Gravity Sewer Laterals
 - 4-inch PVC homes
 - 6 or 8-inch PVC for commercial or municipal
- Force Mains
 - HDPE or Ductile Iron
 - 2,073 feet of 6-inch
 - 4,843 feet of 8-inch
- 5 Main Pump Stations
 - Hand Avenue
 - Woodruff Street
 - Community Center
 - Noble Terrace
 - Footbridge Lane
- 15± Grinder Pump Stations
 - Individual homes
 - 1.25-inch or 2-inch HDPE

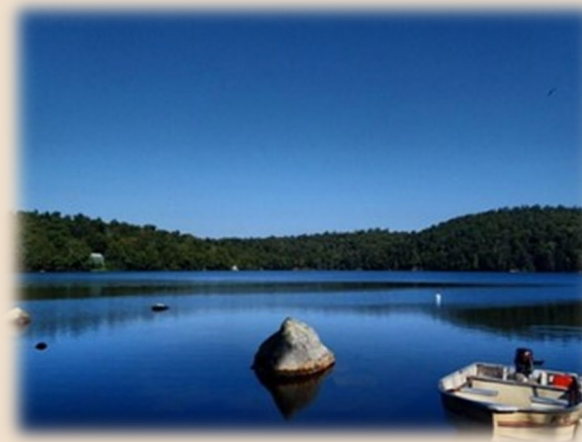
Mount Arab Lake

- Surface Area: 115 acres
- Lake Elevation: 1,659 feet
- Maximum Depth: 60 feet (18 meters)
- Number of Camps: 70±

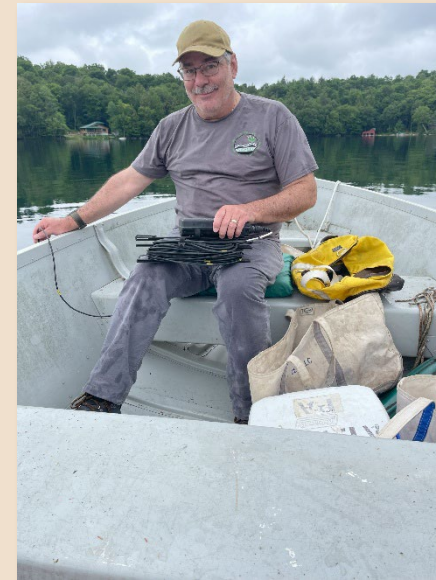
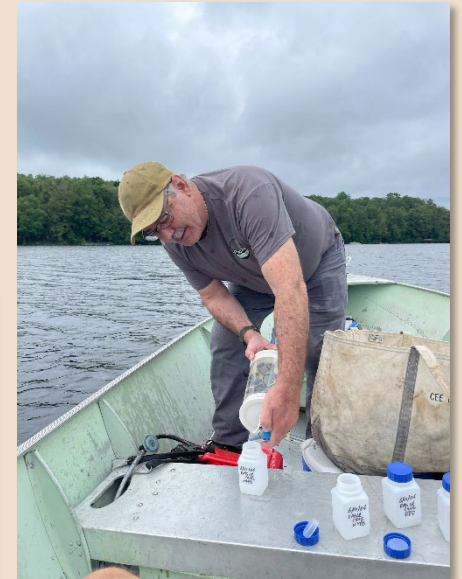
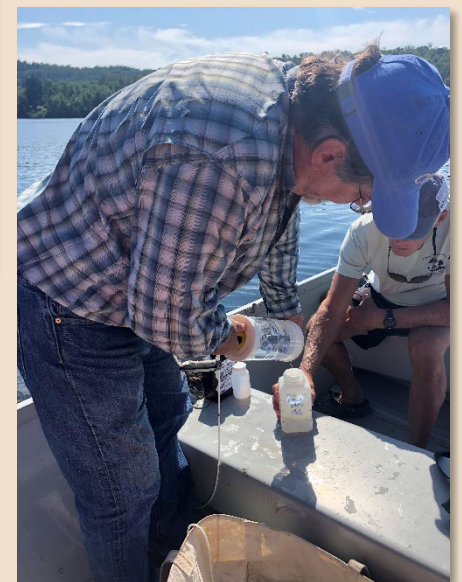
Monitoring Program

- Once per month: June, July & August
- Deepest point of each lake
- Two depths
 - Epilimnion (1.5 meters below surface)
 - Hypolimnion (1.5 meters above sediments)
- pH, Alkalinity, Conductivity, Chloride
- Total phosphorus, Nitrate/Nitrite
- Chlorophyll-*a*
- Transparency
- Dissolved oxygen & temperature profiles

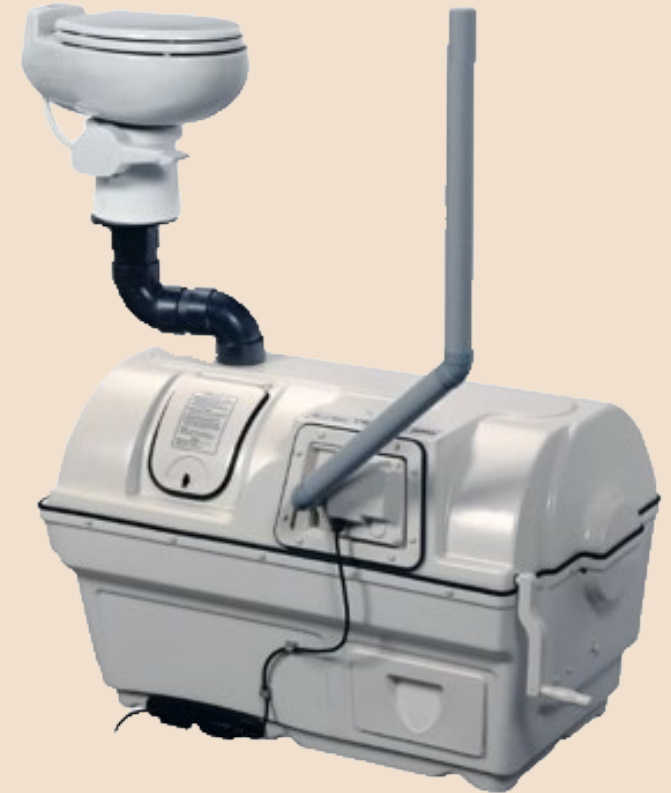
Solution: Replace Standard Systems w/Composting Toilets

- In the late-1990s a major campaign was started to replace standard on-site septic systems with composting toilets.
- Most went with central composting toilets, like the Sun-Mar, with chamber below cabin.
- Inside bathrooms look normal.
- Residents found they had to add biomass to the system due to low volumes of use
- Separated grey water from black water
- Had to work with code enforcement officers and Dept of Health to get approval for grey-water system discharges
- Gray water leach fields had to meet standard code in case system was ever converted back

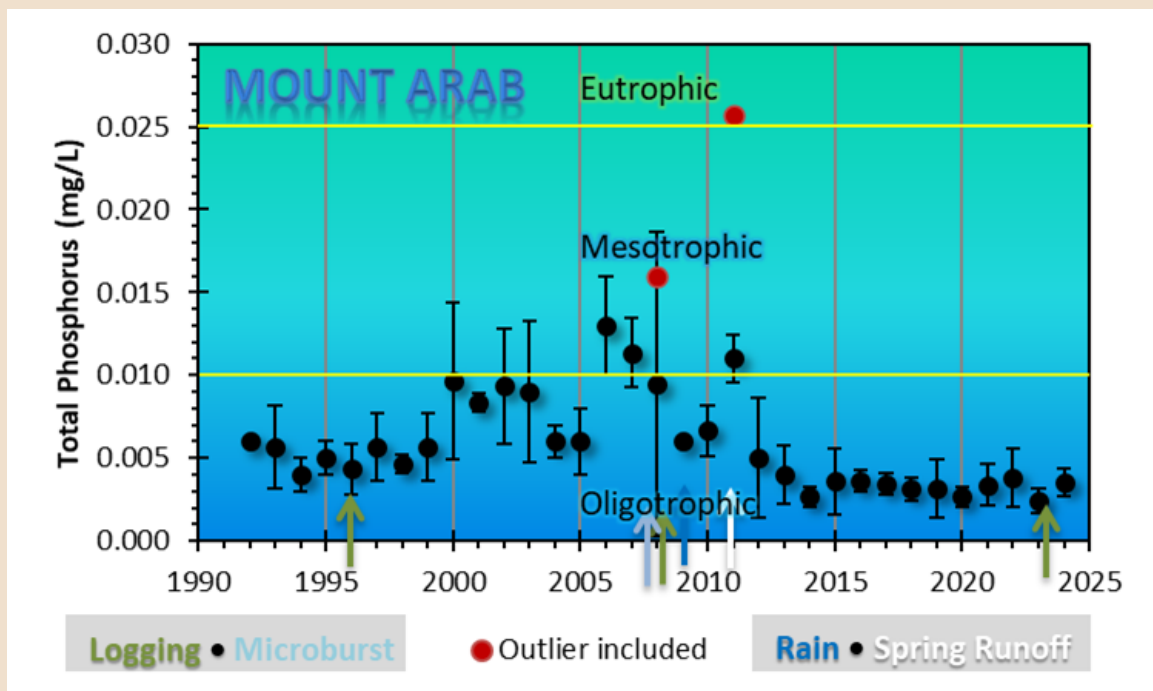
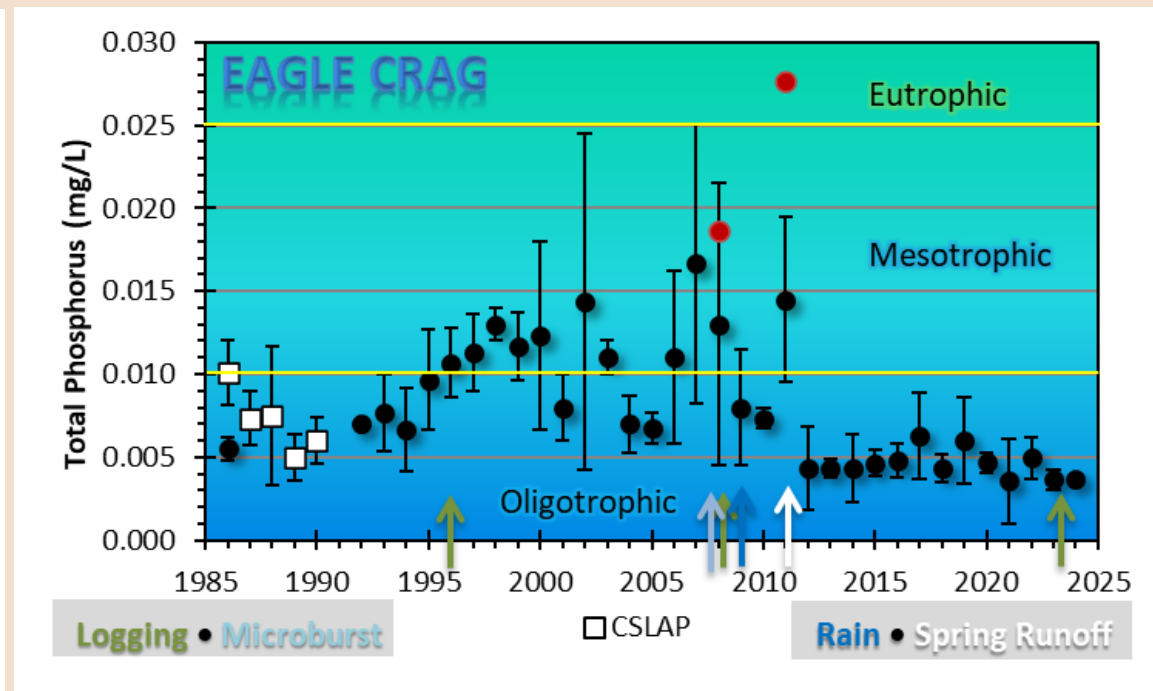
Epilimnetic Total Phosphorus Trends

- Old septic systems can negatively impact water quality
 - Replacing them can positively impact water quality
- Sampling for more than bacteria is important, particularly in a lake environment
- River/Stream detection is easier to do
 - Direction of flow versus complicated mixing in lakes and pond
- Long-Term Monitoring is necessary to detect water quality trends in lakes
