Lake Sebago Hydrilla Control Project; Progress and Lessons Learned

GEI Consultants Inc. PC
Little Bear Environmental

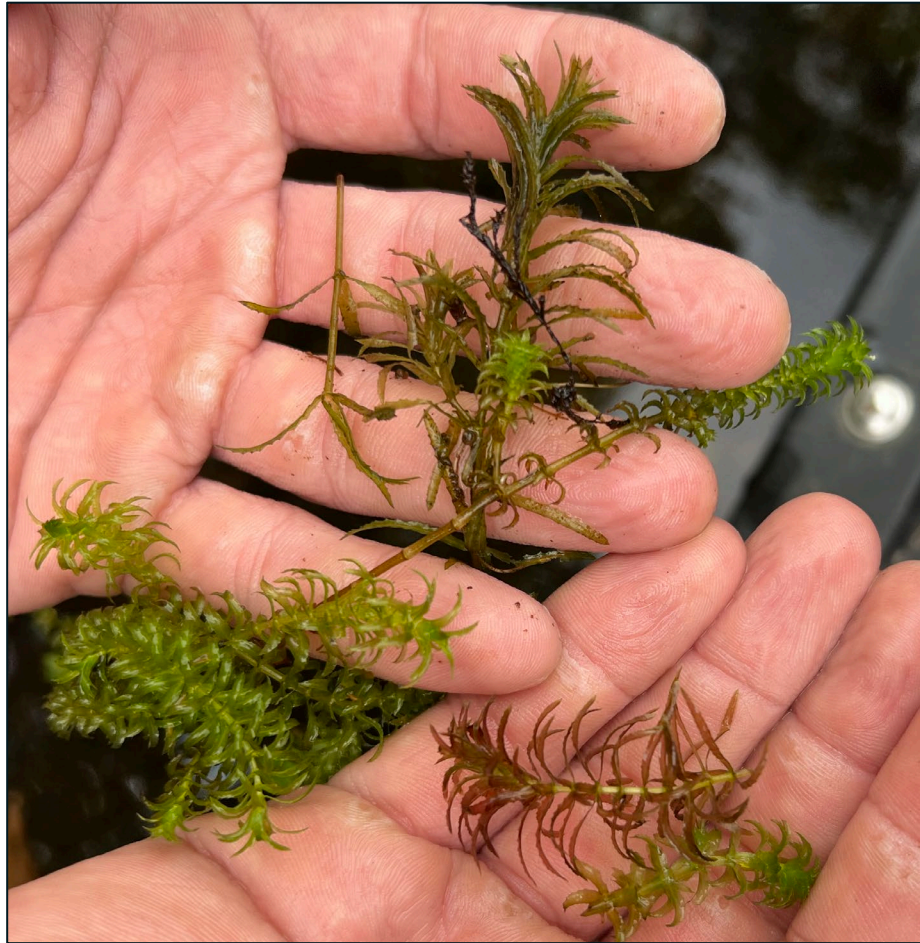
New growth from viable fragments

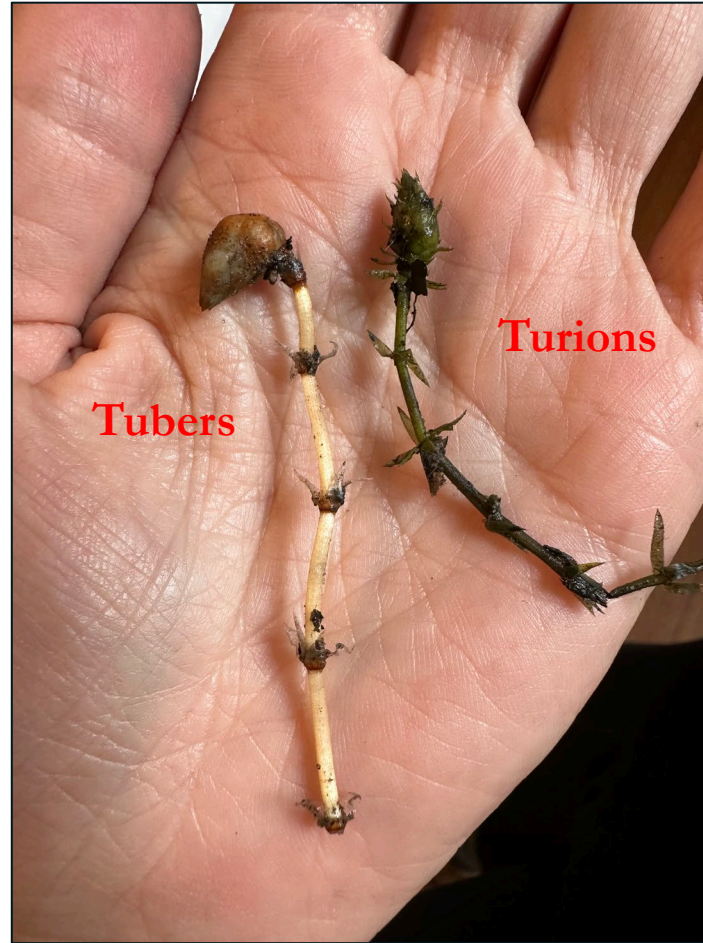
Tubers

Turions

Overwintering structures

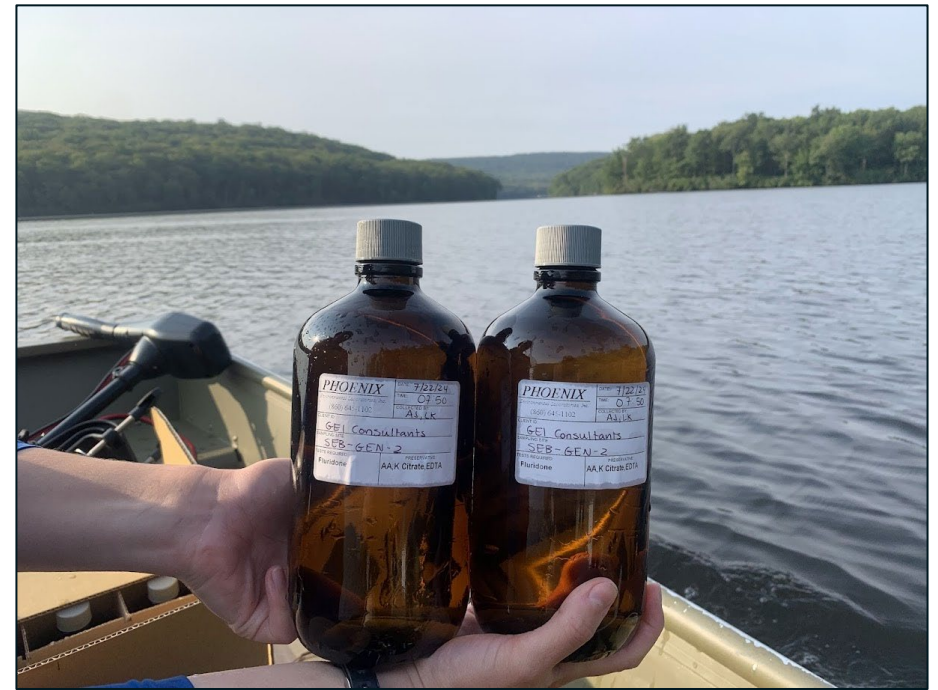
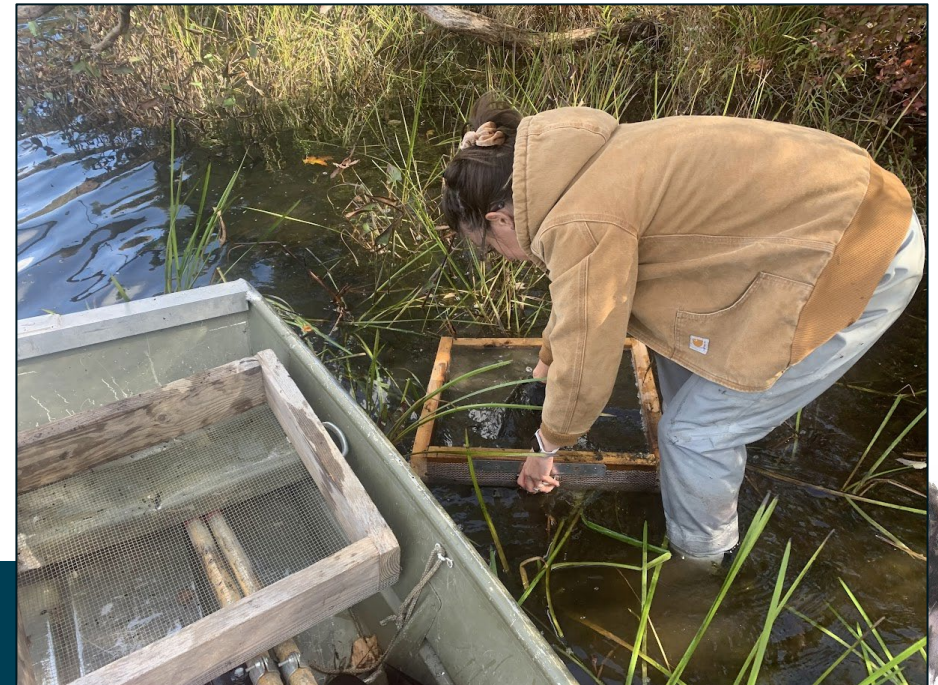
Plant Monitoring Schematic

- Annual Lake Surveys (2023-2025) using Index Points.
 - Native and Invasive Species, Percent Cover and Growth Form (Biovolume)
- Diving Supplemental Sampling (2023-2025).
 - Hydrilla patch size
- Shoreline Supplemental Points (2024-2025).
 - Hydrilla patch size
- Day of Treatment Surveys.
 - Presence/Absence

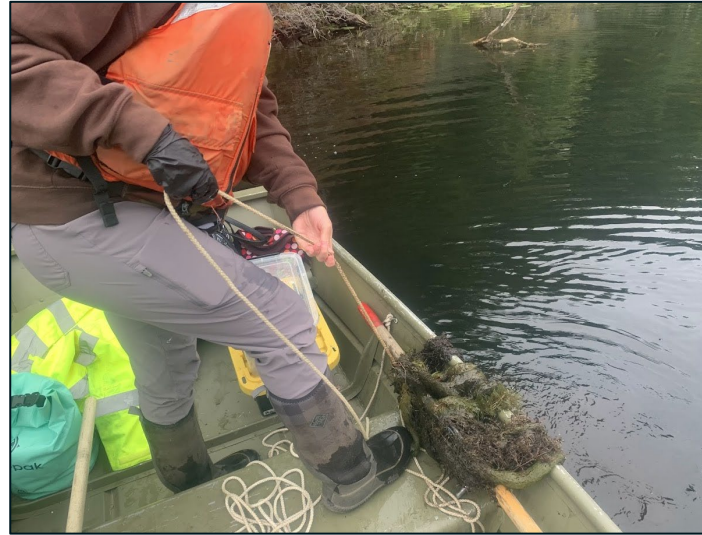
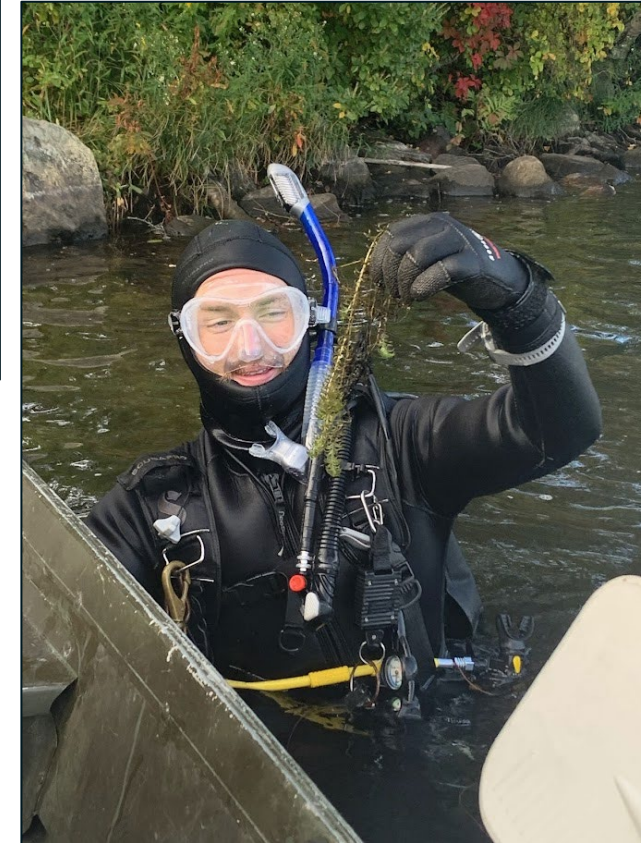
- Annual Index Points
- Dive Sampling
- Supplemental Shoreline Sampling
- Day of Treatment Surveying

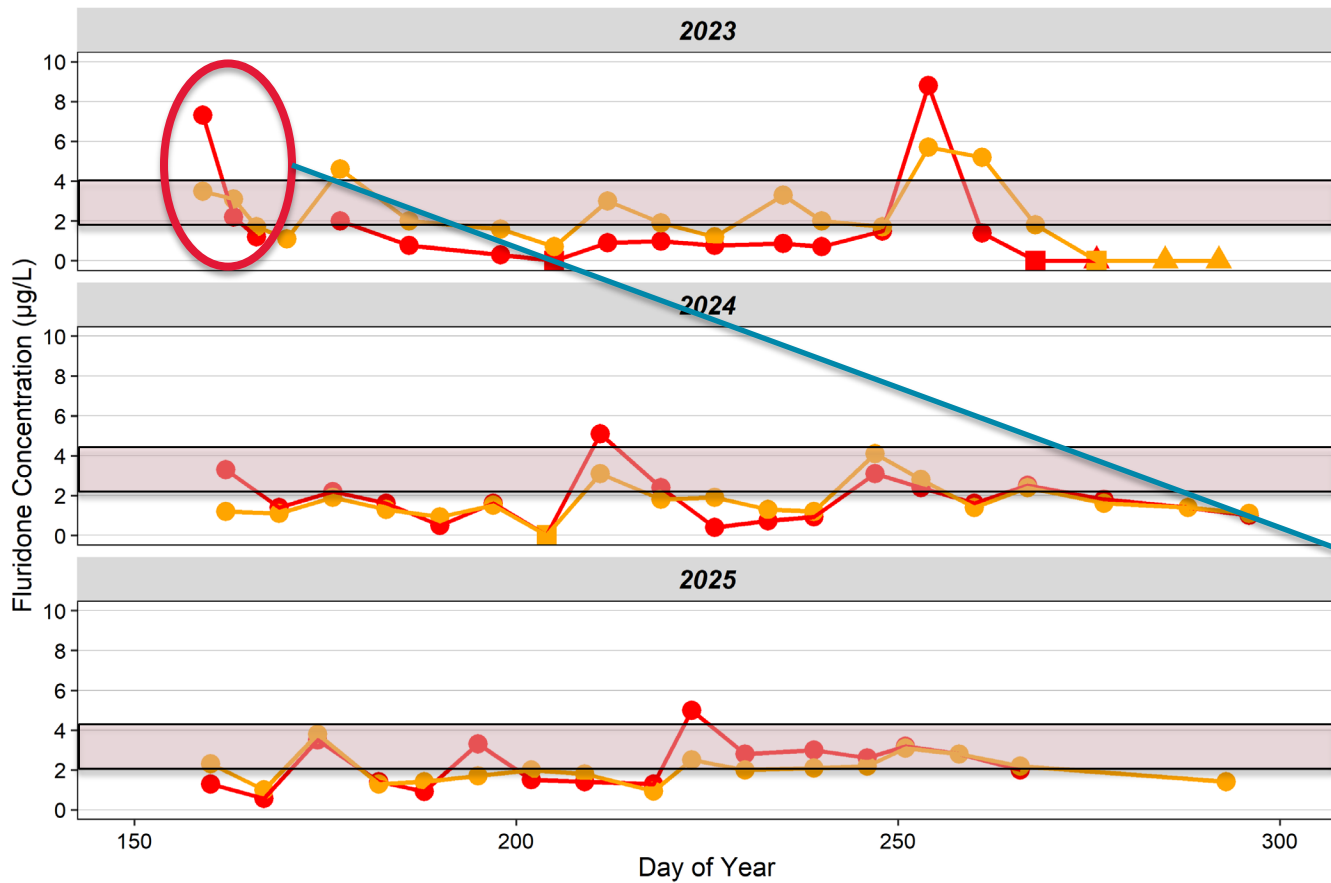
Fluridone (Genesis) Residue Concentrations 2023-2025

| Number of Days | | | | | | |
|---|---|---|---|---|---|---|
| SEB_GEN_1 | 46 | 13 | 120 | 43 | 146 | 60 |
| SEB_GEN_2 | 110 | 44 | 142 | 30 | 154 | 62 |

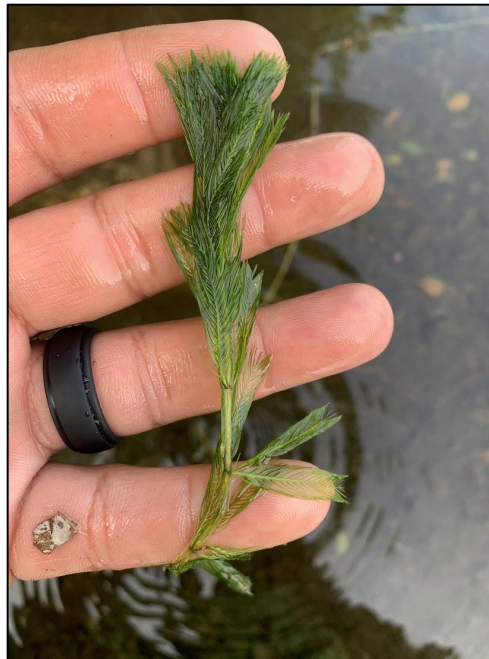
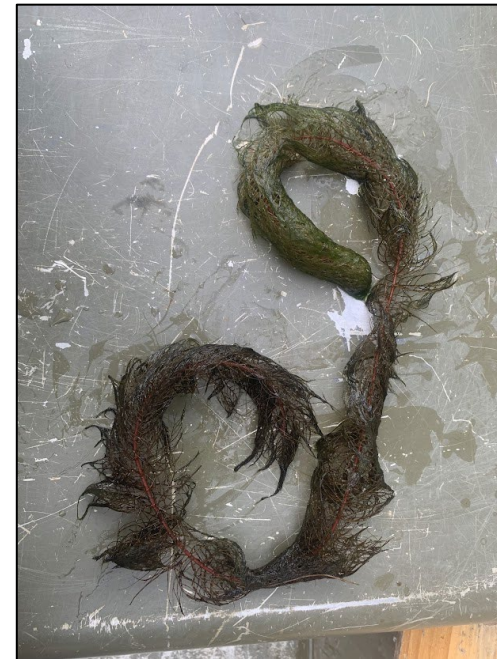
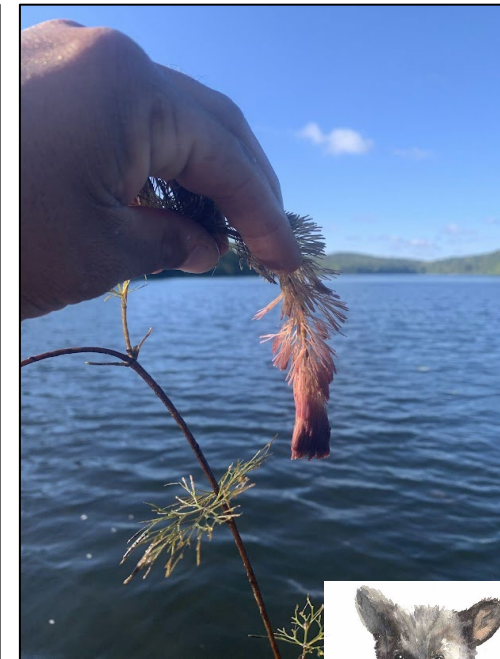
- Hydrilla declines at index sites '23-'25
- Fanwort declines from '23-'24
 - Evidence of fluridone damage
- (Native) VLM large '25 increase.
- EWM completely controlled within the north basin.

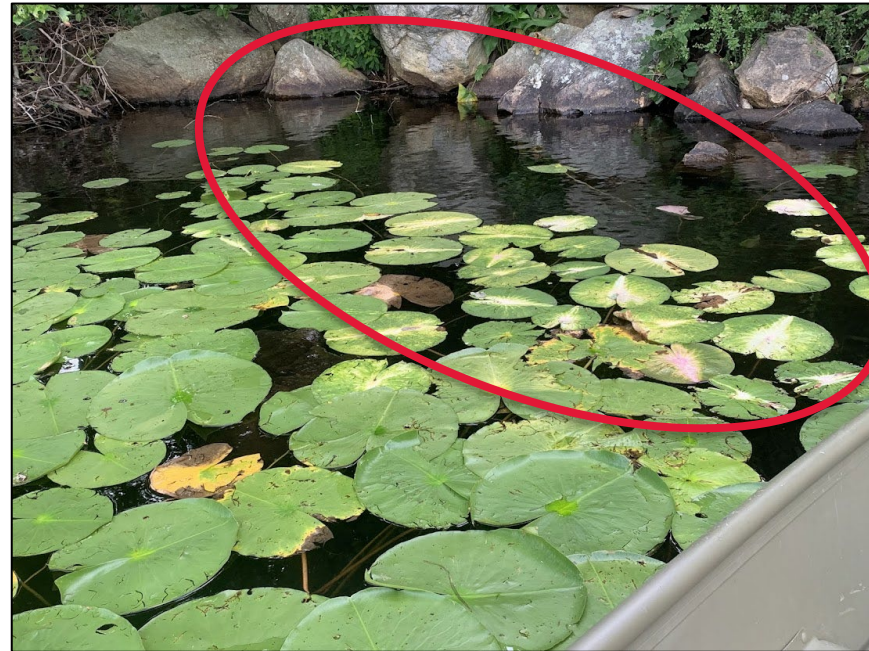
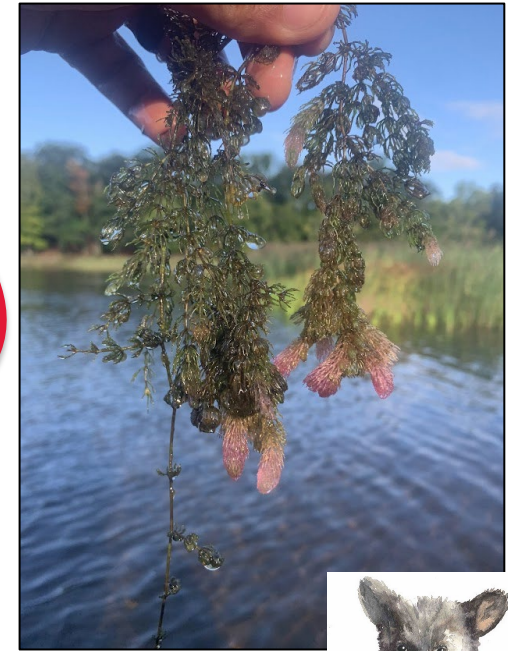
- North basin is currently mix of purple bladderwort, inflated bladderwort, coontail and ribbonleaf pondweed.
- Partial bleaching of select species.
- Return of large Robbin's pondweed beds.
