Current Water Quality Conditions and Initial Documentation of Hydrilla (*Hydrilla verticillata*) in Harveys Lake, Luzerne County, PA

**New York State Federation of Lake Associations
4th – 5th May 2018**

Fred S. Lubnow, Ph.D., and Michael Hartshorne
Princeton Hydro, LLC
203 Exton Commons
Exton, PA 19341

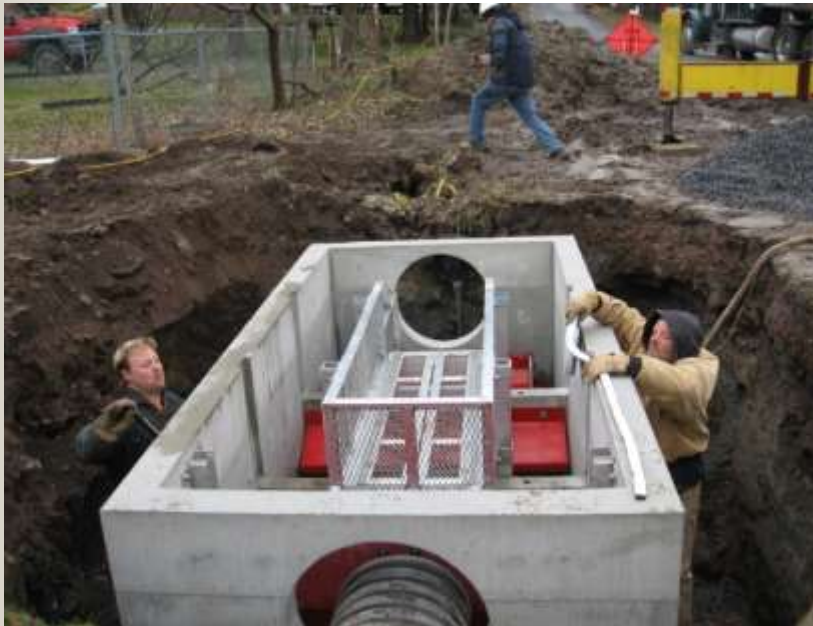
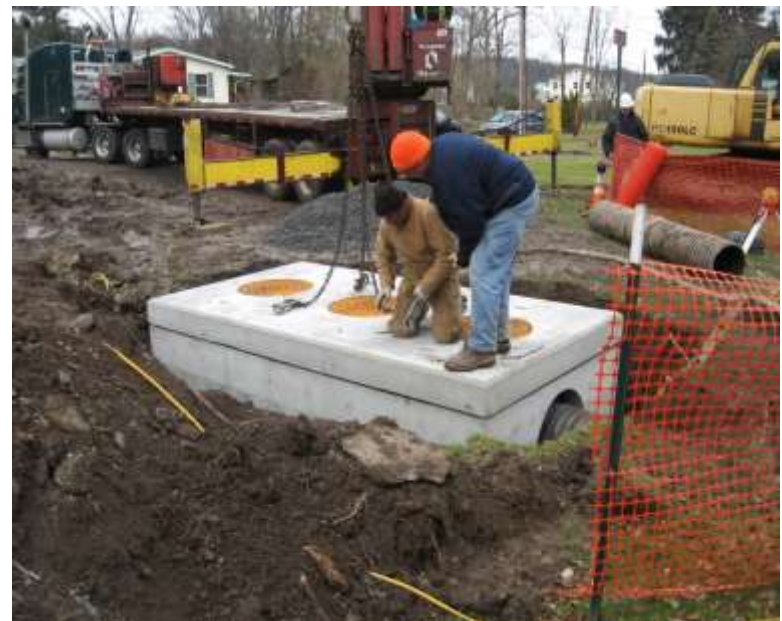
Installation of 3-Chambered Baffle Box at Wood Street in December 2011

Implemented Stormwater or In-Lake Project	Total Phosphorus Removed in kgs (lbs)
Two streambank / shoreline stabilization projects	10.0 (22)
Hemlock Garden Nutrient Separating Baffle Box	13.6 (30)
Series of small, catch basin retrofits	6.1 (13.4)
Wood Street Nutrient Separating Baffle Box	3.0 (6.6)
Old Lake Road Nutrient Separating Baffle Box	3.0 (6.6)
Floating Wetland Islands (Five); 2014	22.7 (50)
Large Nutrient Separating Baffle Box system (PA F&BC); early 2017	24.1 (53)
TOTAL	82.5 (181.6)

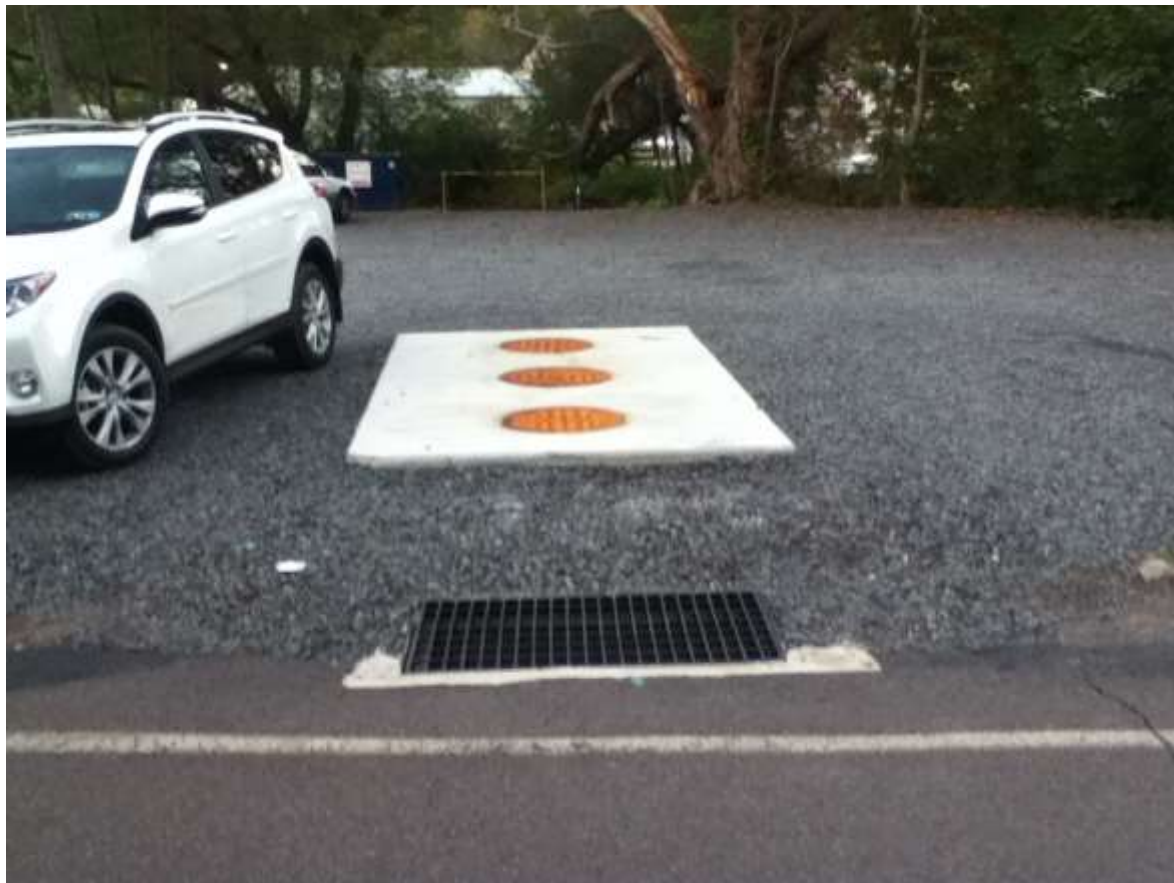
Installation of 3-Chambered Baffle Box at Old Lake Road completed in September 2013

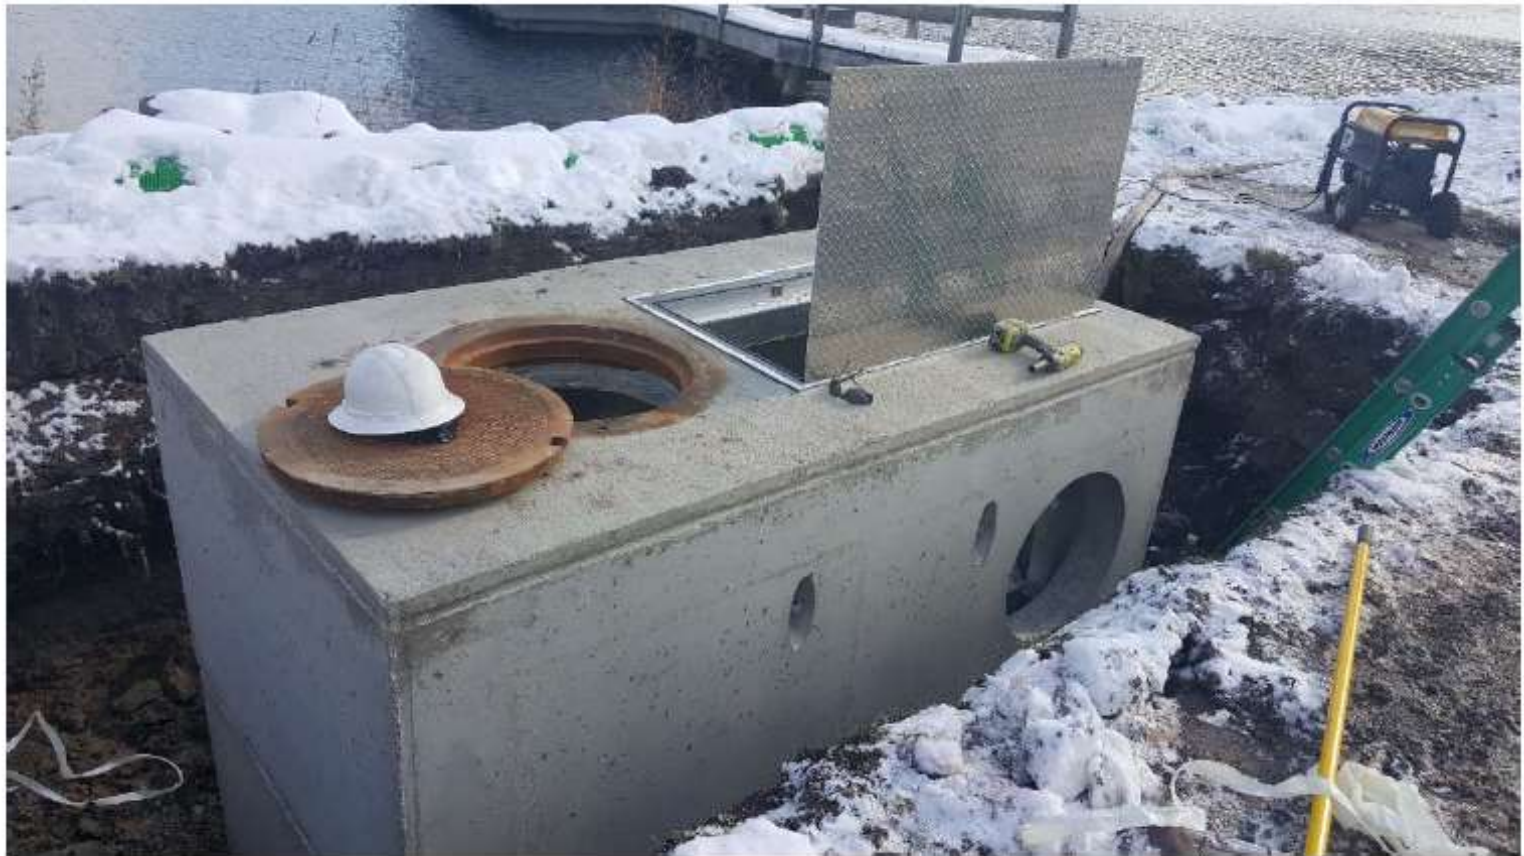
PA F&BC Boat Launch Stormwater Project (2016)

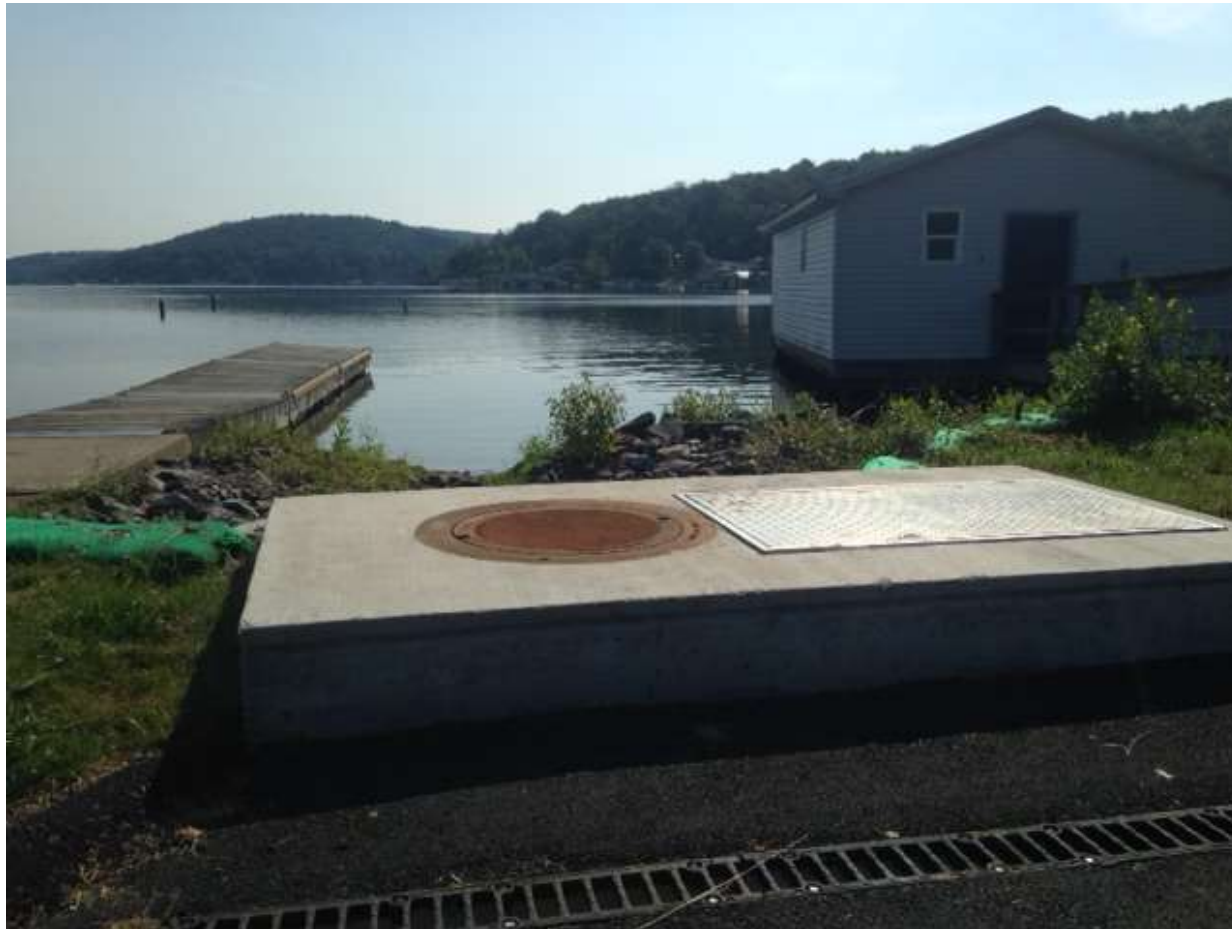
PA F&BC Boat Launch Stormwater Project (2017)

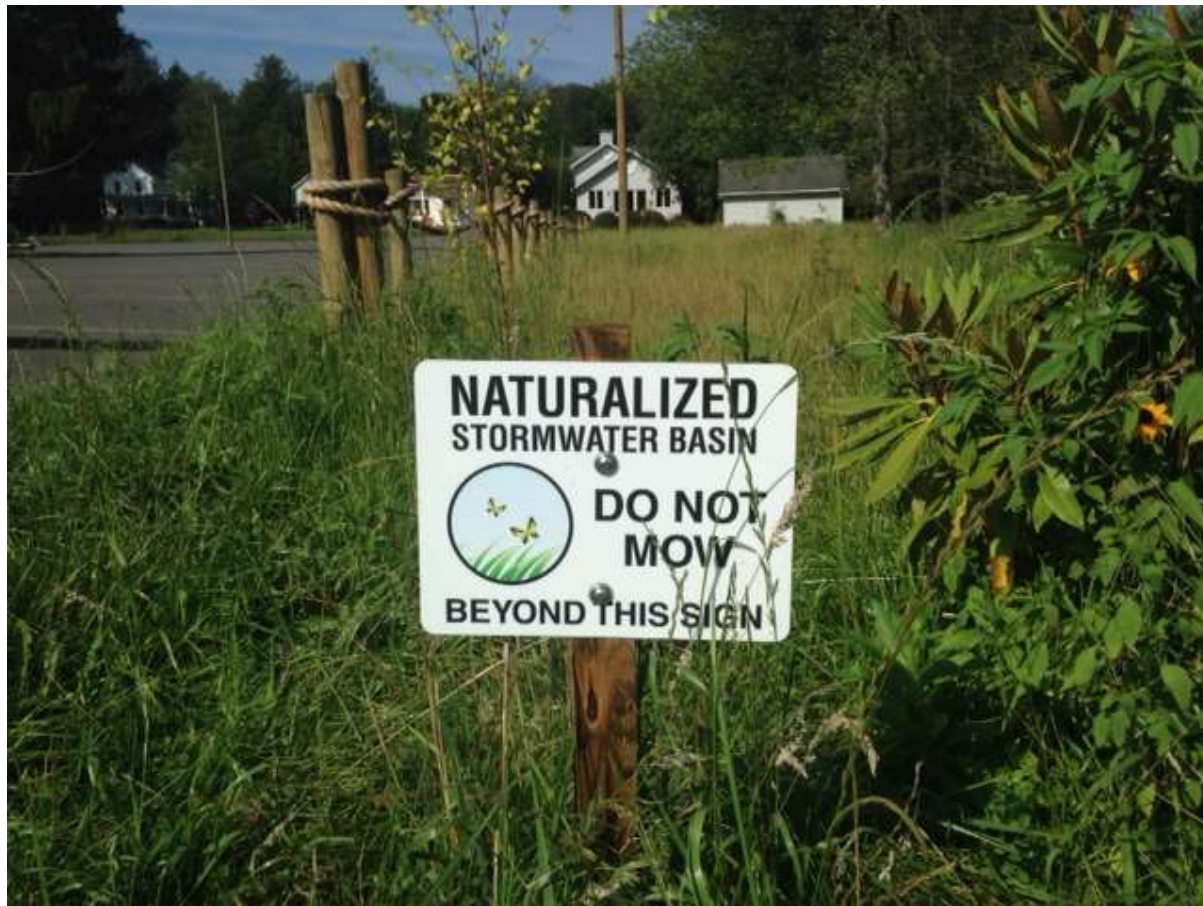
PA F&BC Boat Launch Riparian Buffer (2017)

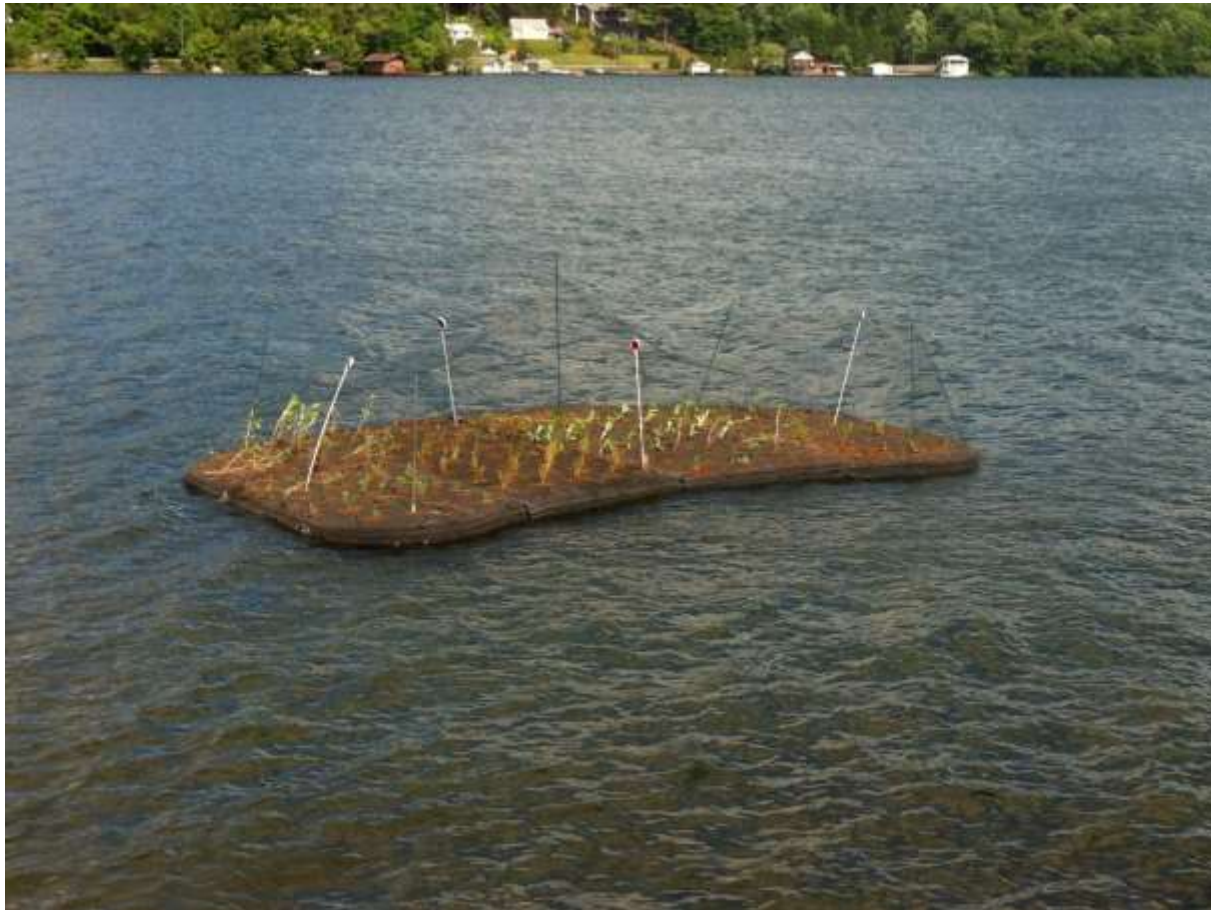
Installation of five Floating Wetland Islands (FWIs) in 2014

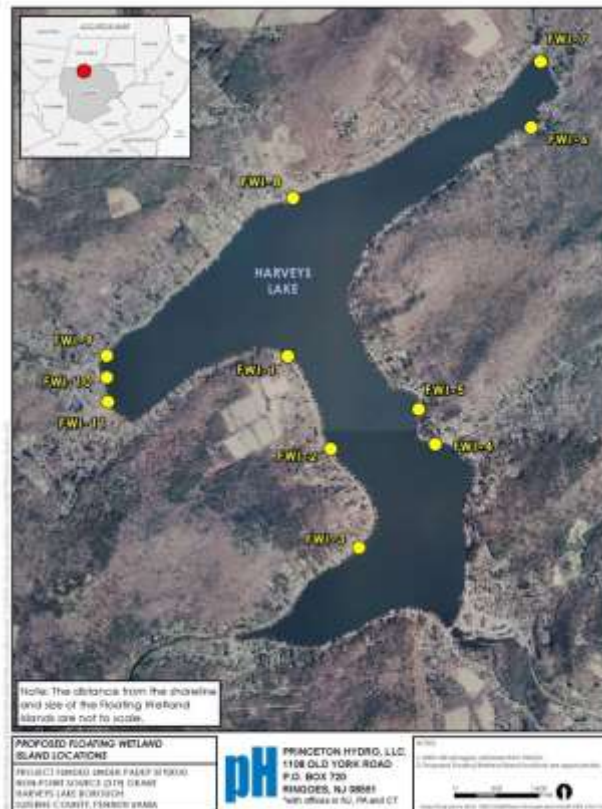
2012 SAV Survey Locations

- SAV community was comprised of several native *Potamogetons*, coontail, elodea and tape grass. Invasives consisted of Eurasian watermilfoil and ornamental lilies
- State T&E Grassy pondweed was found at 6 of the 11 transects.
- No hydrilla was noted during this survey

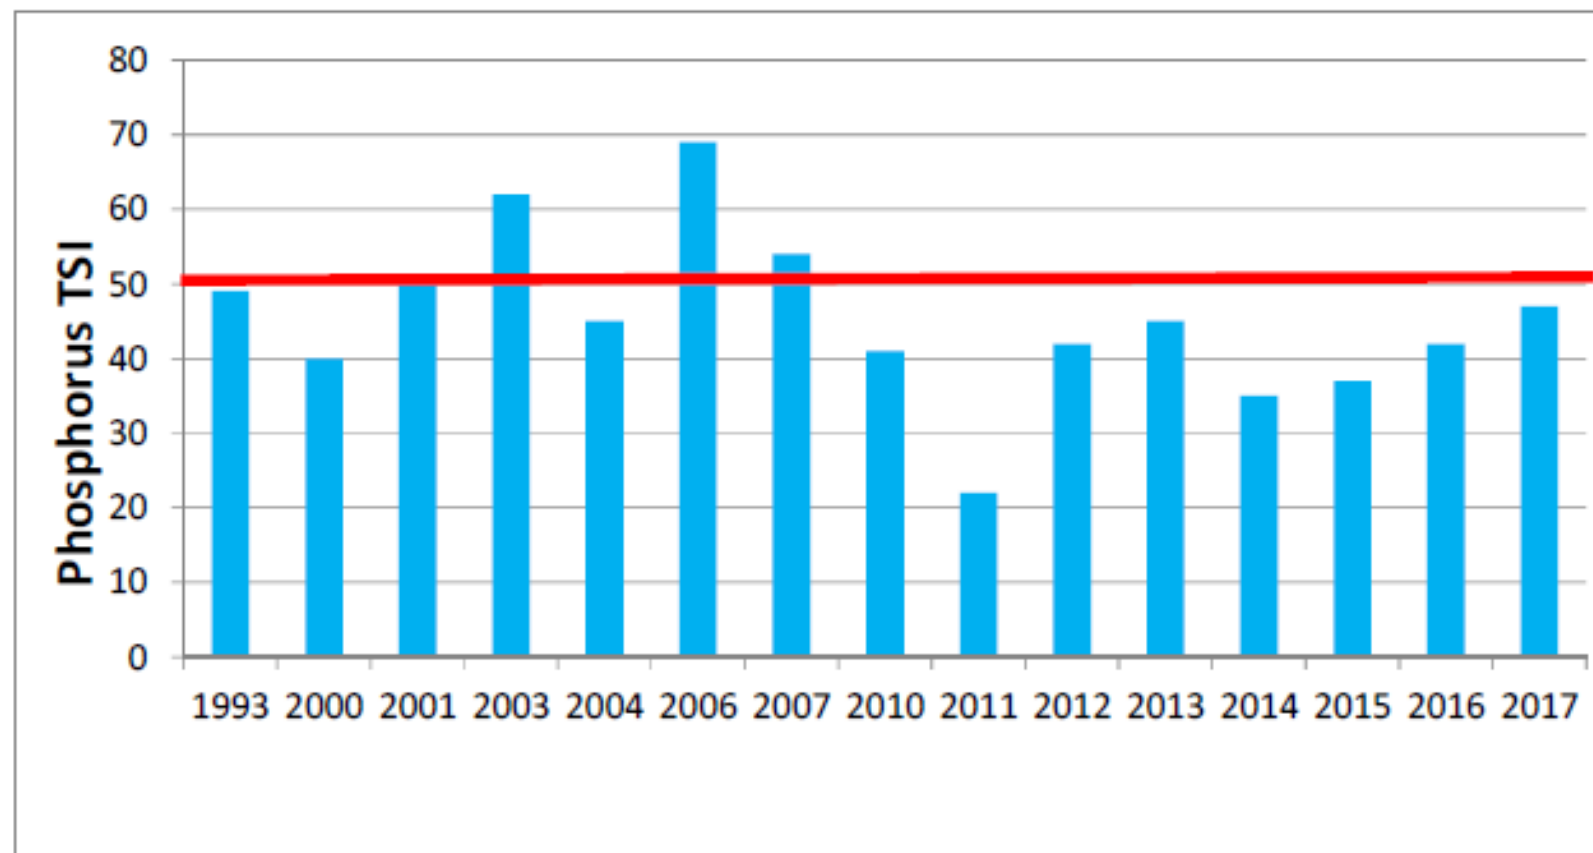
Figure 3.13: Station 1 - Total Phosphorus Mean Trophic State Index

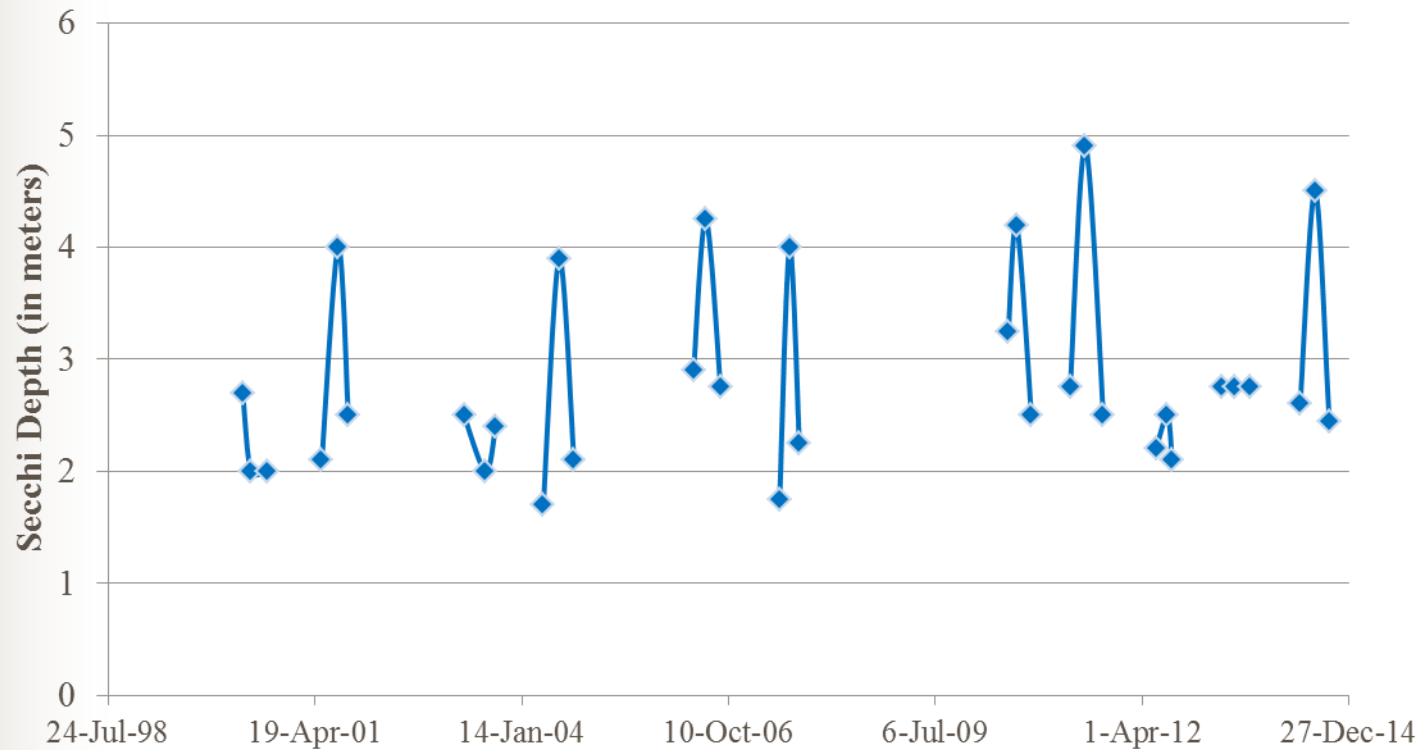
**Figure 1 - Secchi Depth (in meters) at Harveys Lake,
Luzerne County, PA (Station-1)**

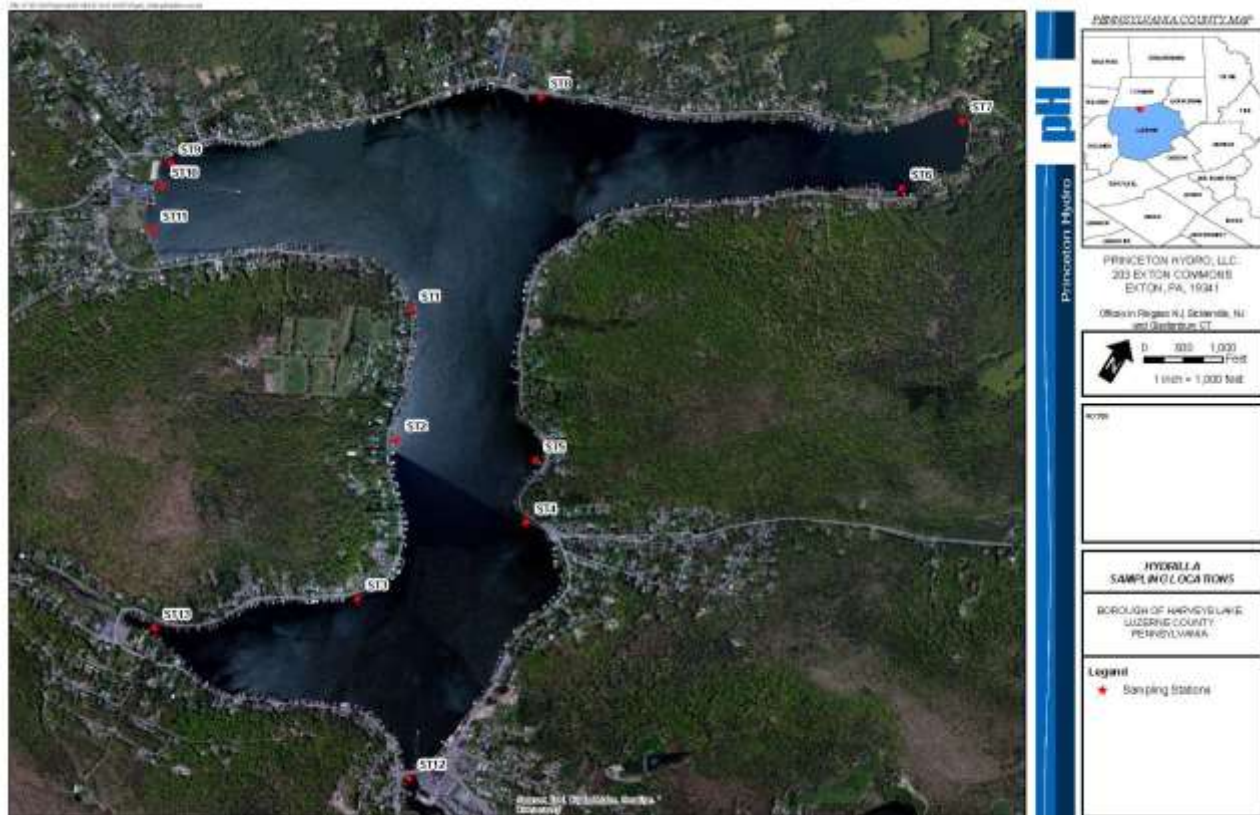
SAV Survey - September 4-5, 2014

Phase I

- 20 Species identified; Twice number as in 2012
- Grassy pondweed found in 10 of the 13 transects
- Vasey's pondweed found in 2 of the 13 transects

- Three exotics present
- Eurasian watermilfoil at 8 of the 13 transects
- Ornamental lily throughout shoreline
- Hydrilla at 5 of the 13 transects
 - All instances in Northern end of lake
 - Heaviest infestation where major boat launch is located

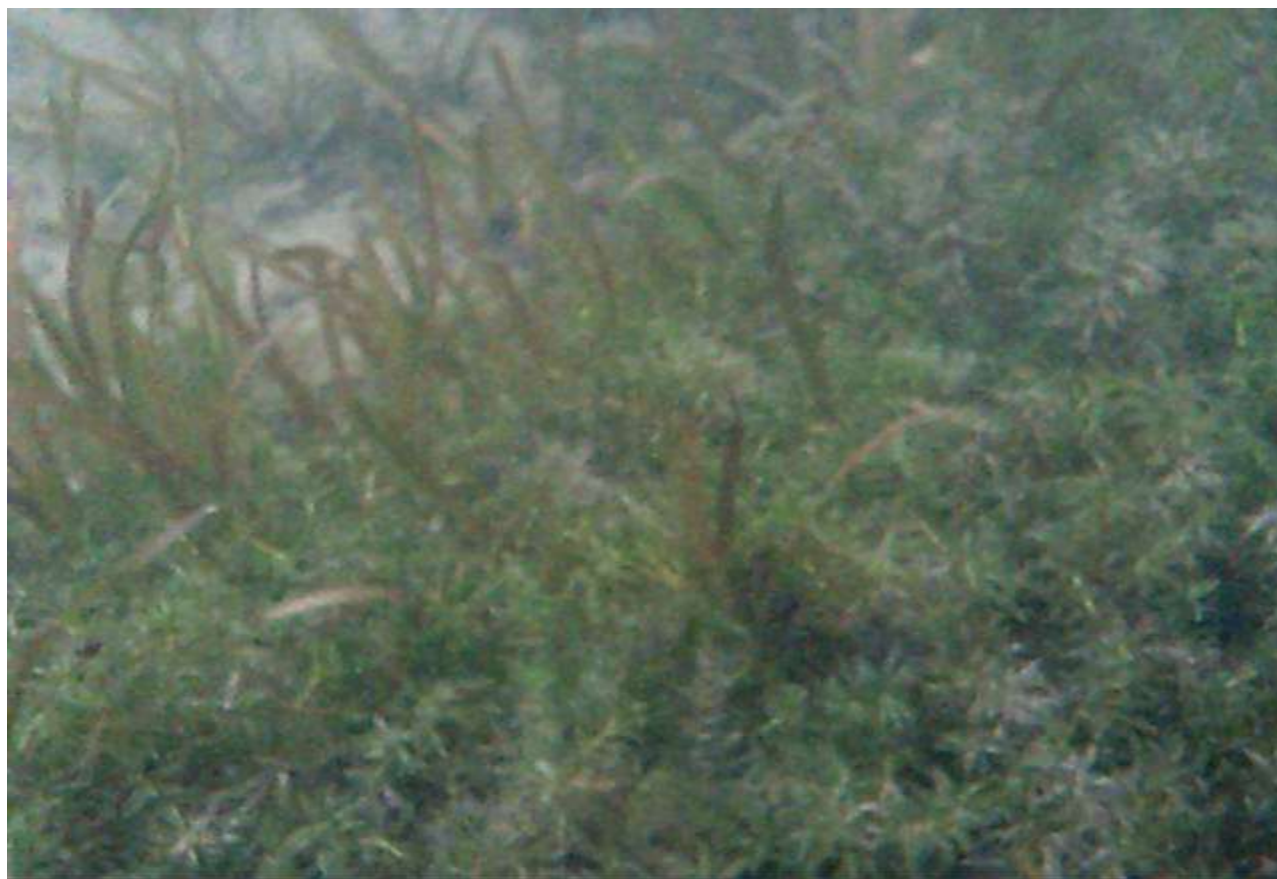
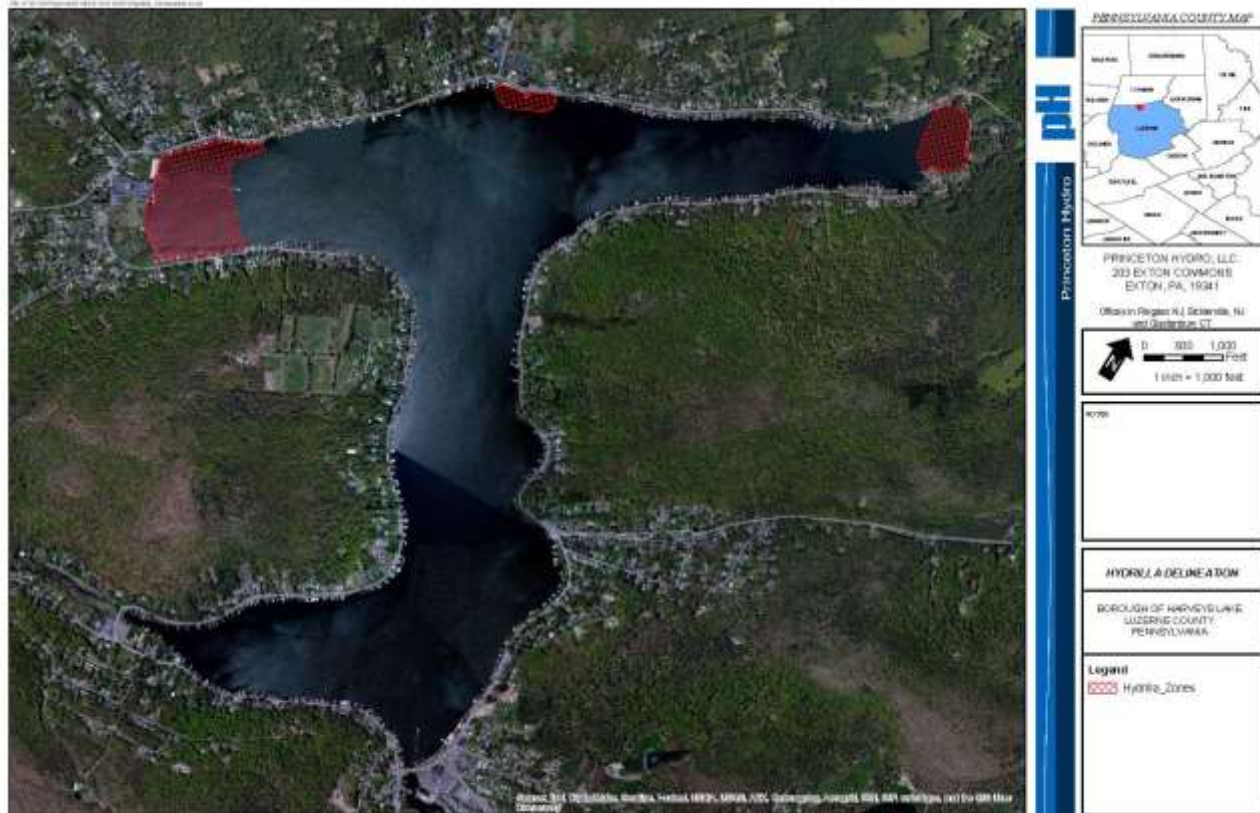
Diving Survey – Sept. 11-12, 2014

Phase II

- Hydrilla was found in 38% of the transect locations
- Hydrilla was found in waters as shallow as 2 feet but tended to be most abundant in depths of 4 feet and greater and dominant in waters deeper than 12 – 15 feet.
- Hydrilla is known to grow in waters as deep as 20 ft but was found in Harveys Lake as deep as 25 ft

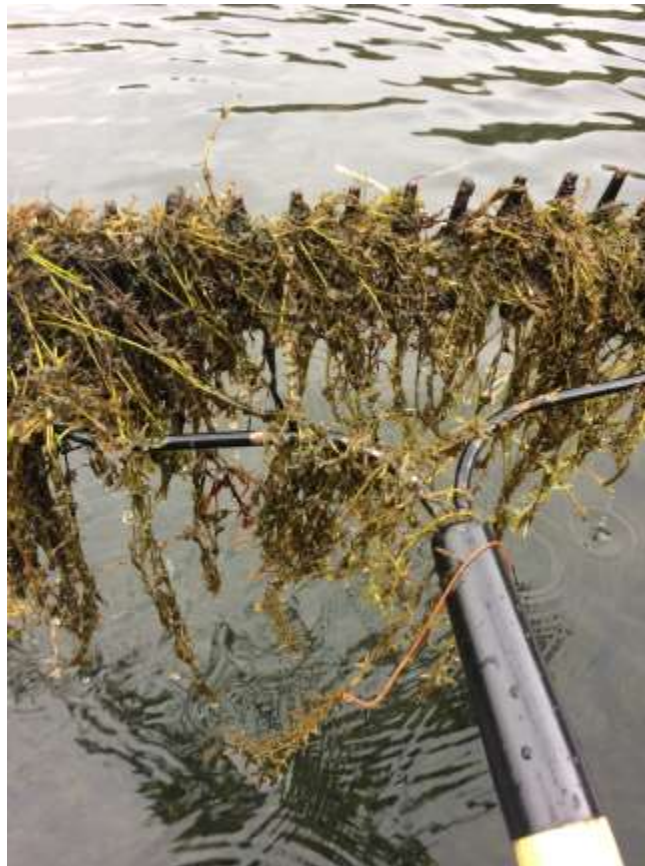
October 2016 – outlet treated

- Treated 9 acres at the outlet for hydrilla
- The Borough of Harveys Lake paid for it
- Minimize the moving of hydrilla down stream of the lake
- Treatment conducted in September 2016

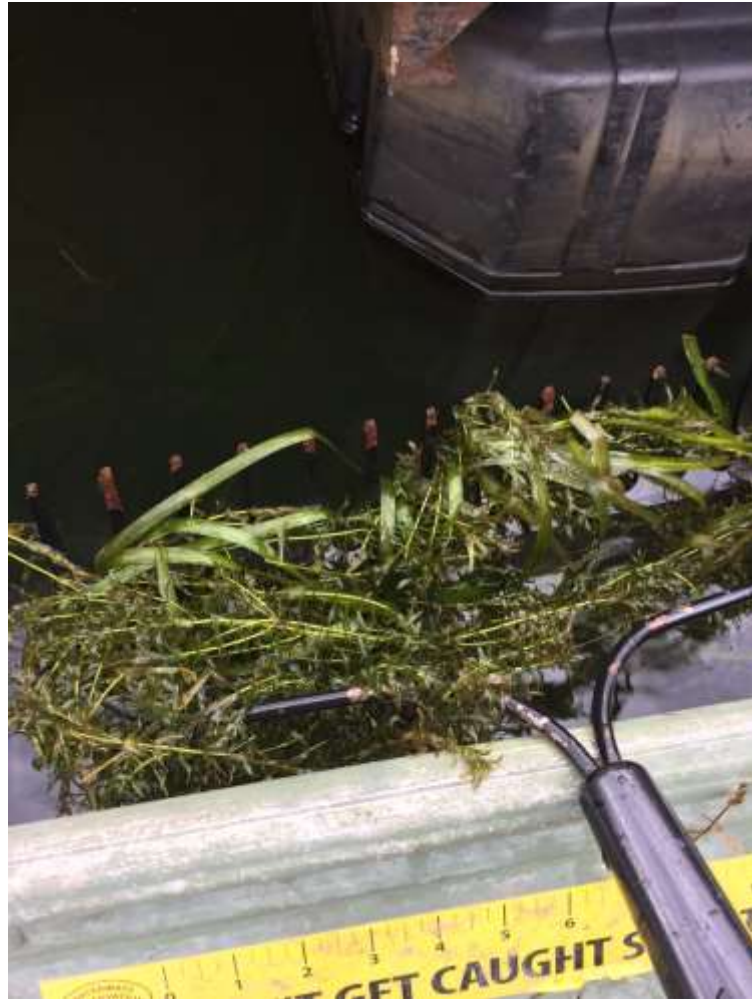
October 2016 – boat launch untreated
