Developing a Management Plan for a Small Private Lake

Biology Department and Biological Field Station, SUNY College at Oneonta, NY 13839

Pleasant Lake

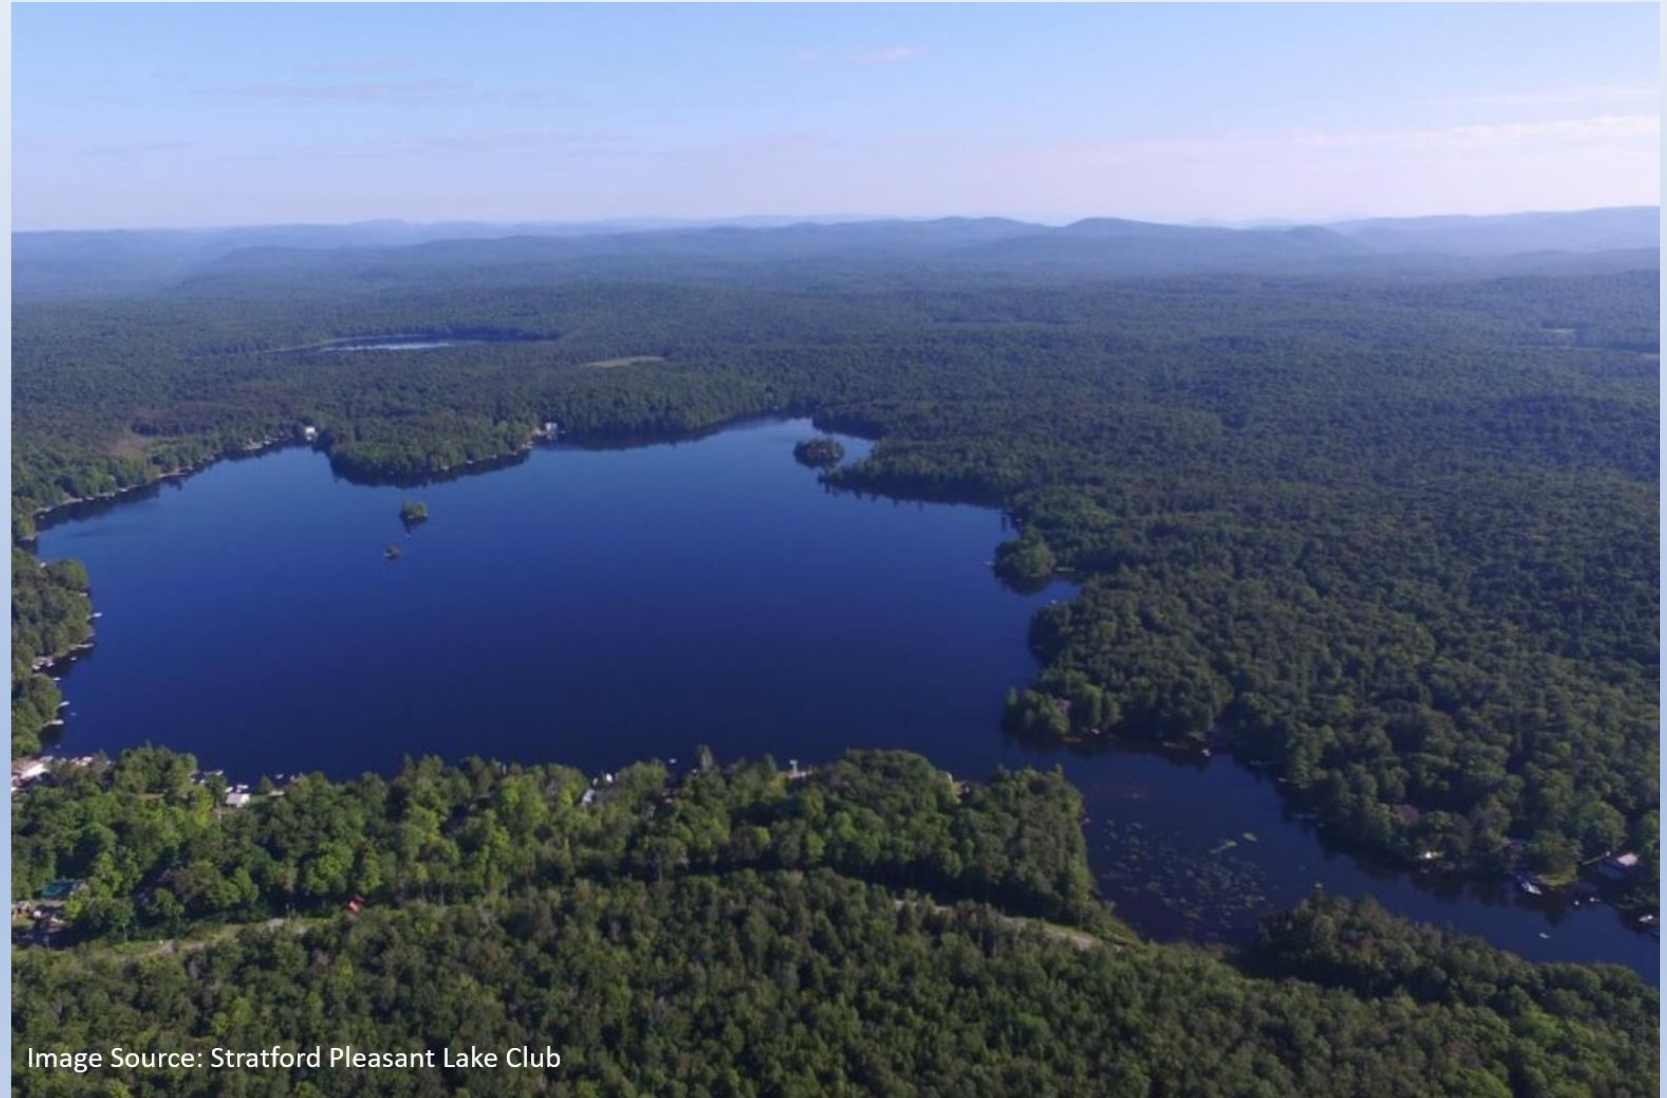
Image Source: Stratford Pleasant Lake Club

- Lake surface Area: 0.98 km²
- Watershed: 5.02 km²
- 1:5 ratio

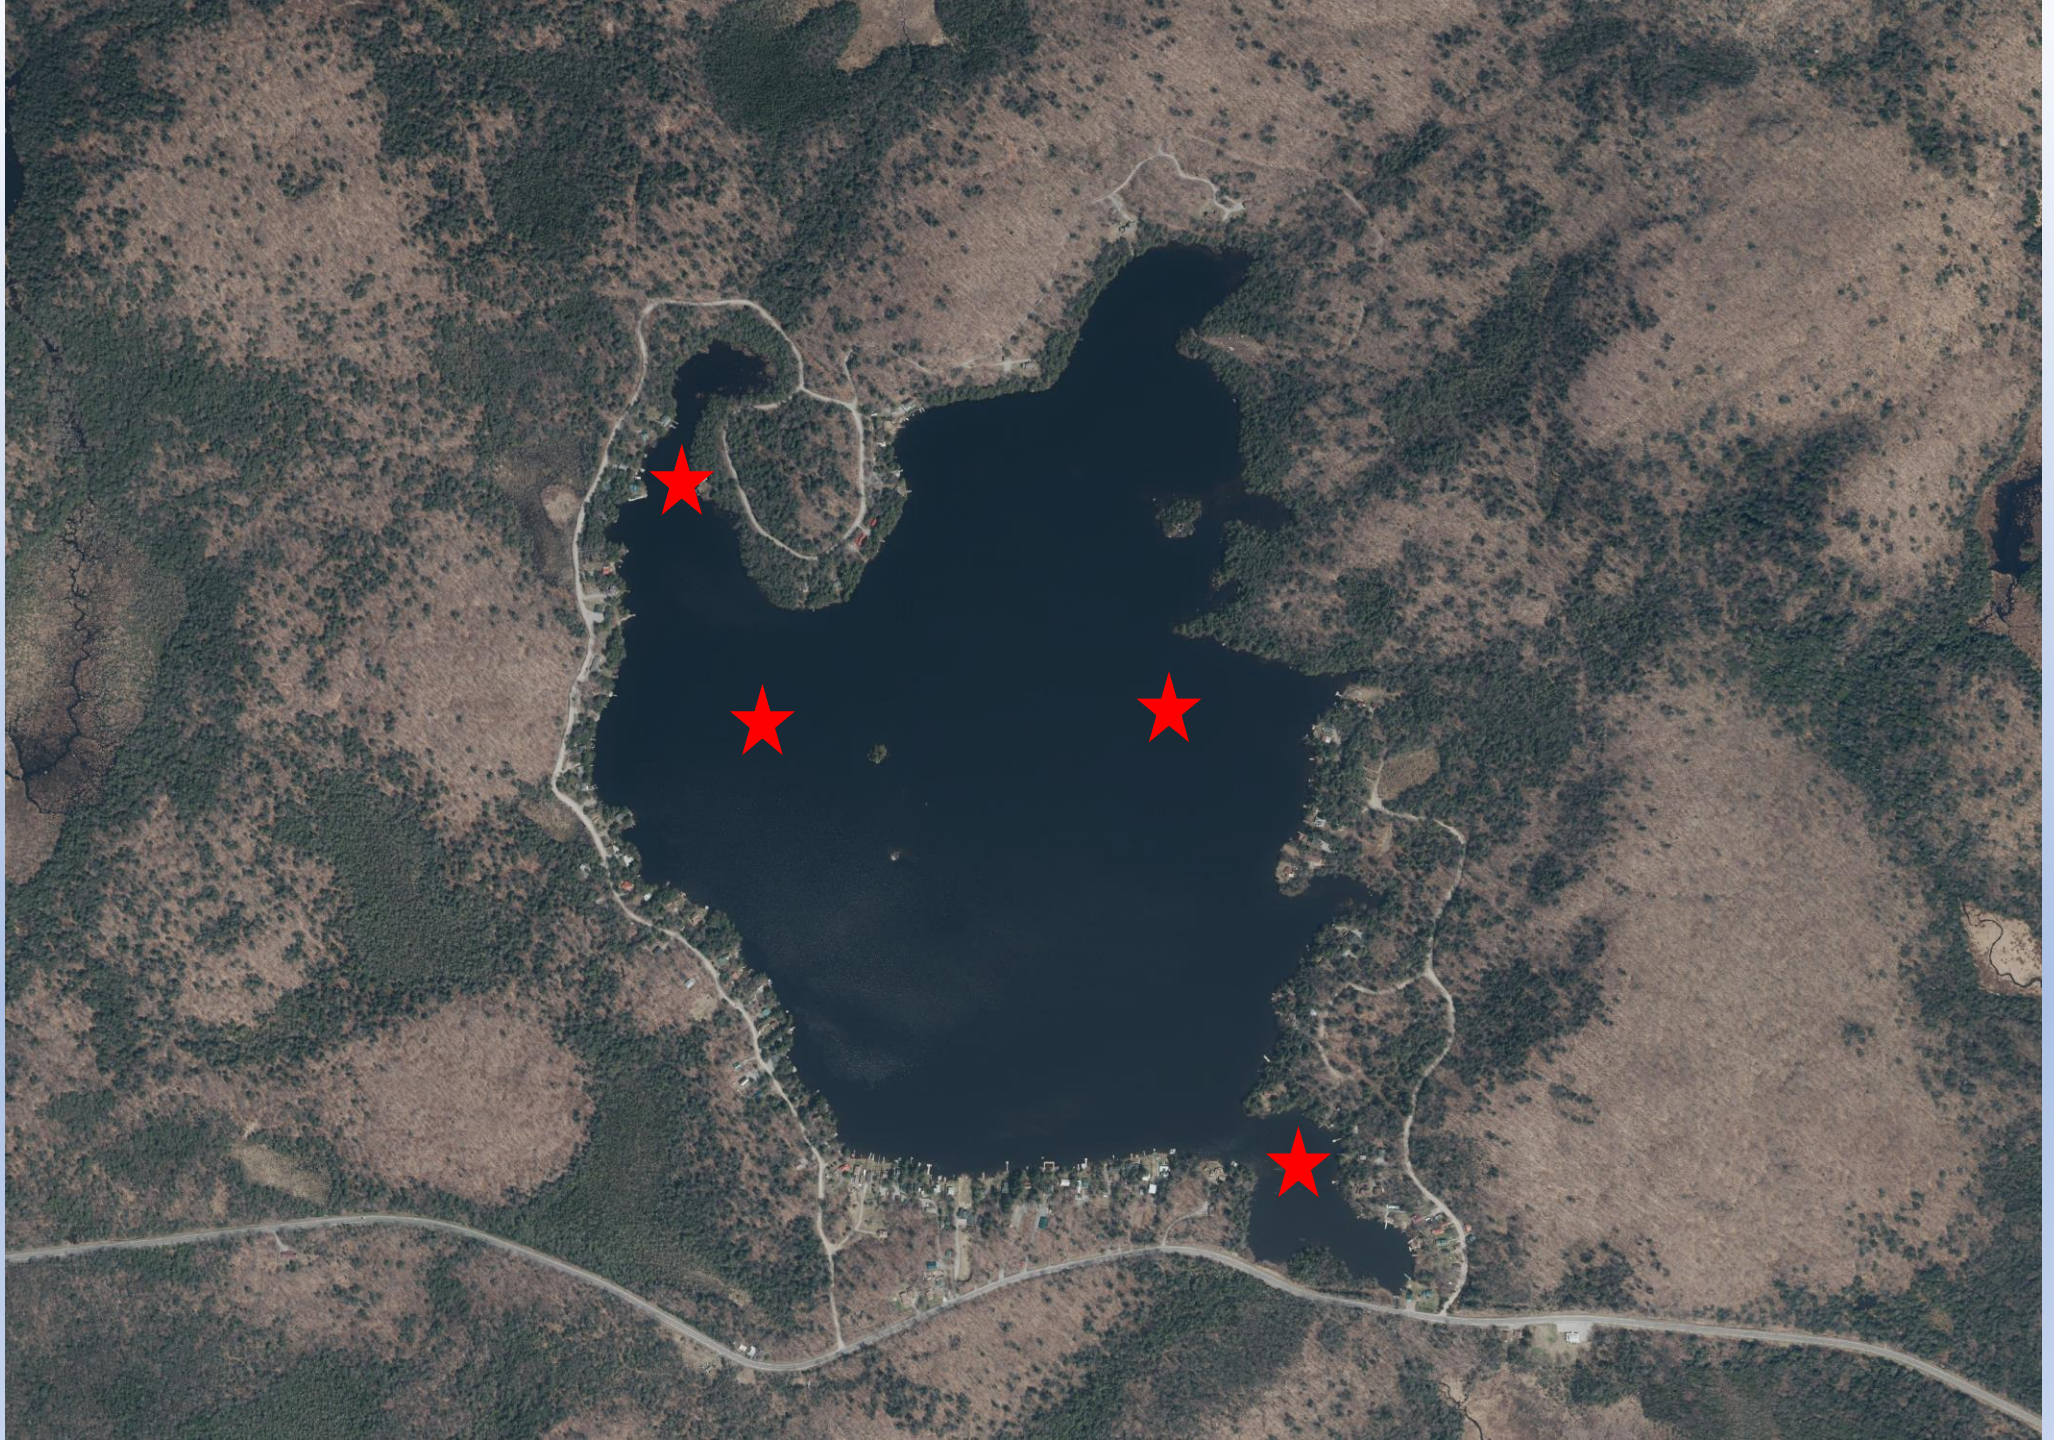
- Sampling of Pleasant Lake occurred in October of 2018
 - Water samples taken at 1 m increments
 - Water quality parameters measured at 1 m increments
- Total Nitrogen concentration was determined using peroxodisulfate digestion followed by the cadmium reduction method (Pritzlaff 2003; Ebina et al. 1983)
- Total phosphorus concentration was determined using the persulfate digestion method (Liao and Marten 2001)
- Nitrite+ nitrate was measured using the cadmium reduction method (Pritzlaff 2003)
