Lake & Watershed Management Plan Development for Three Connected Lakes

Town of Lewisboro, Westchester County, NY

Michael R. Martin, CLM

NYSFOLA Annual Conference – May 4, 2019

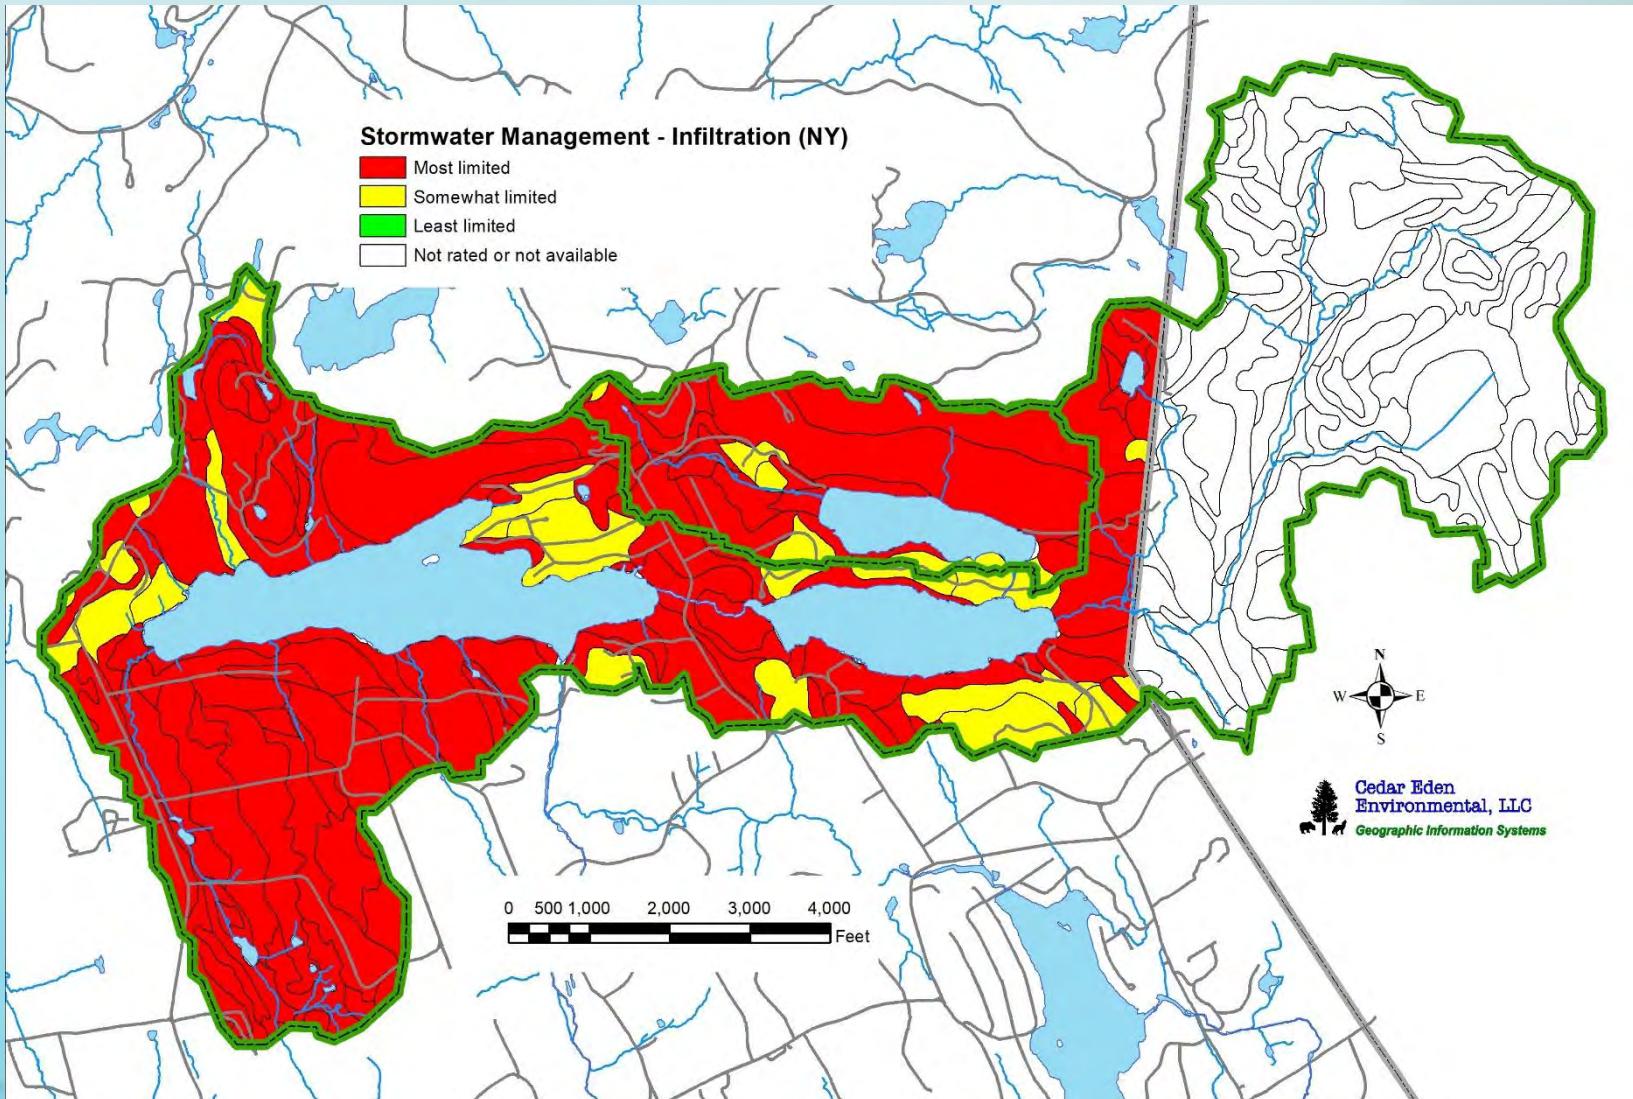
Soil Limitations for Stormwater Management

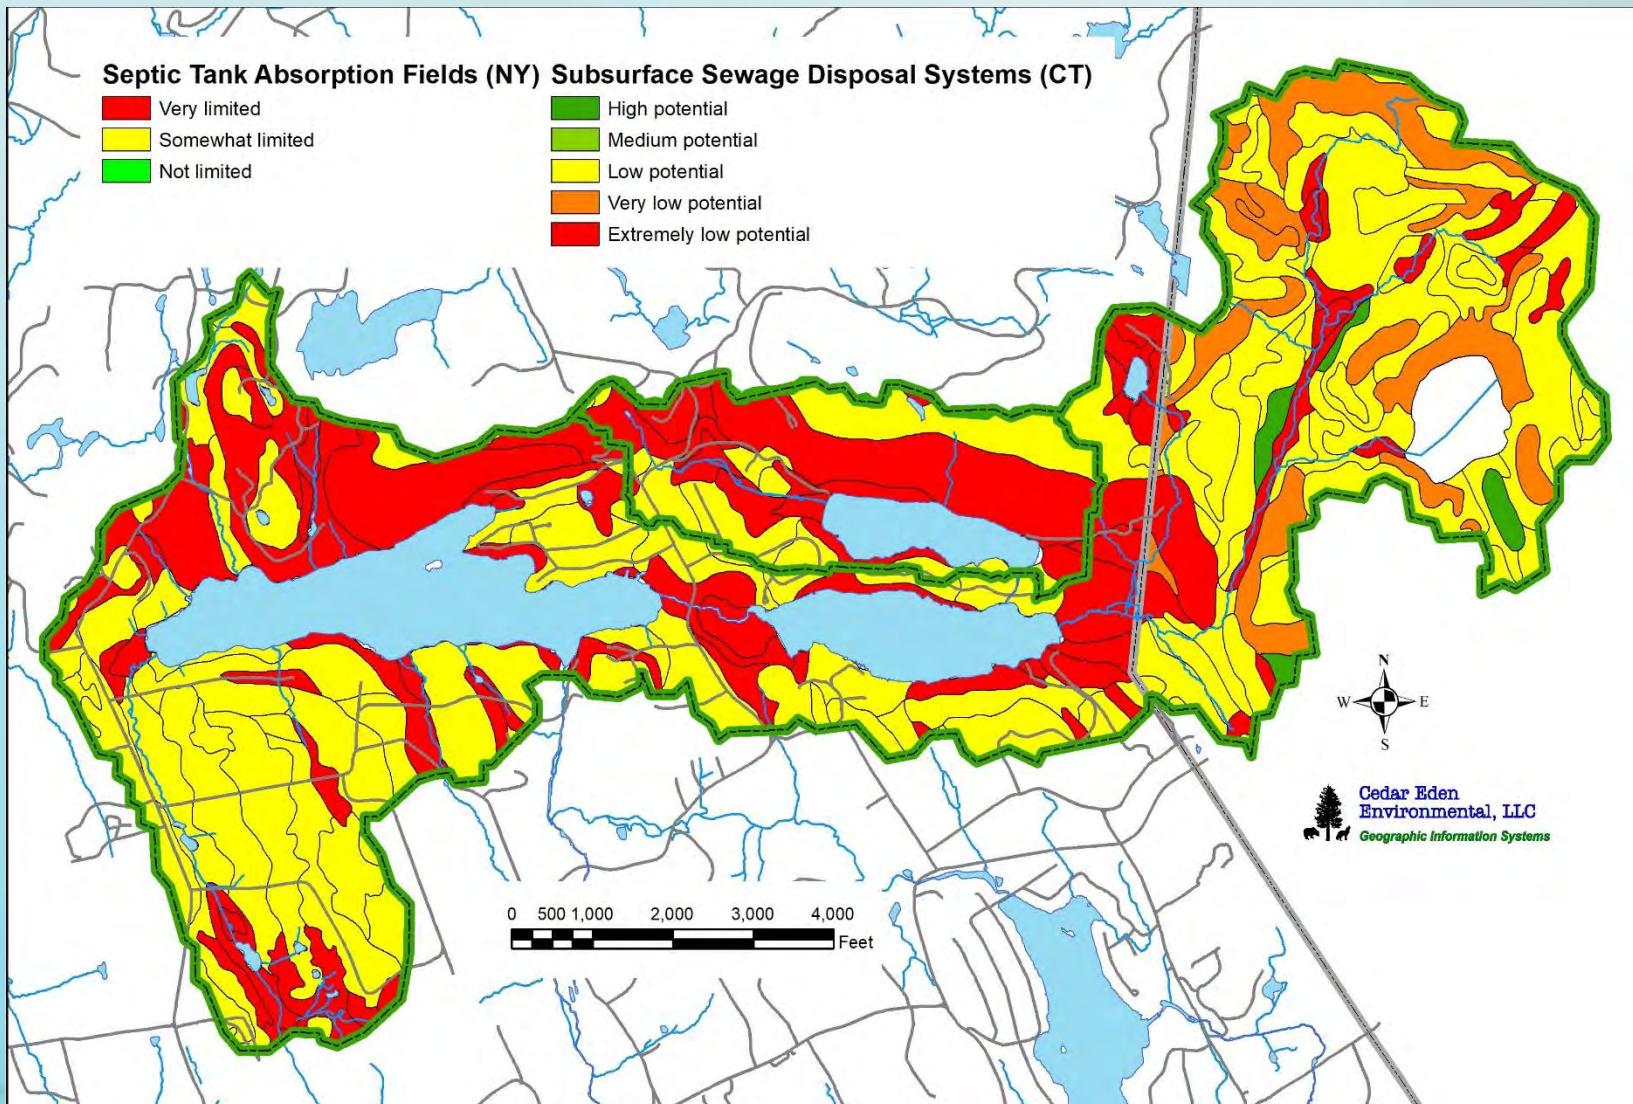
Soil Limitations for Septic Systems

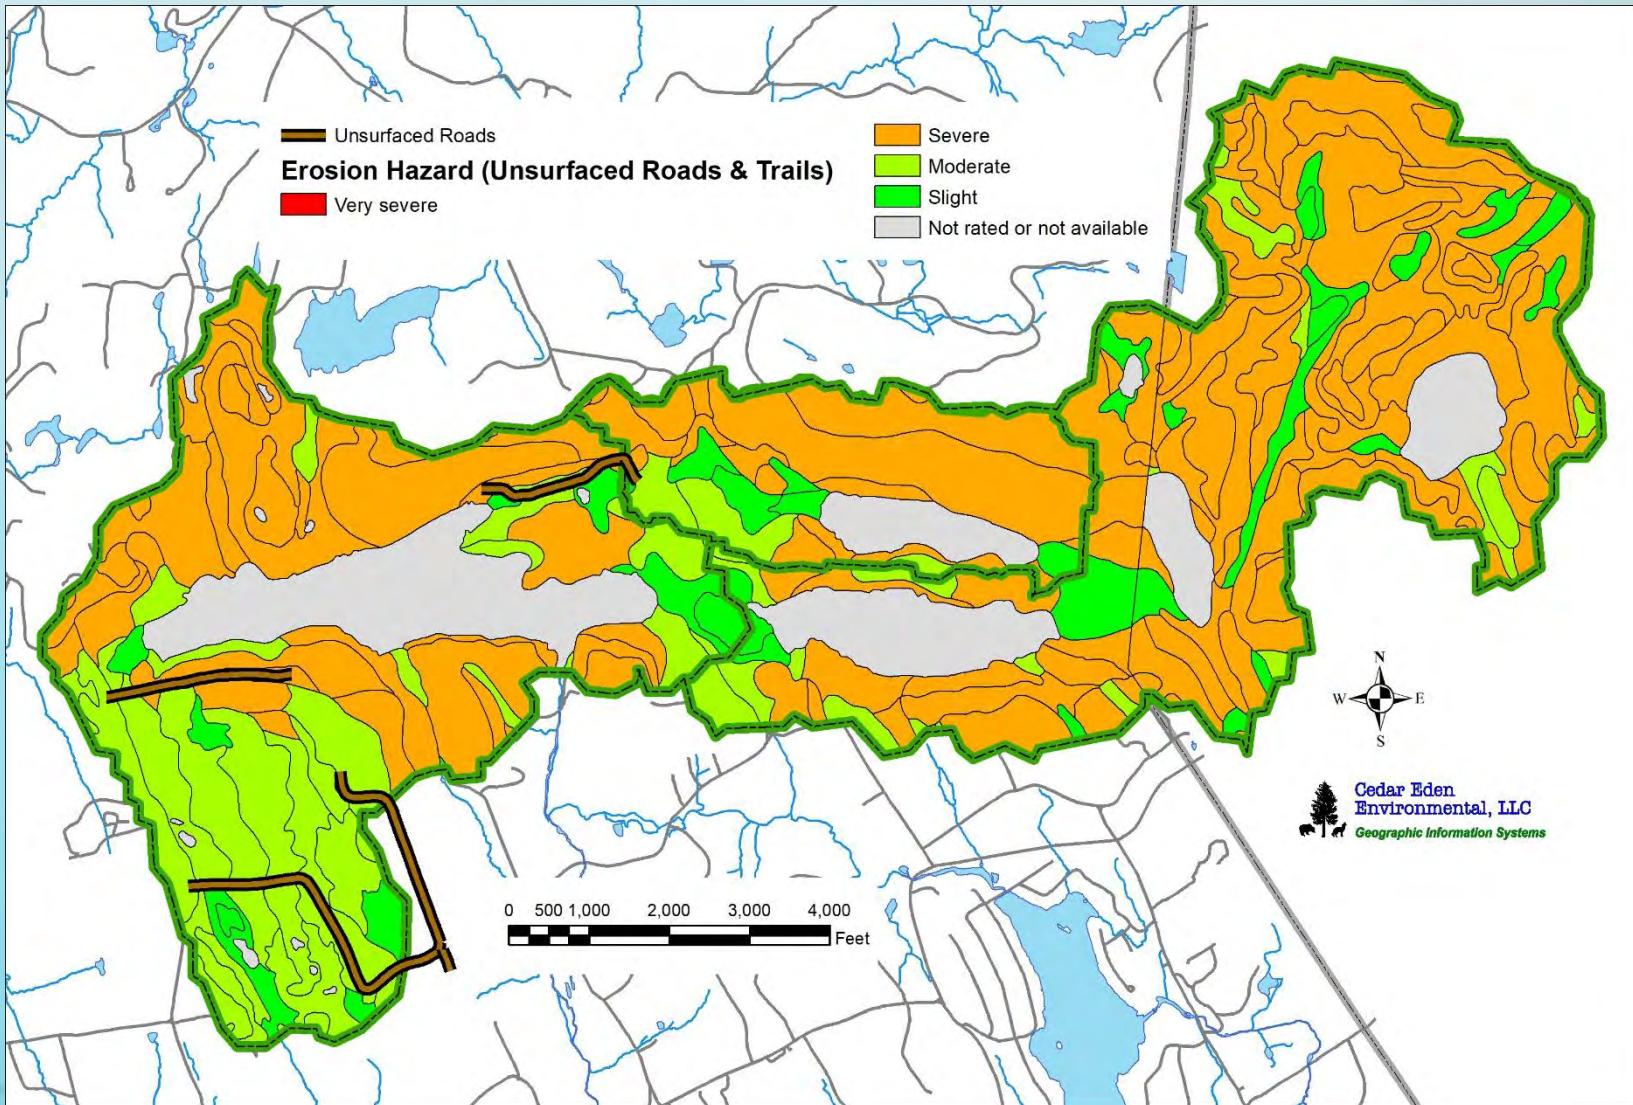
Soil Erosion Hazard for Unsurfaced Roads

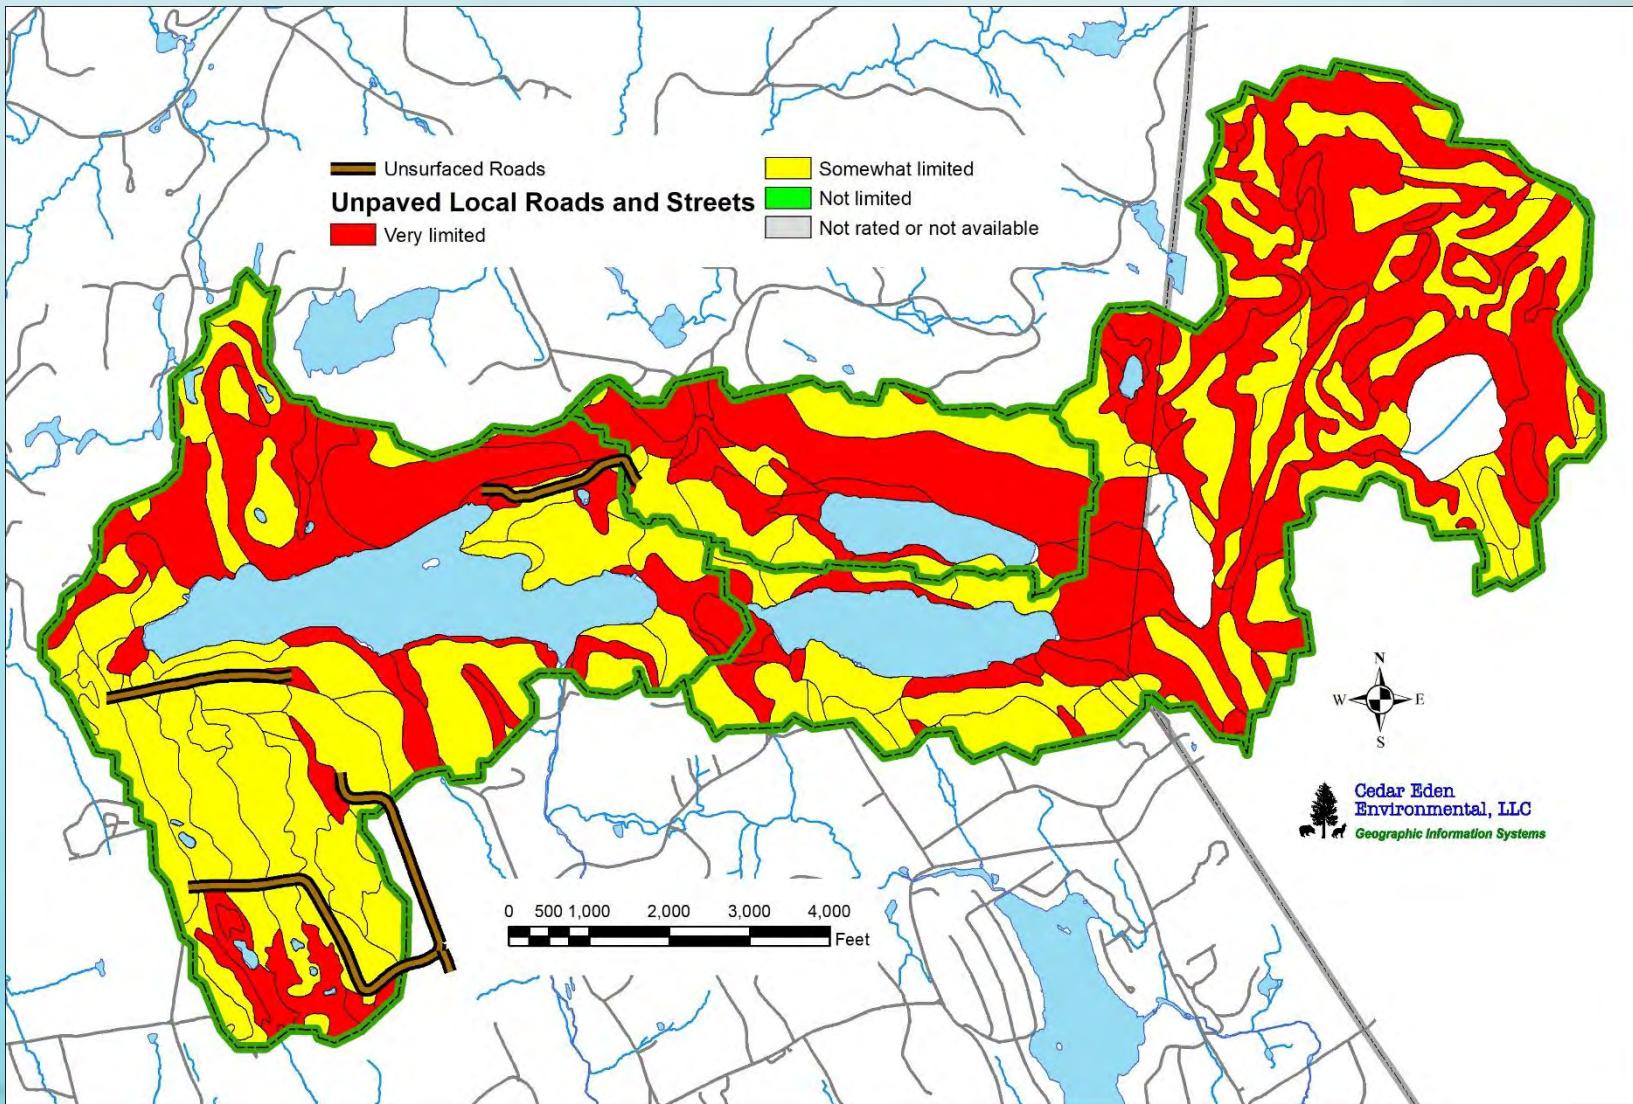
Soil Limitation for Unpaved Local Roads

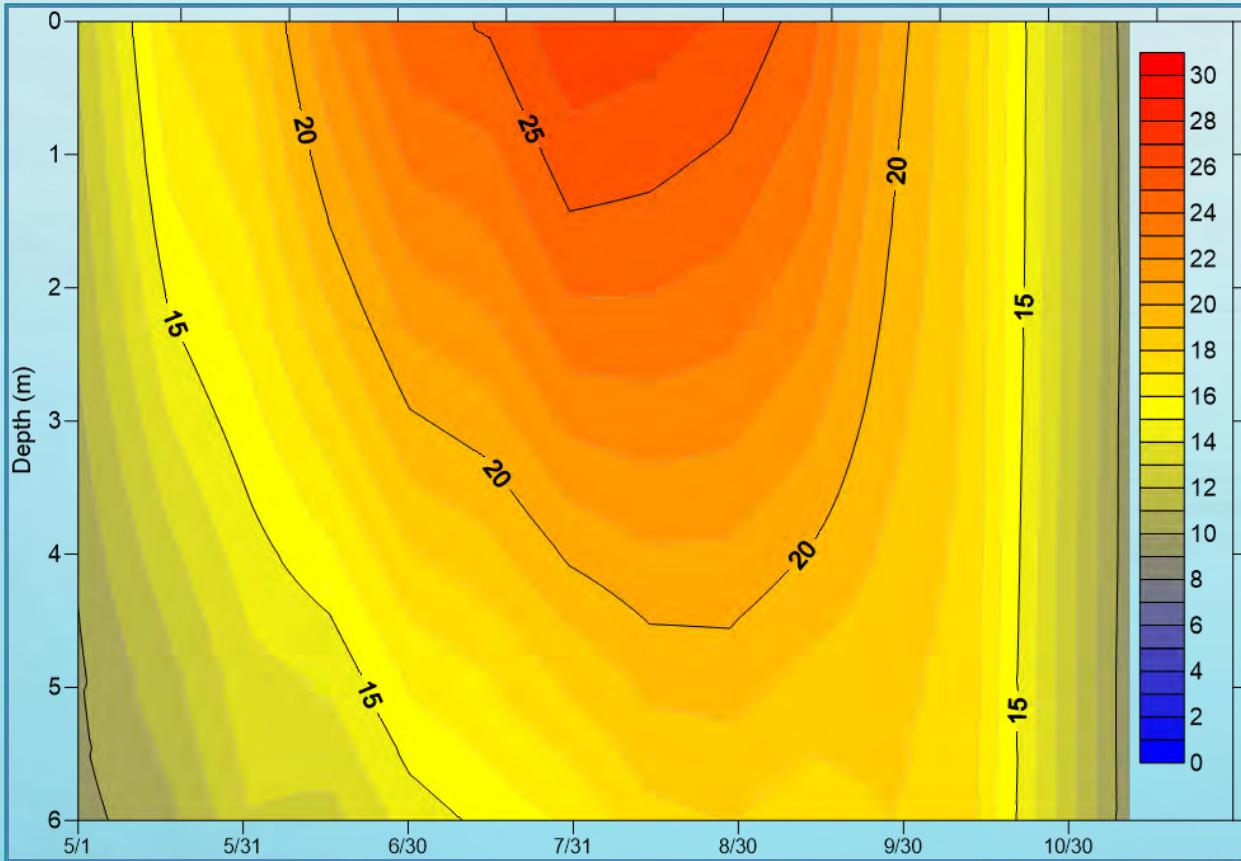
Lake Rippowam Dissolved Oxygen & Temperature

Temperature Isopleths

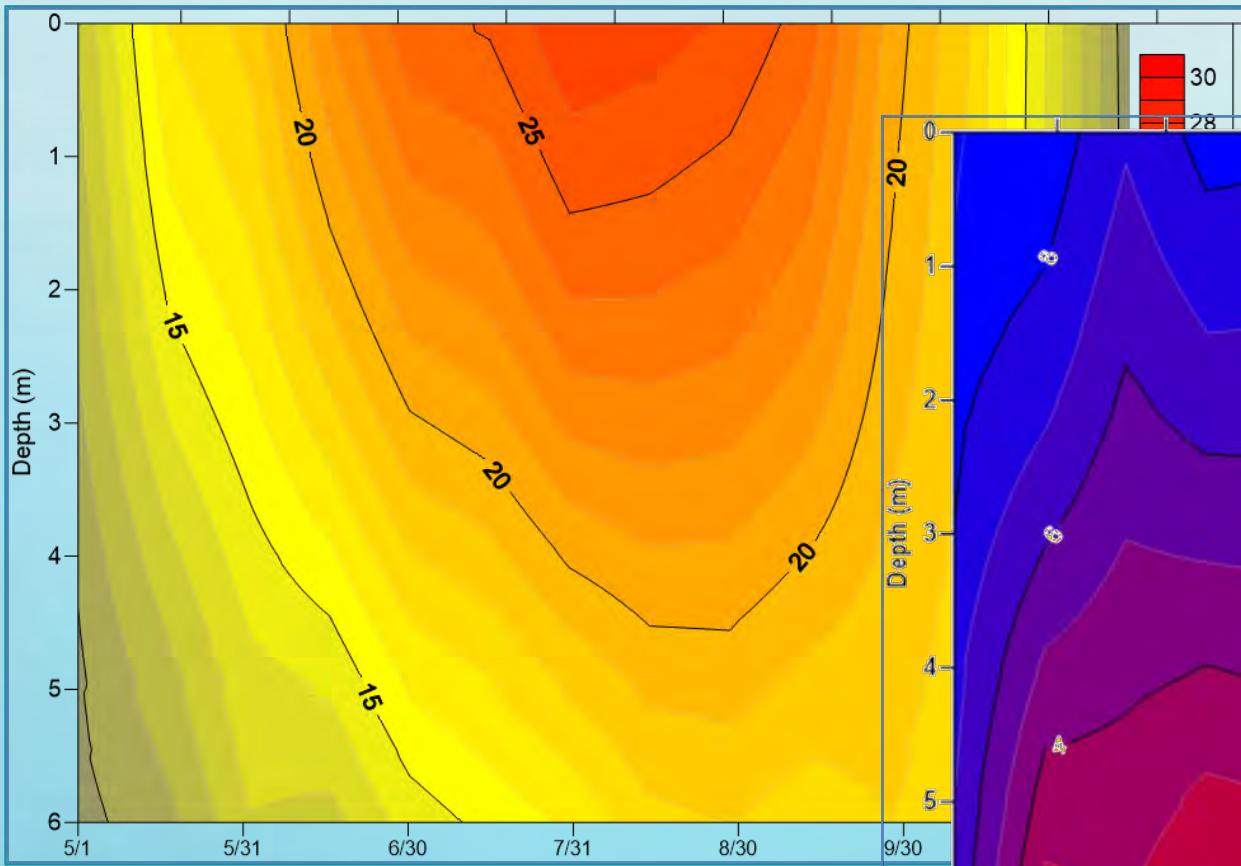
Lake Rippowam Dissolved Oxygen & Temperature

Temperature Isopleths

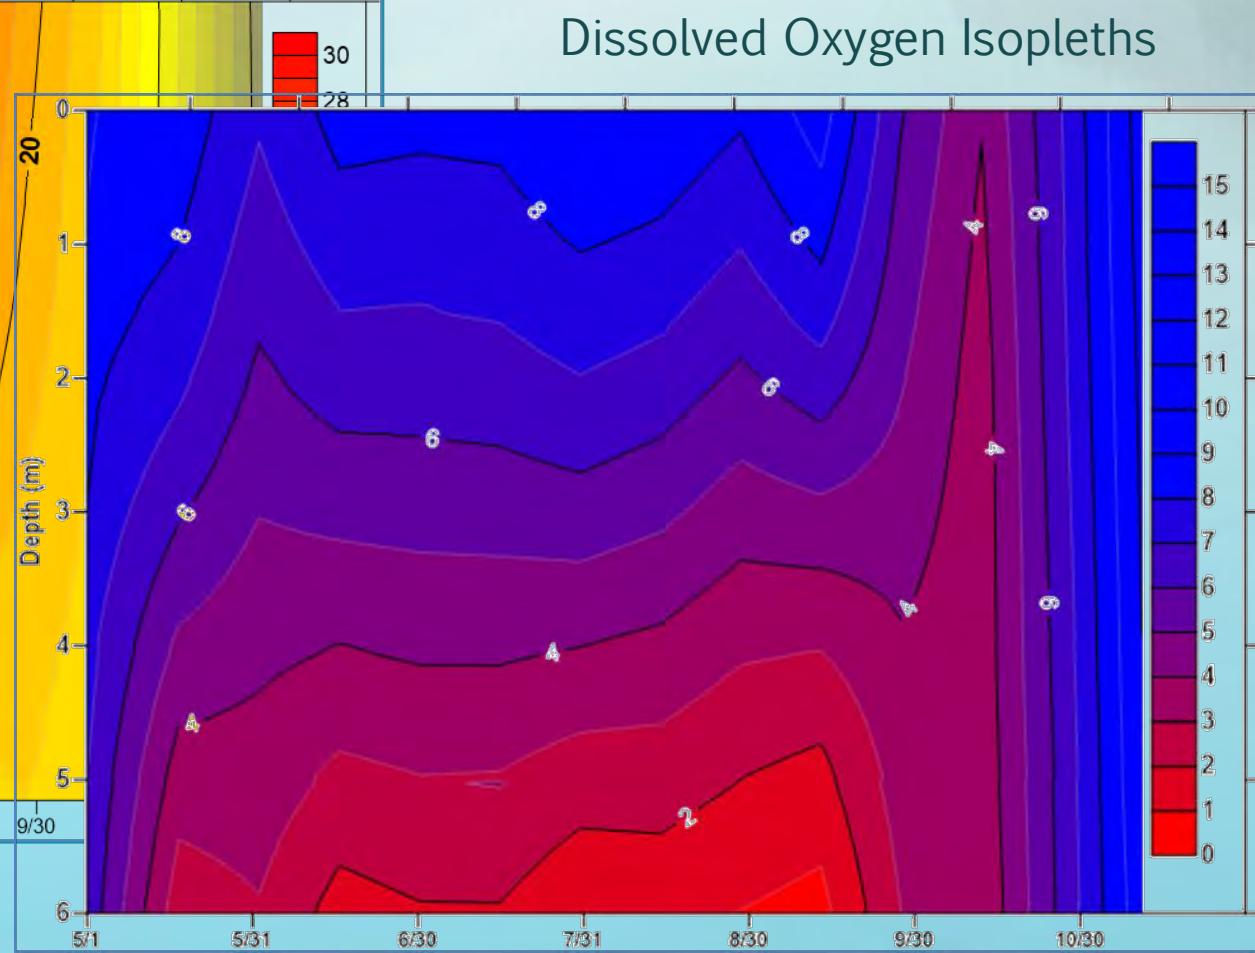
Dissolved Oxygen Isopleths

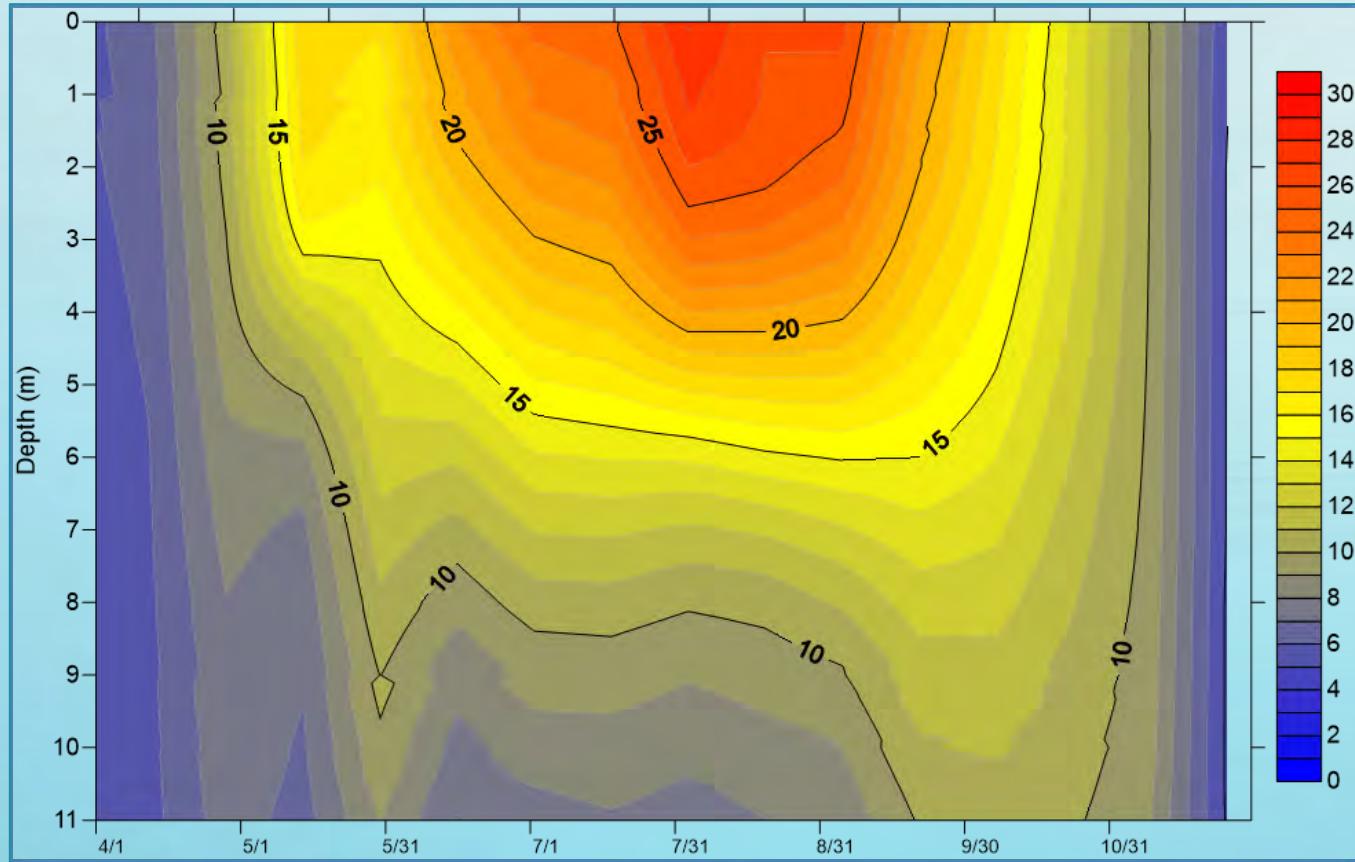
Lake Oscaleta Dissolved Oxygen & Temperature

Temperature Isopleths

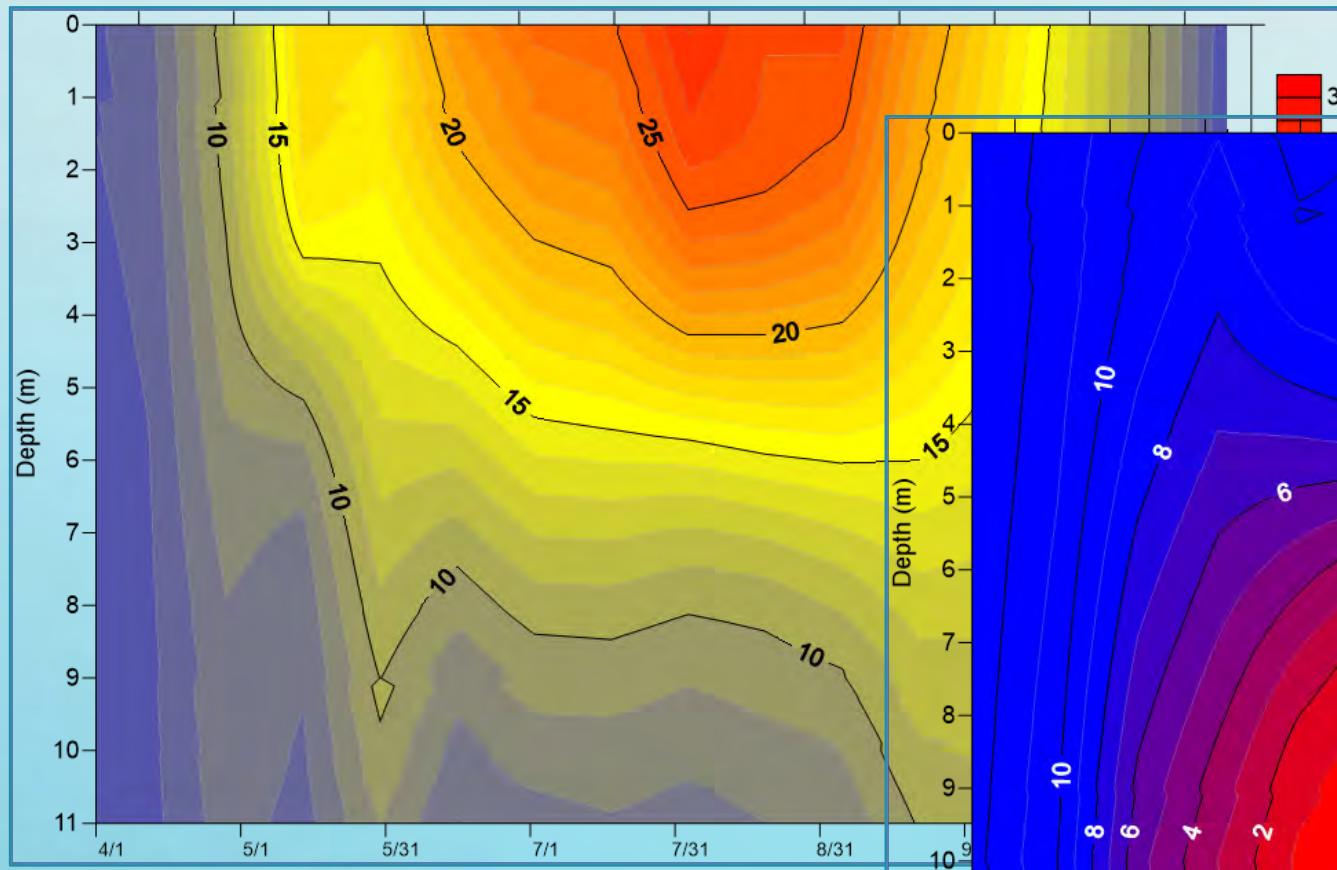
Lake Oscaleta Dissolved Oxygen & Temperature

Temperature Isopleths

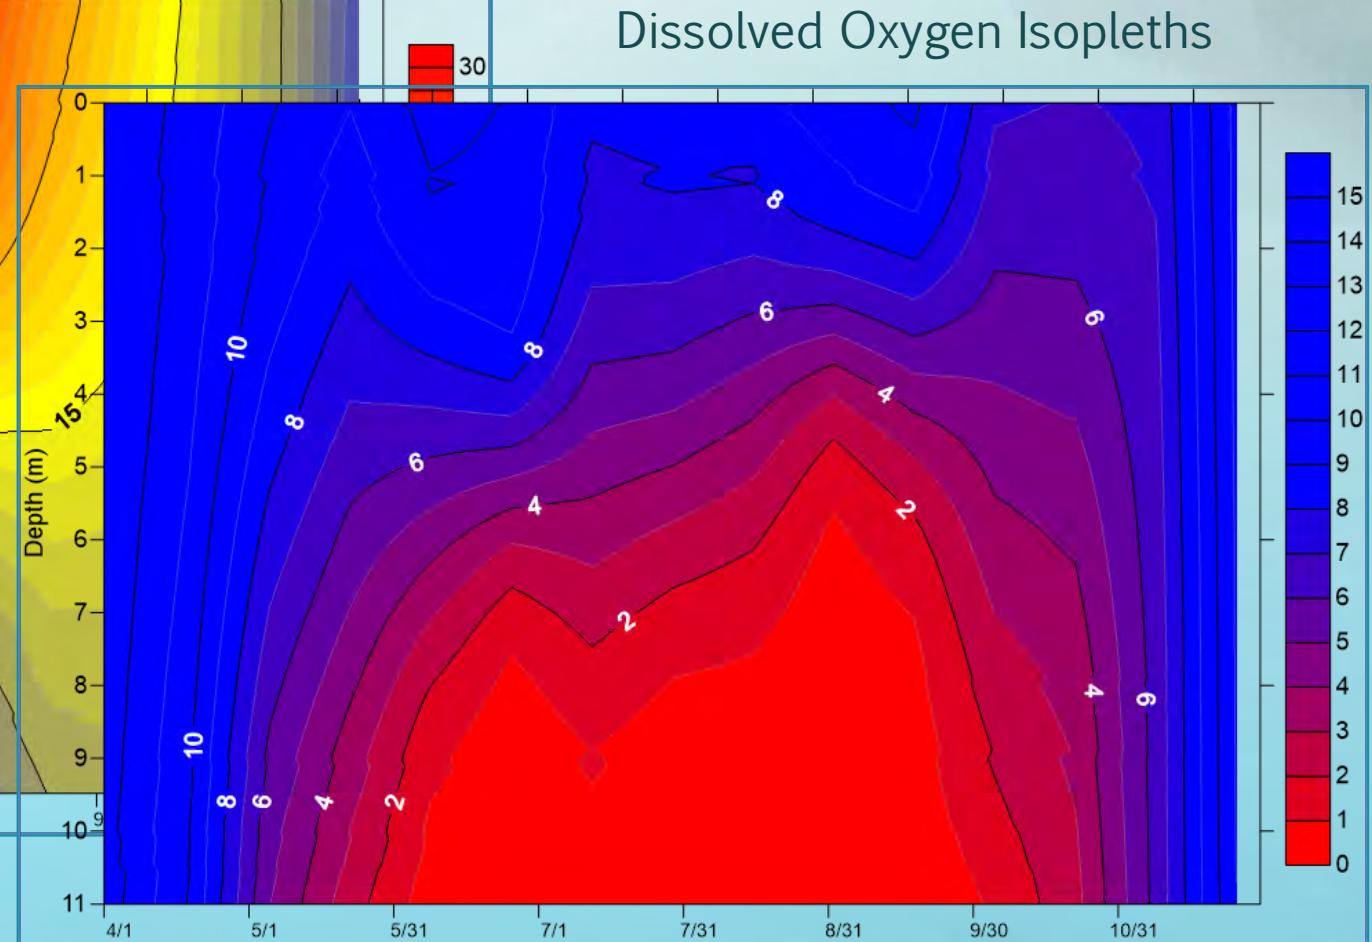
Dissolved Oxygen Isopleths

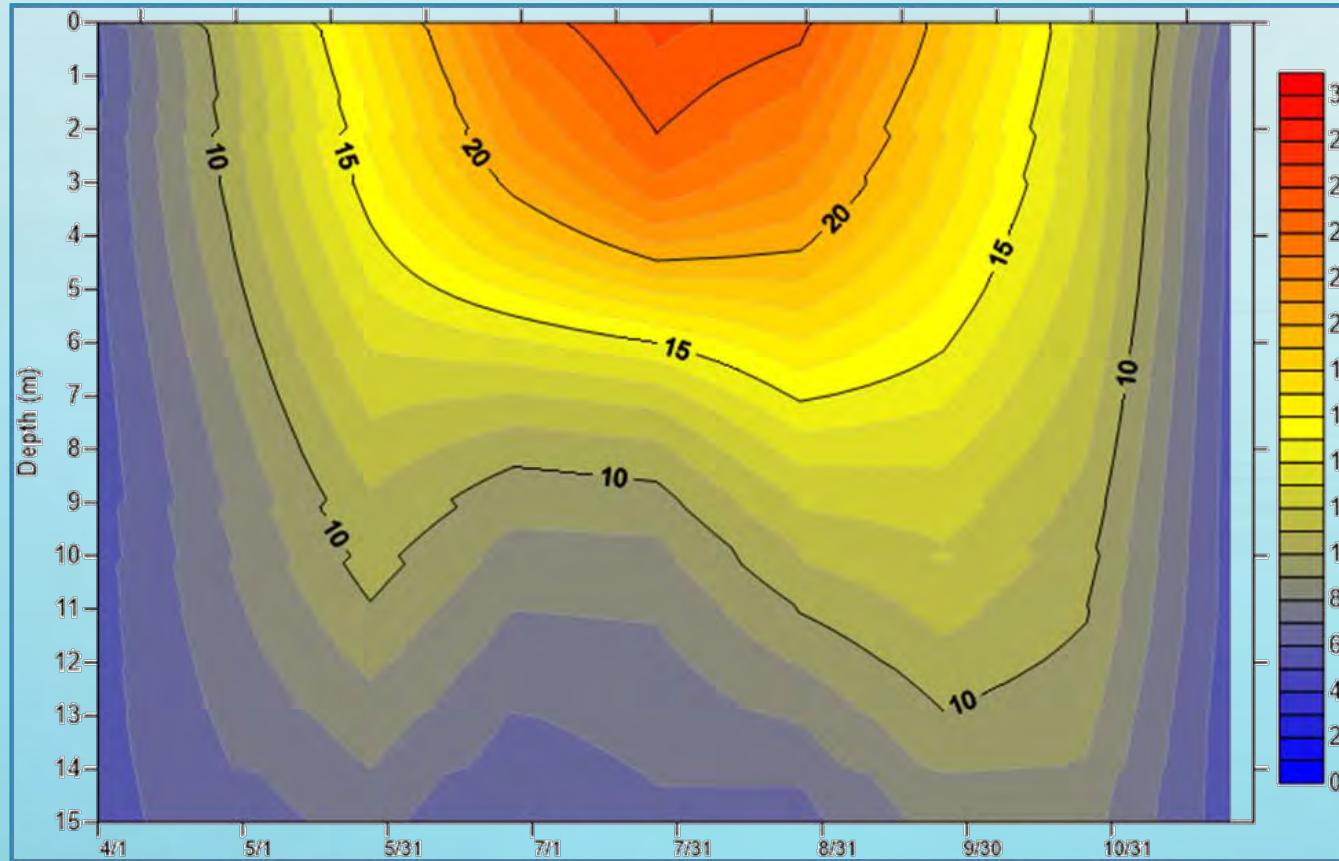
Lake Waccabuc Dissolved Oxygen & Temperature

Temperature Isopleths

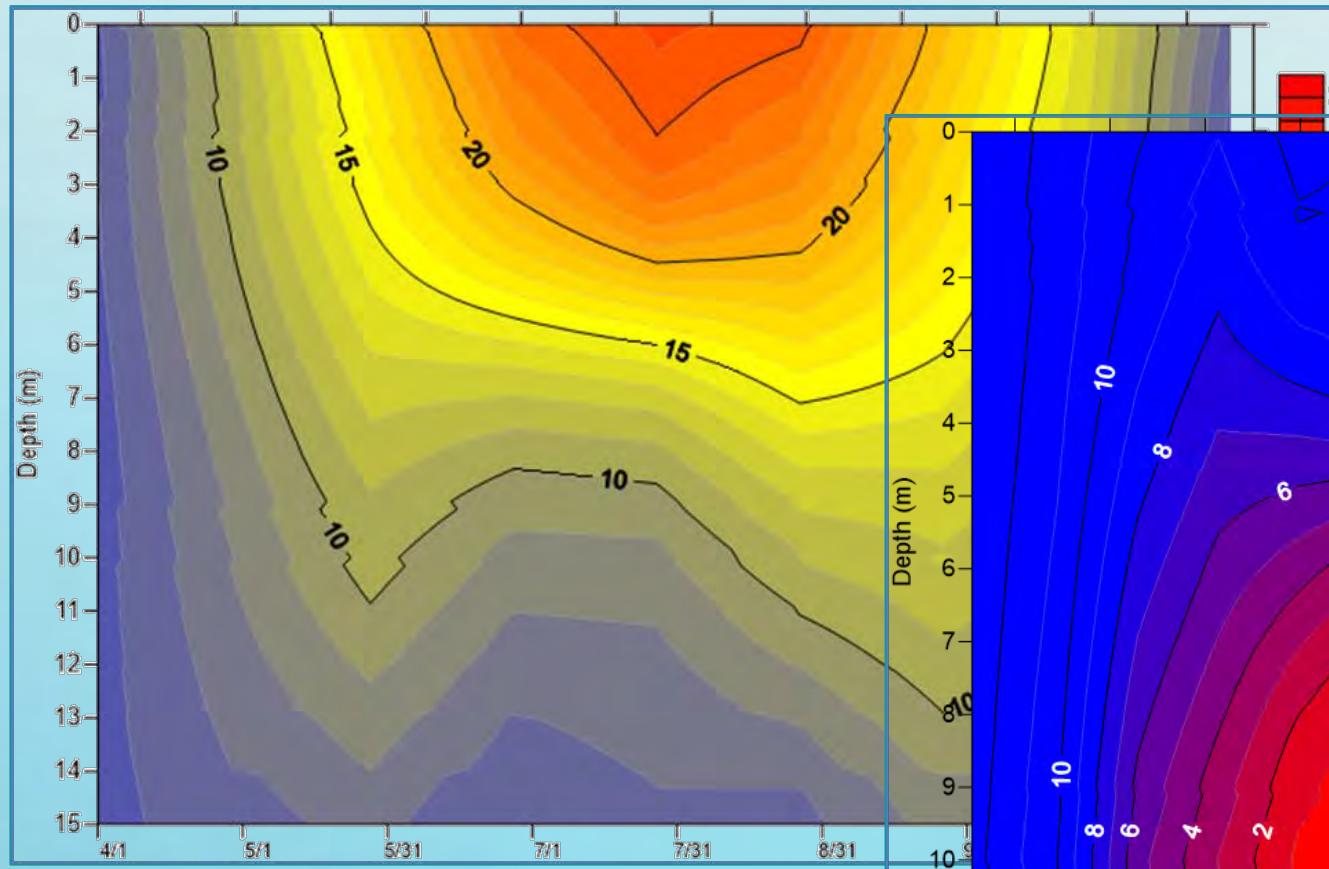
Lake Waccabuc Dissolved Oxygen & Temperature

Temperature Isopleths

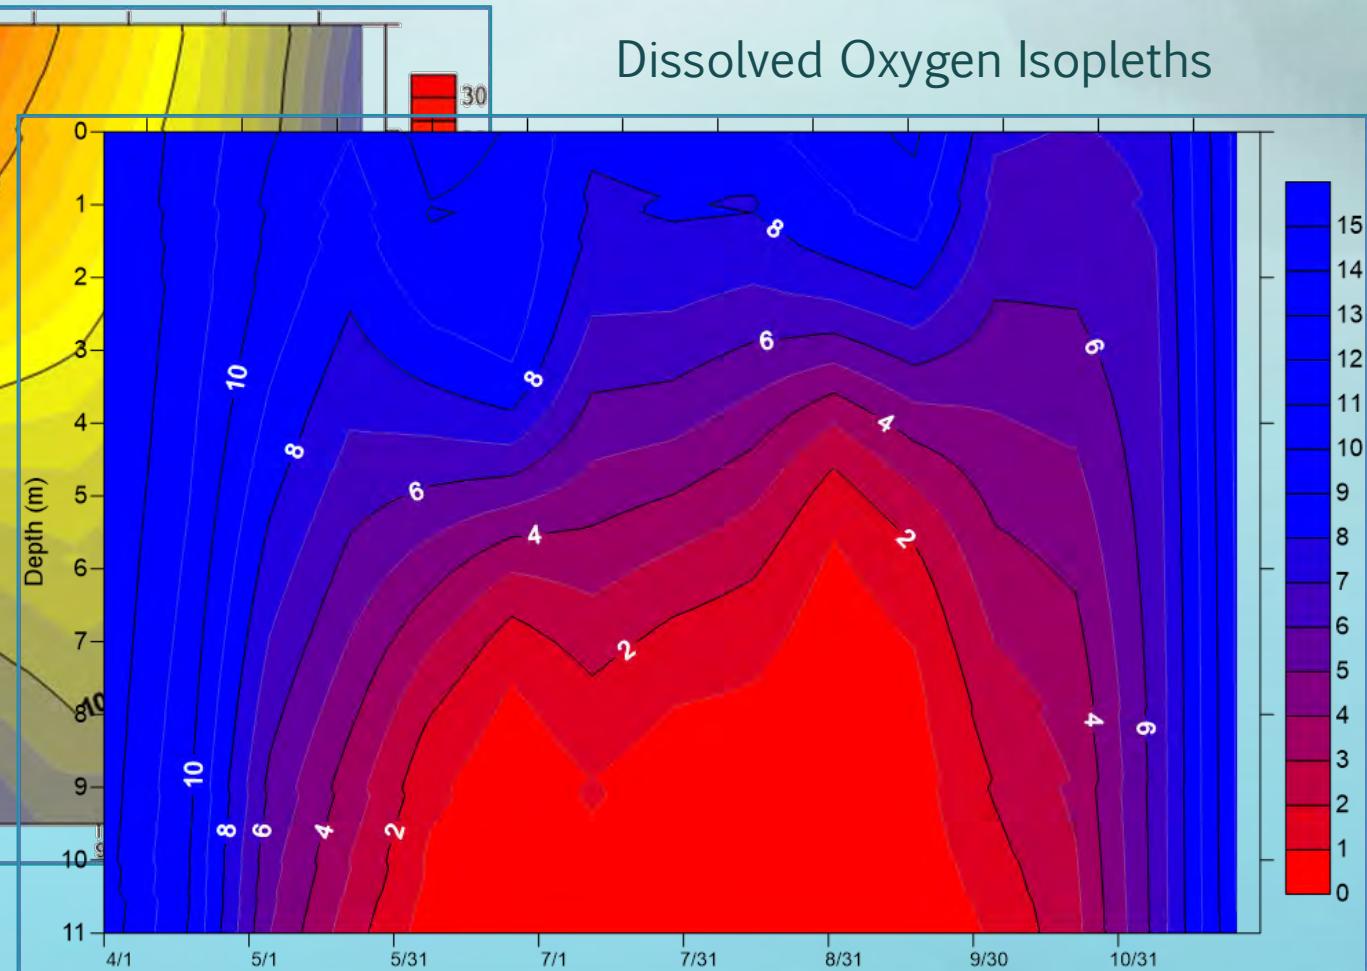
Dissolved Oxygen Isopleths

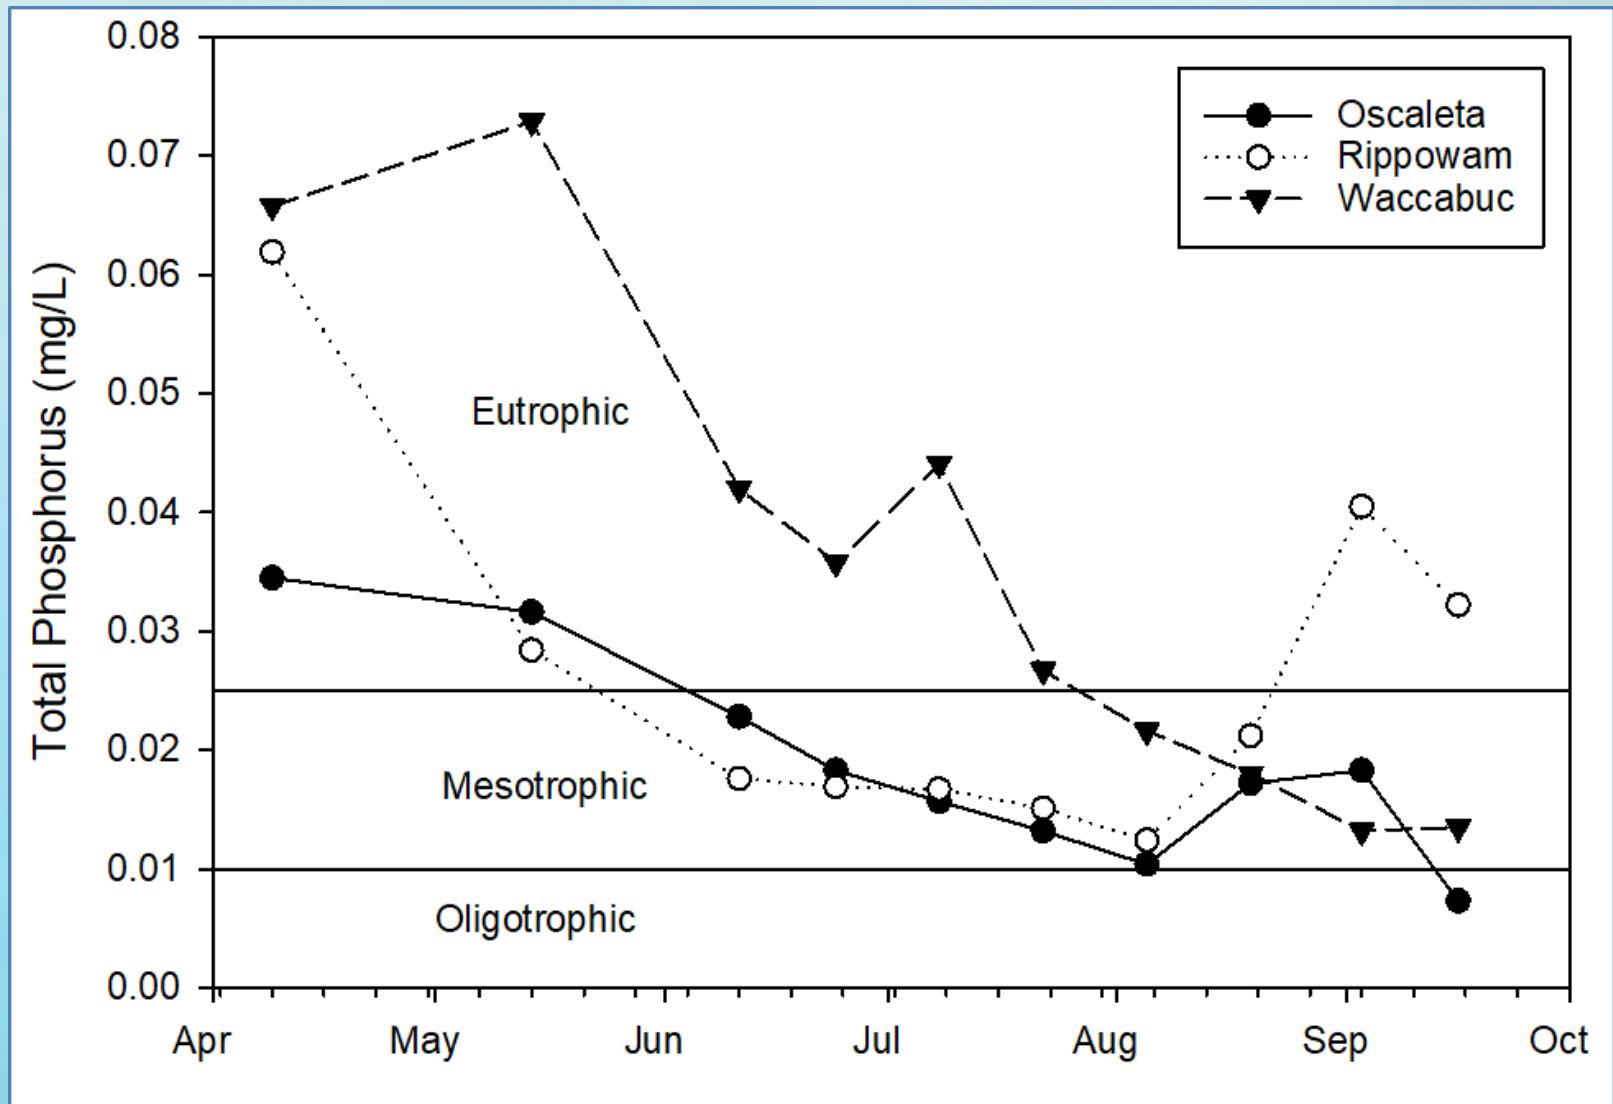
Total Phosphorus (epilimnia)

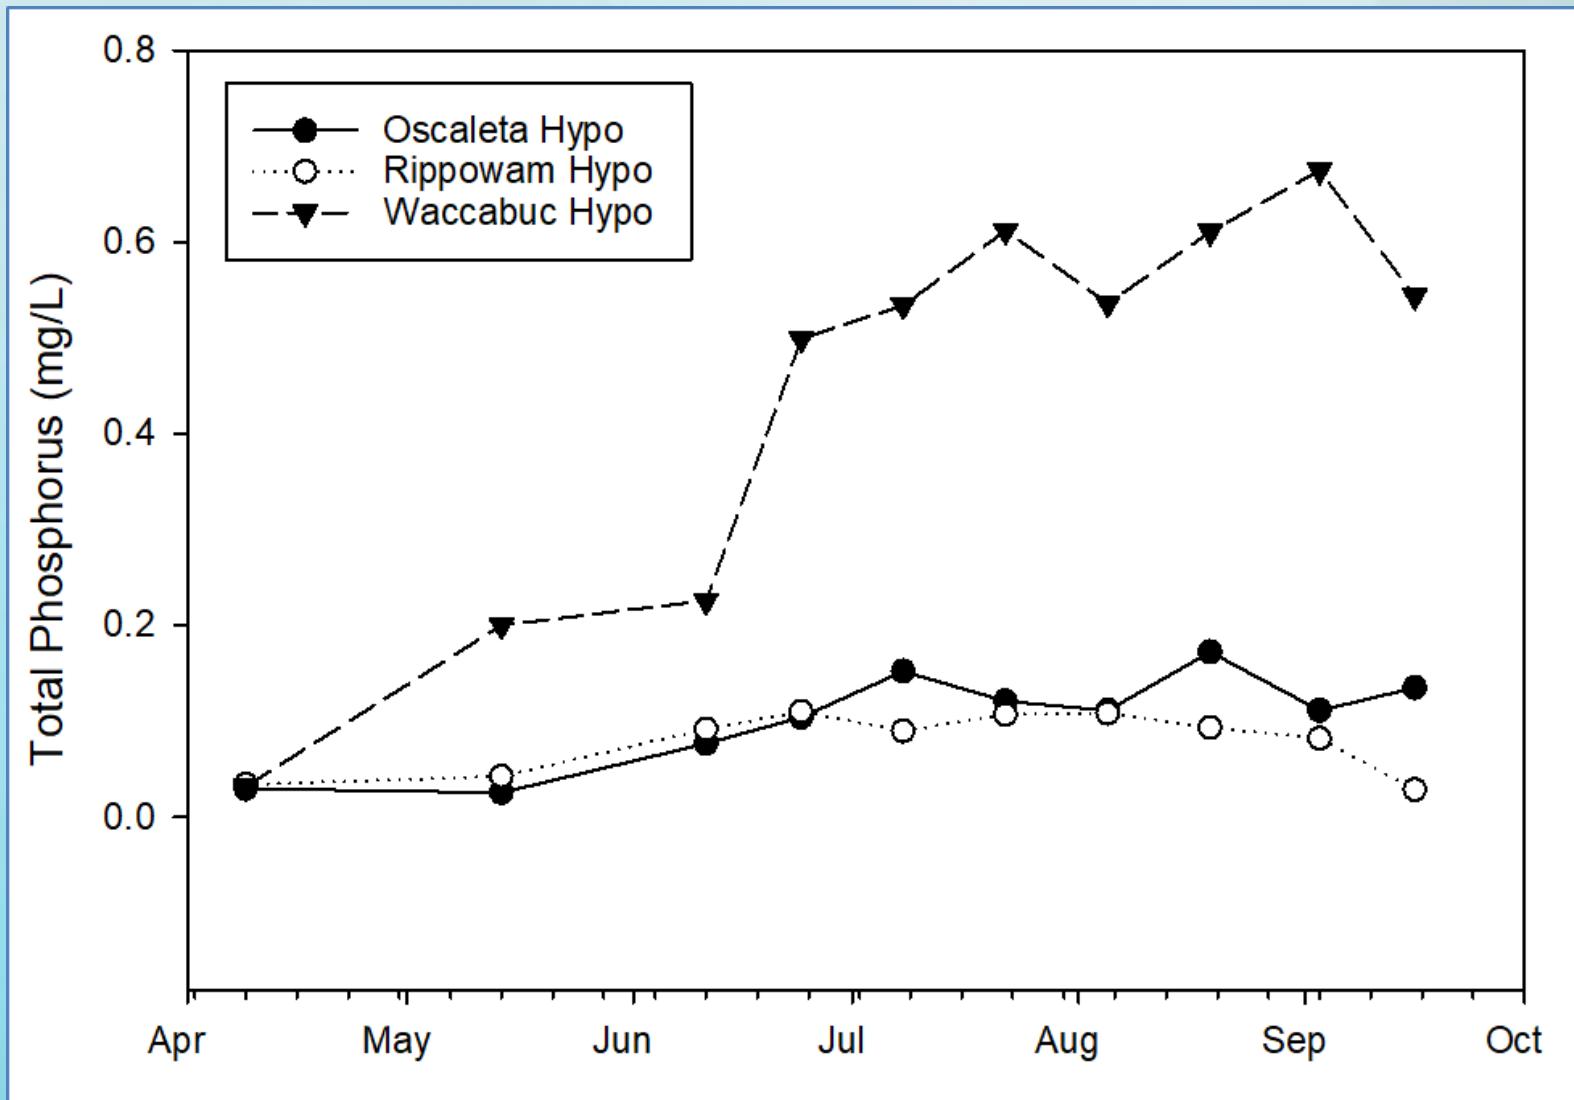
Total Phosphorus (hypolimnia)

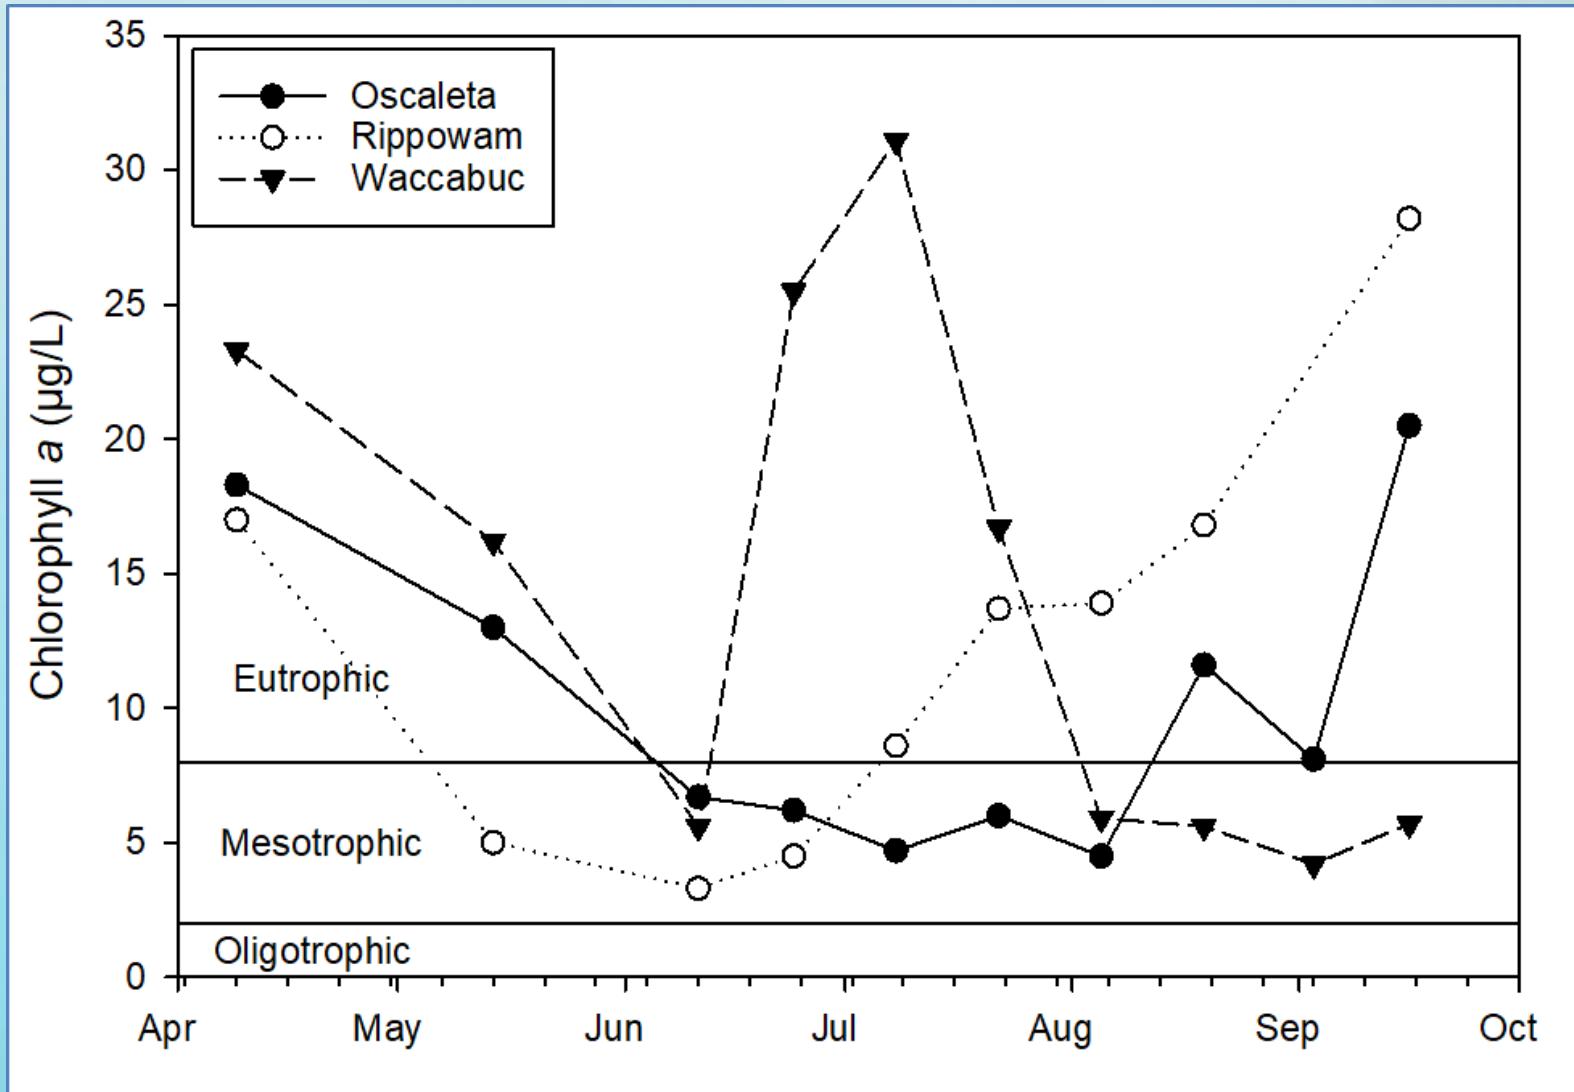
Chlorophyll *a*
