Lake & Watershed Management Plan Development for Three Connected Lakes

Town of Lewisboro, Westchester County, NY

Michael R. Martin, CLM

NYSFOLA Annual Conference – May 4, 2019

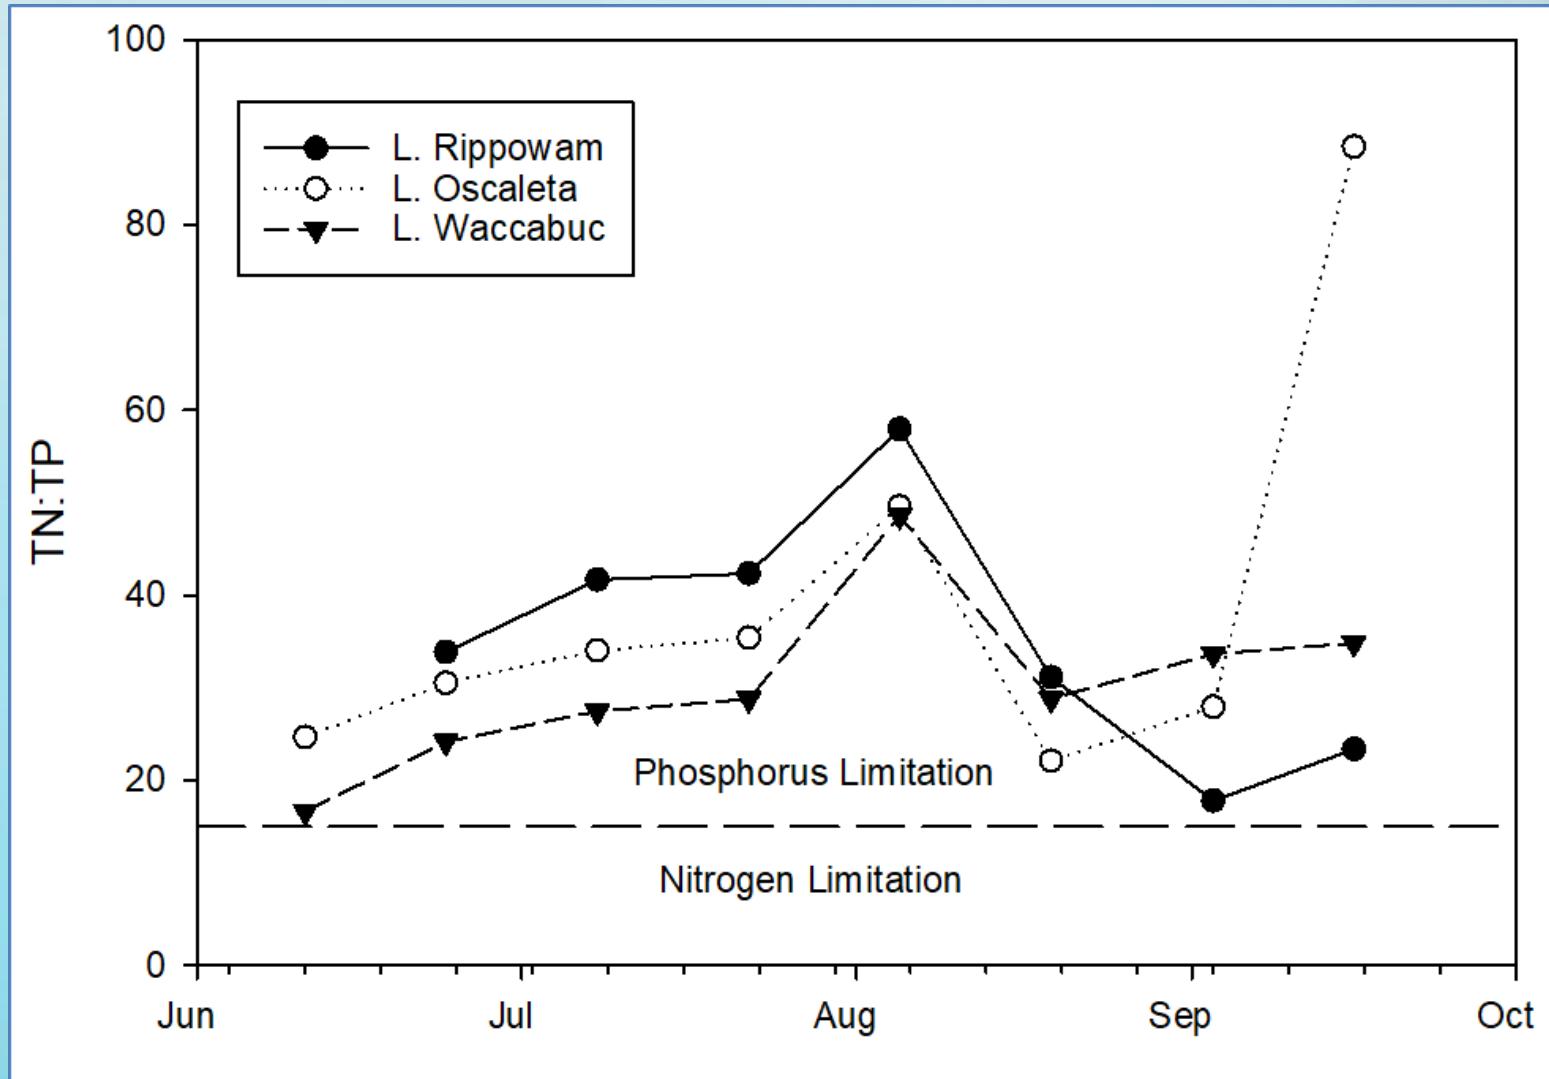
Limiting Nutrient

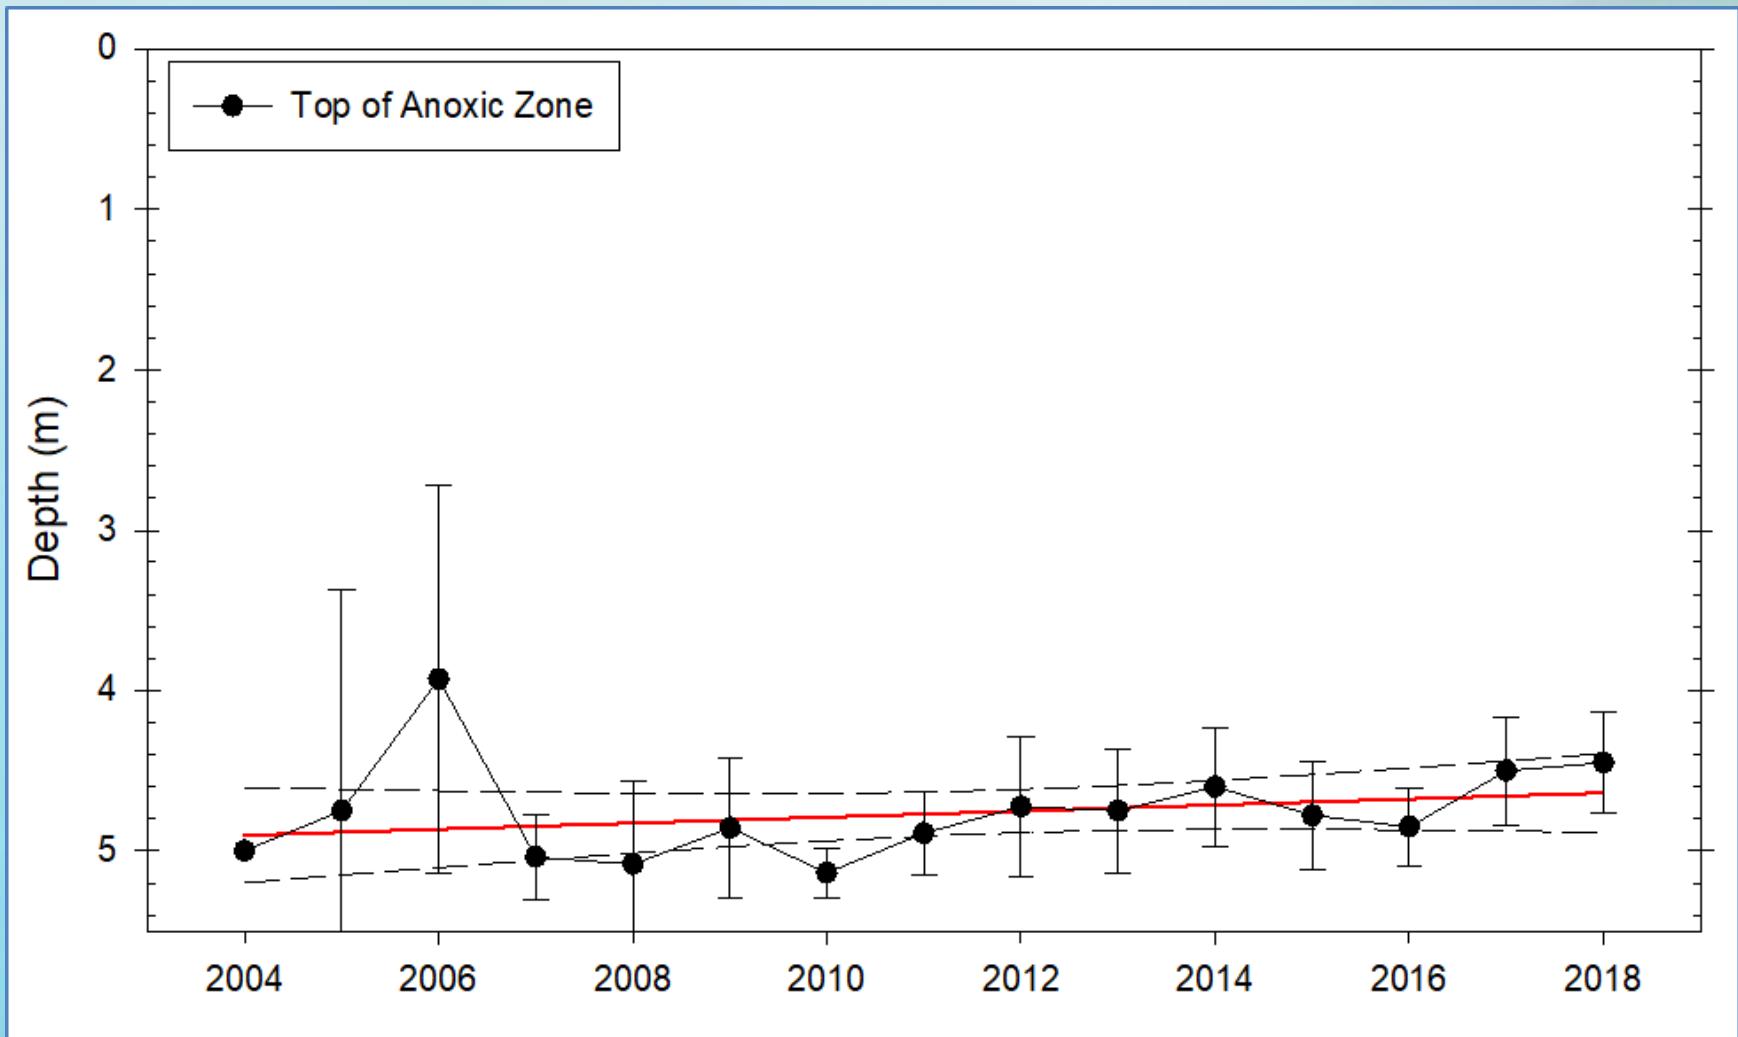
Lake Rippowam Anoxia Trend

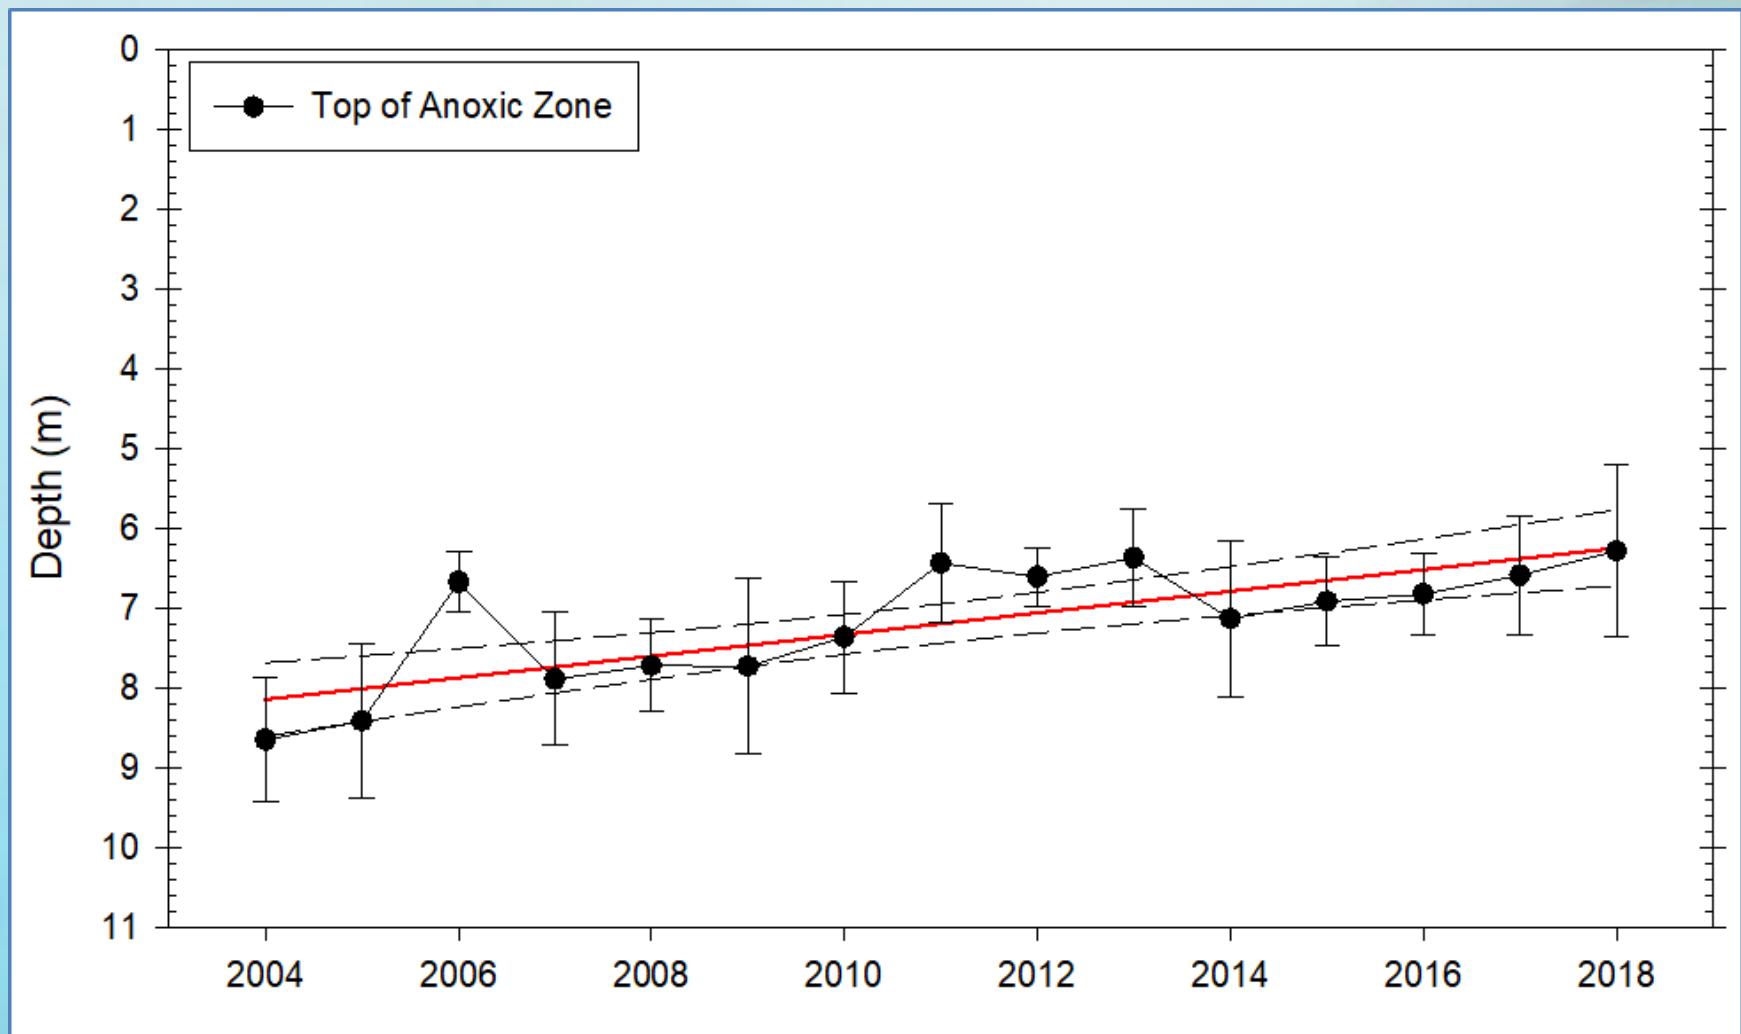
Lake Oscaleta Anoxia Trend

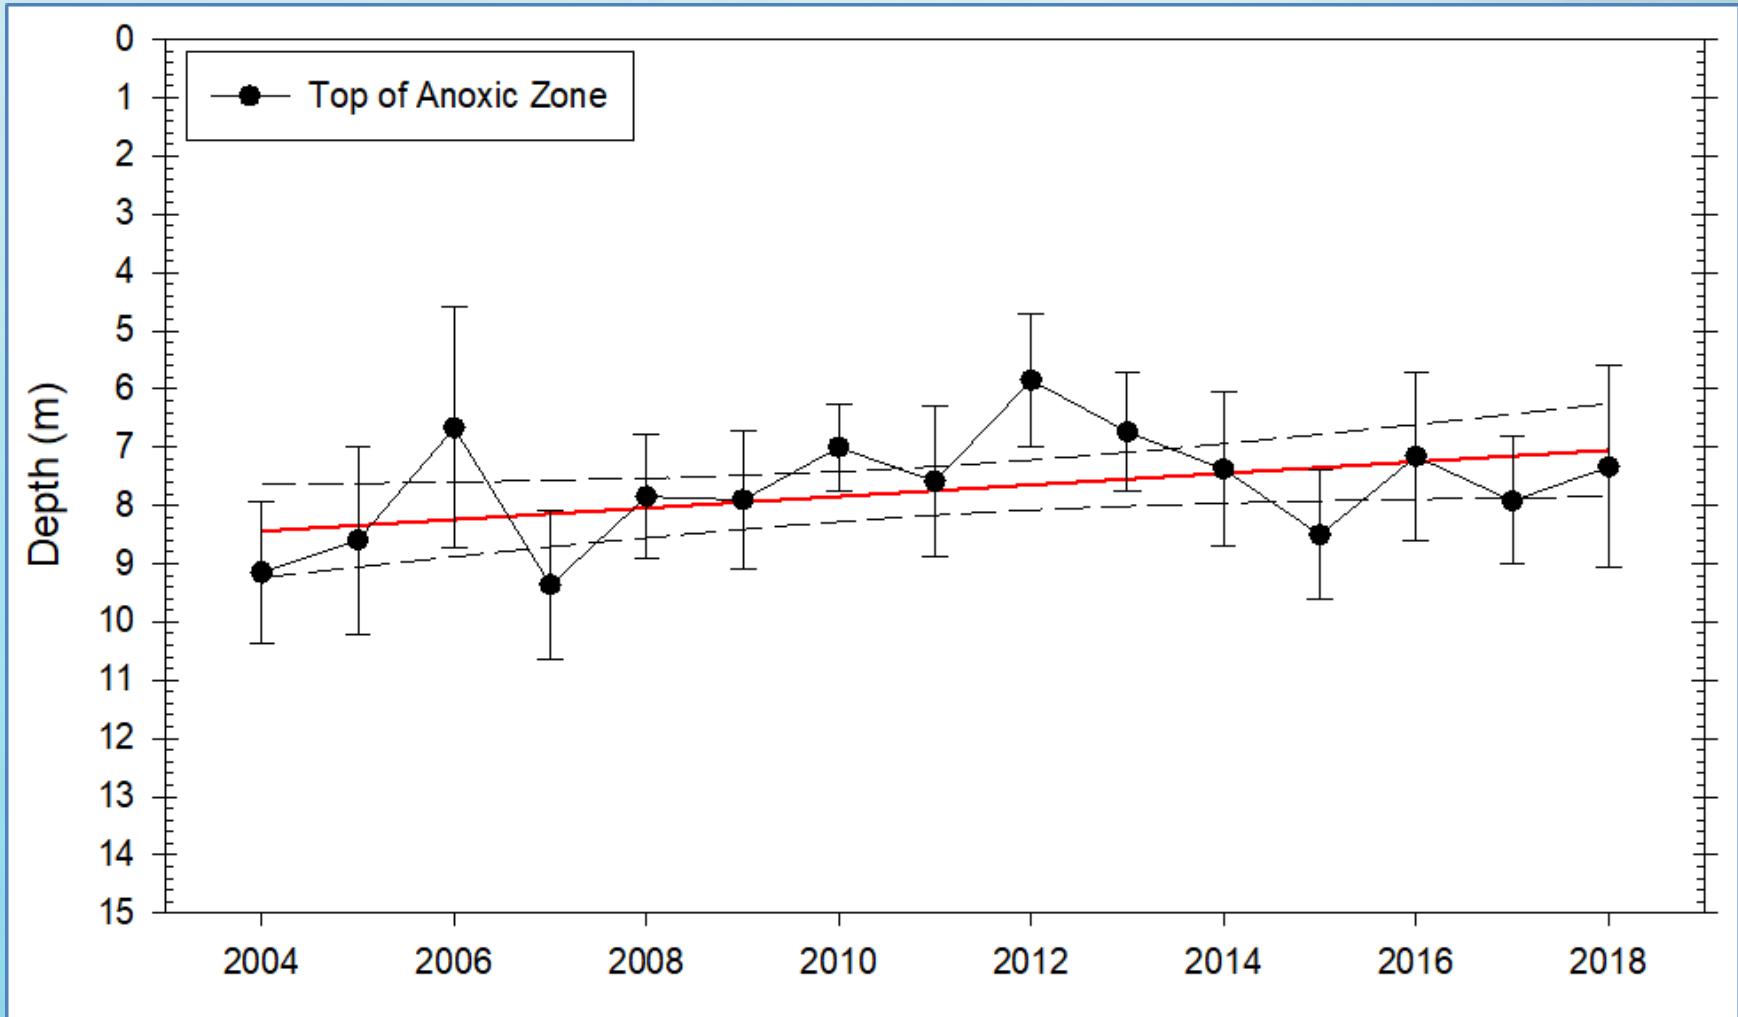
Lake Waccabuc Anoxia Trend

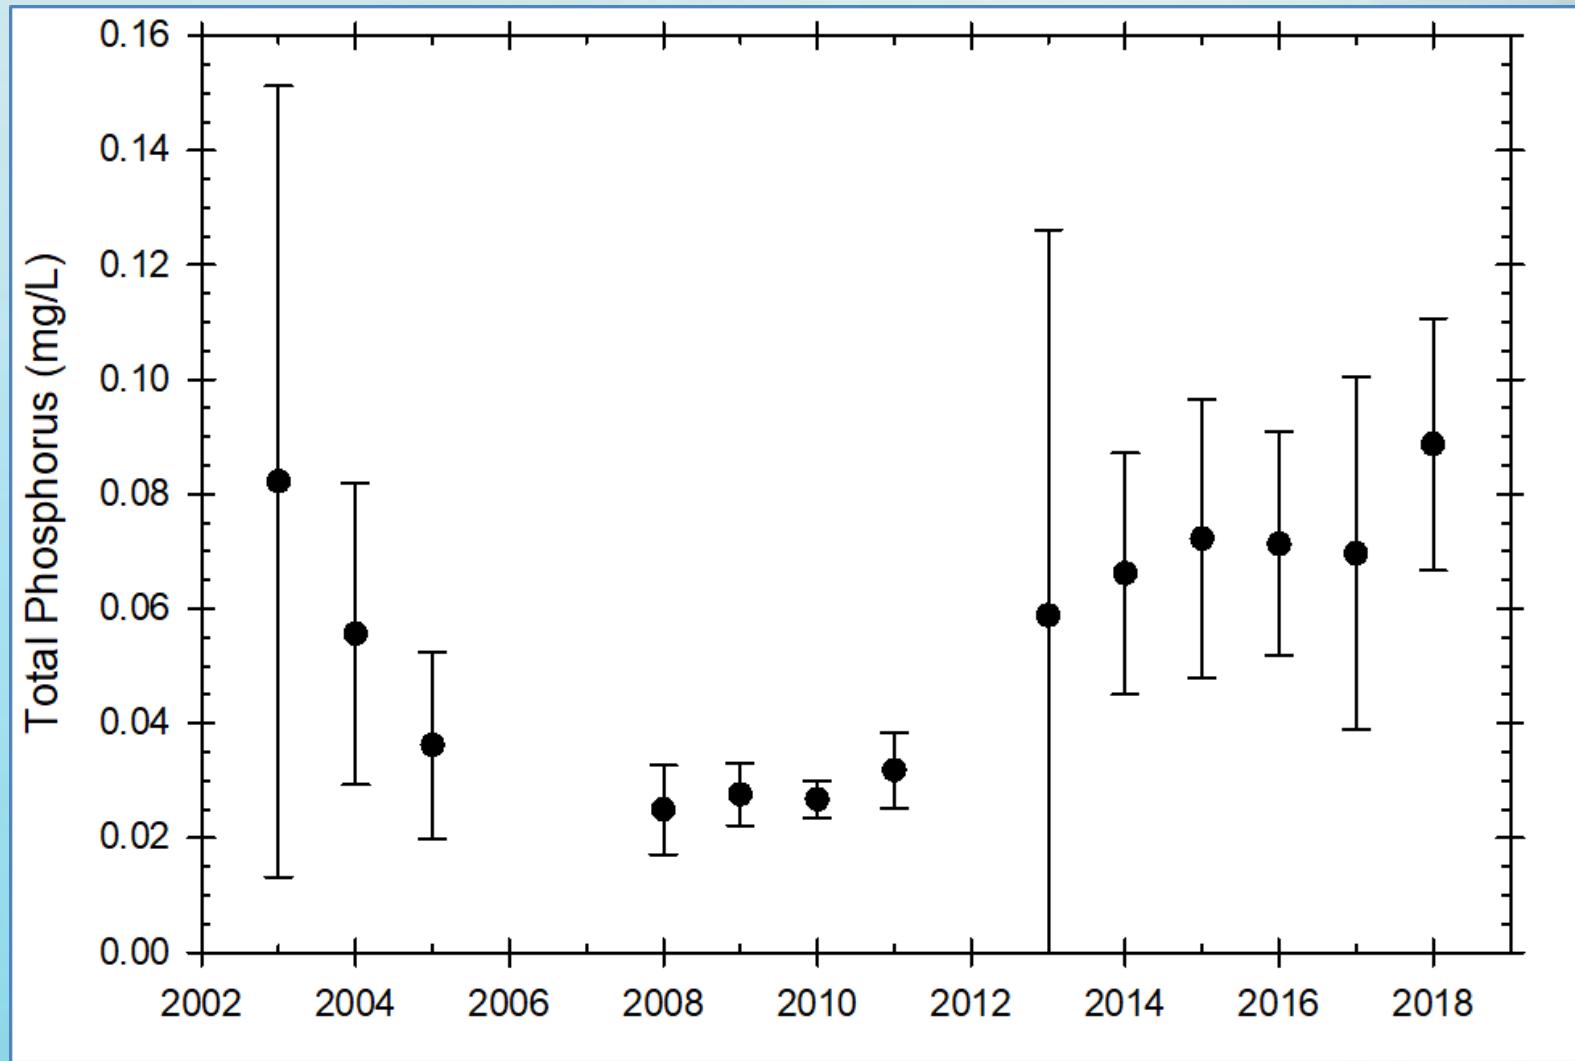
Lake Rippowam Hypolimnetic TP Trend

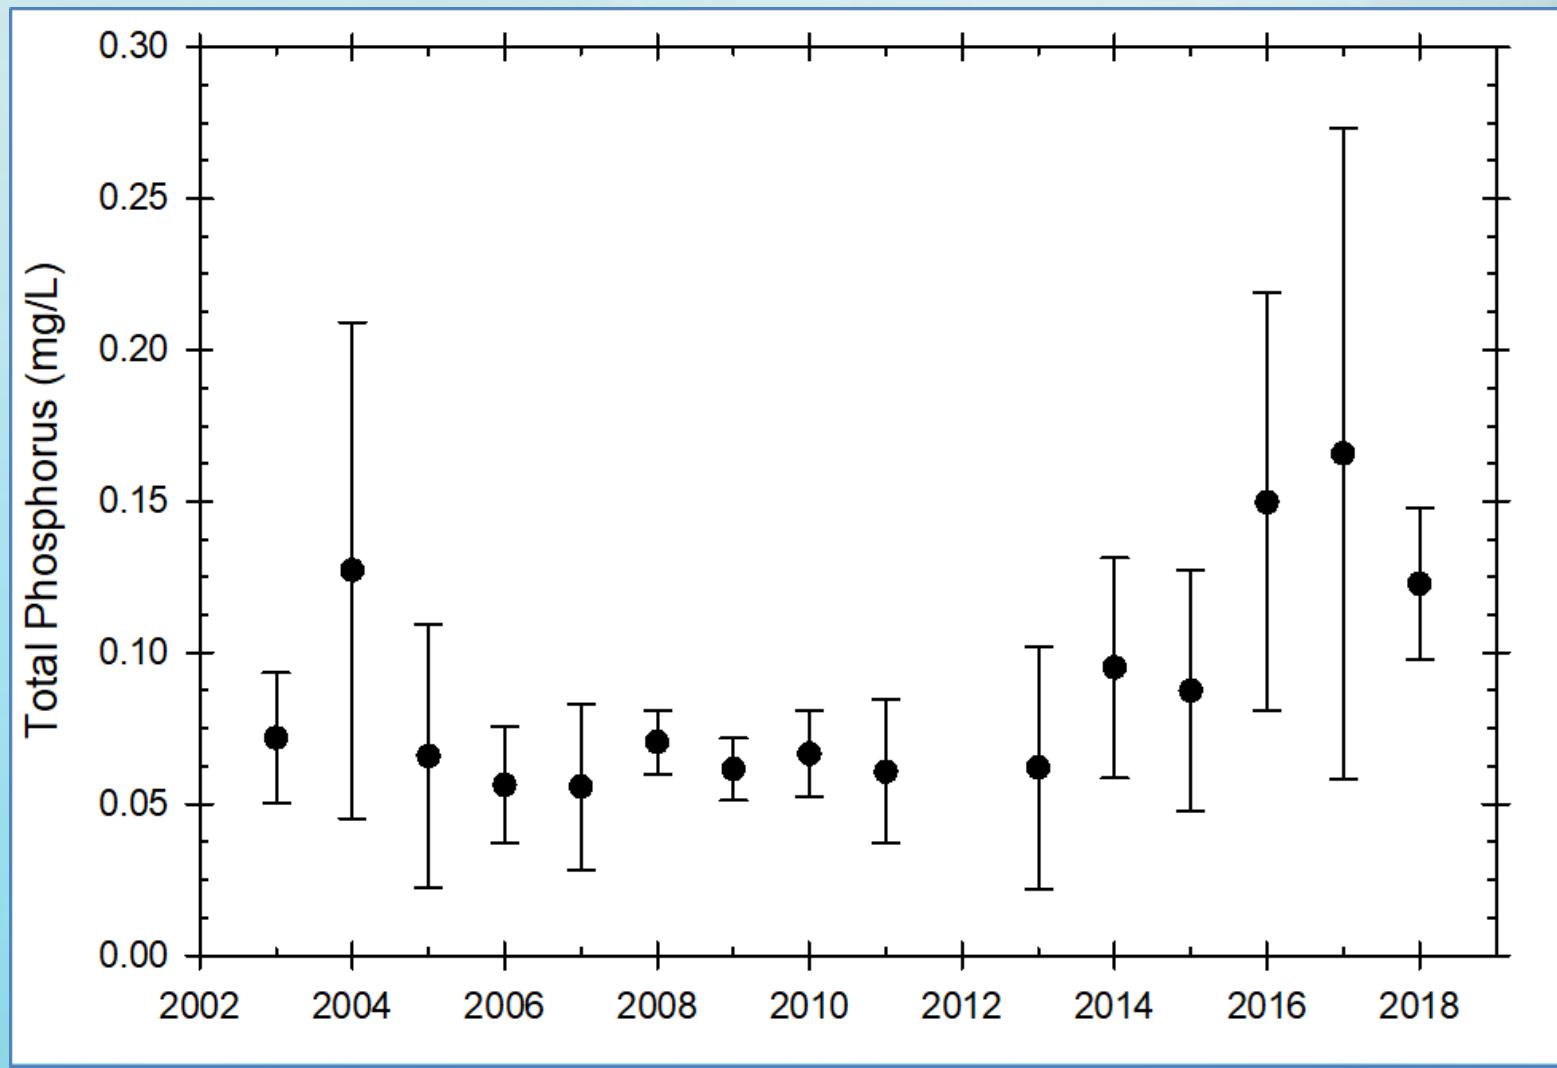
Lake Oscaleta Hypolimnetic TP Trend

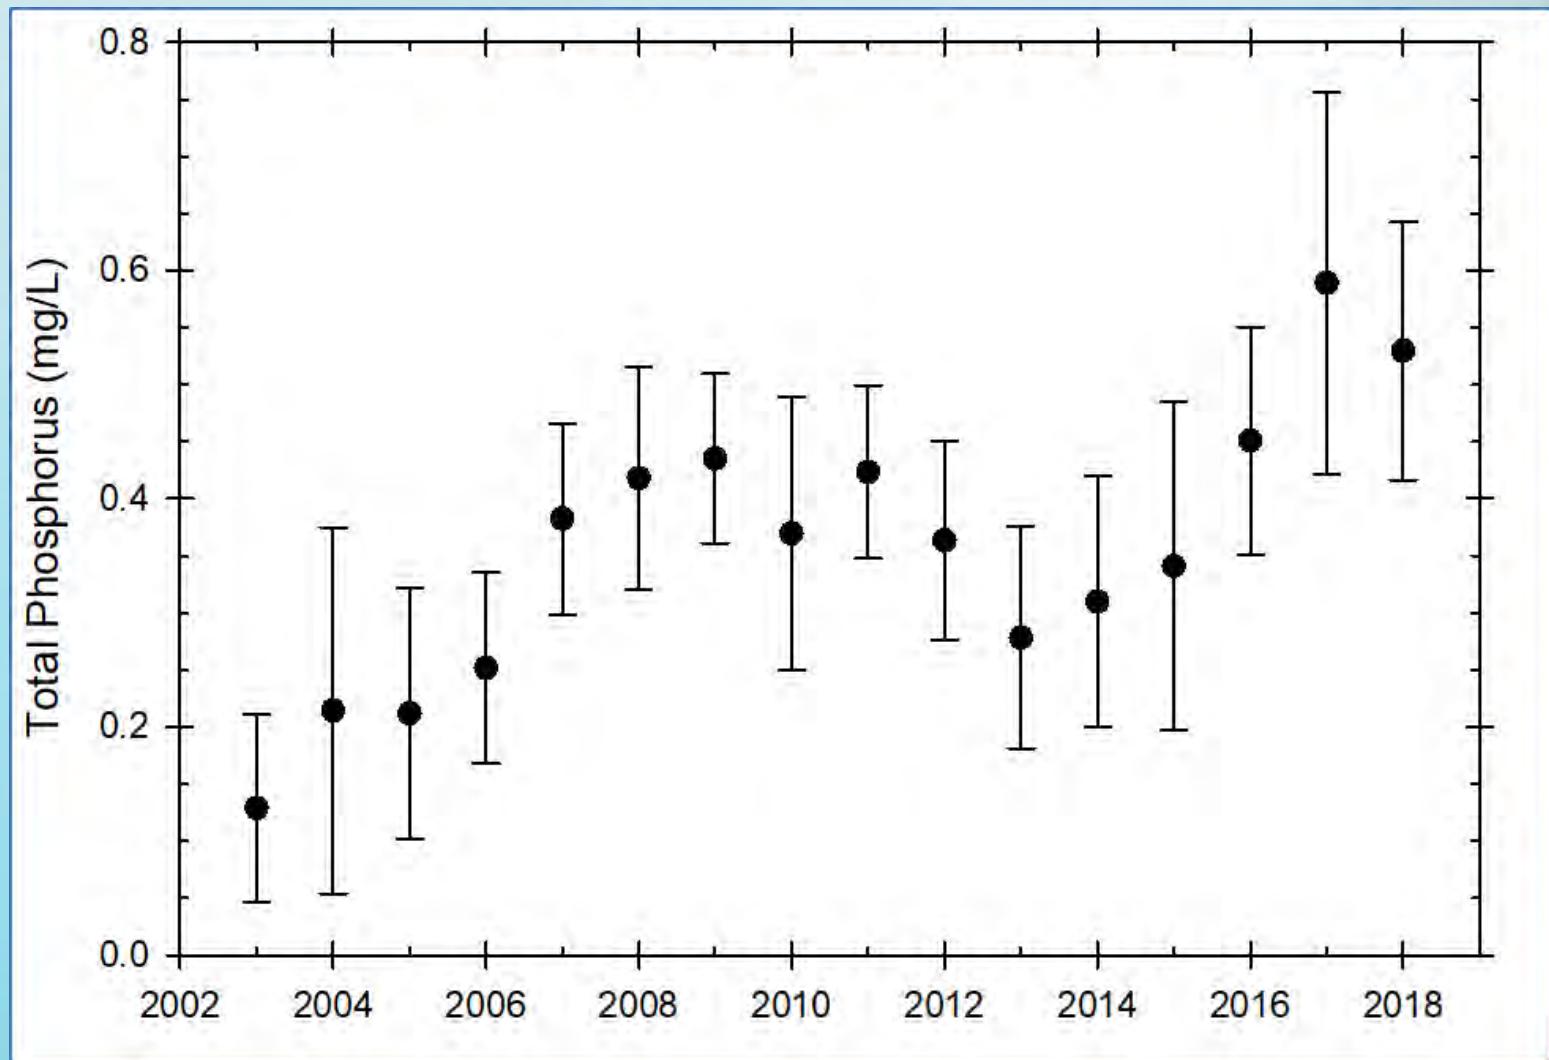
Lake Waccabuc Hypolimnetic TP Trend

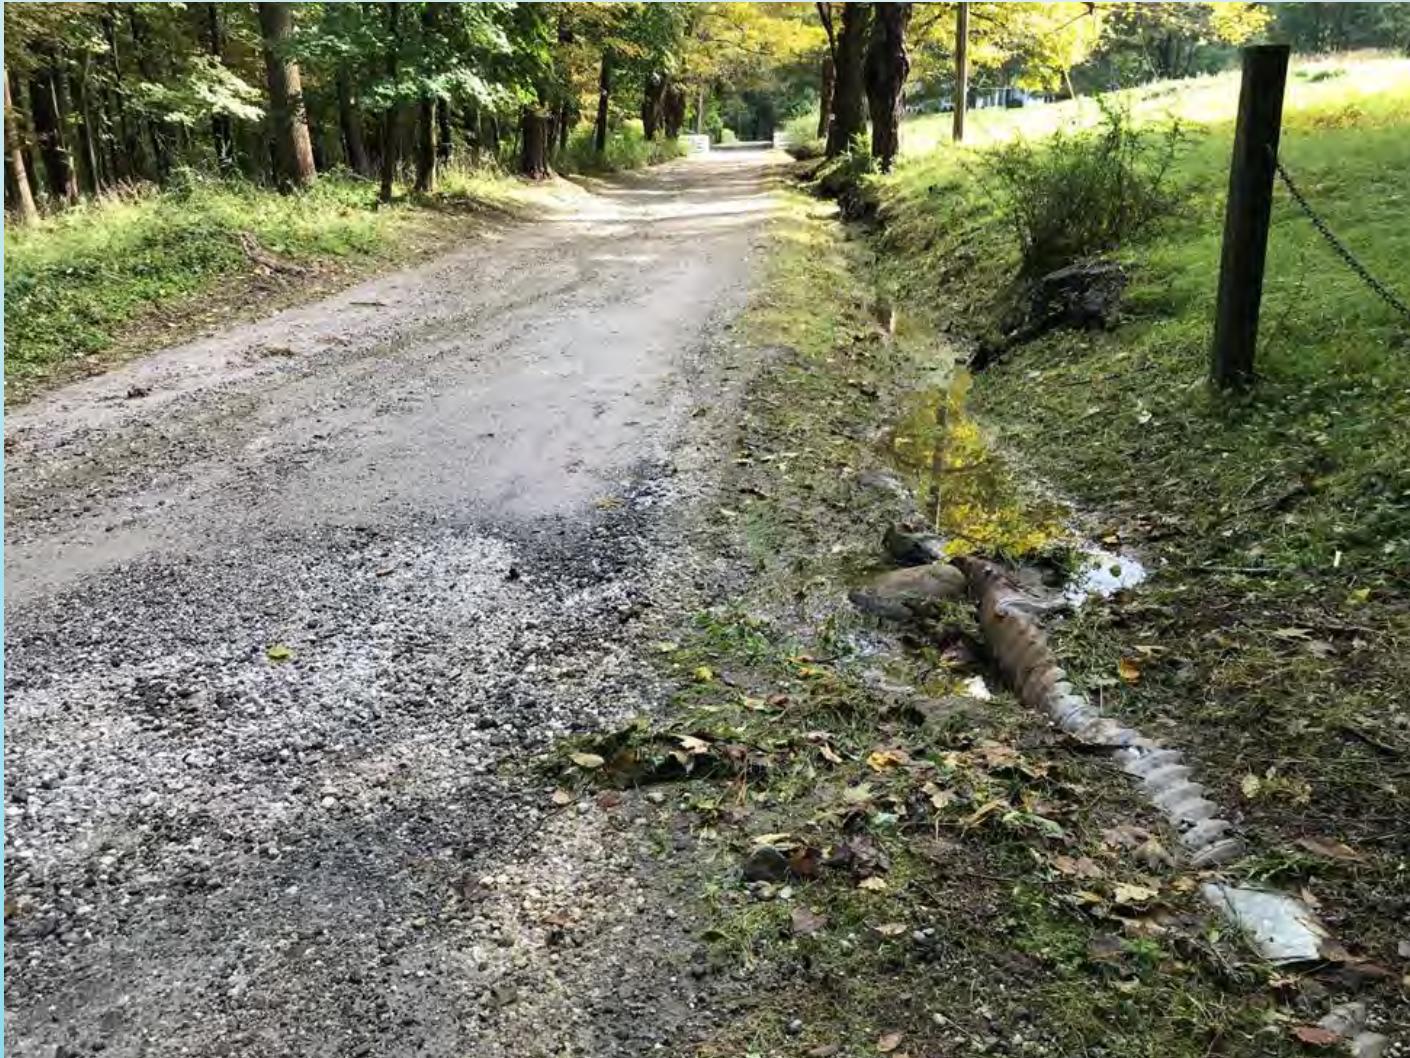
Eroding Gravel Roads

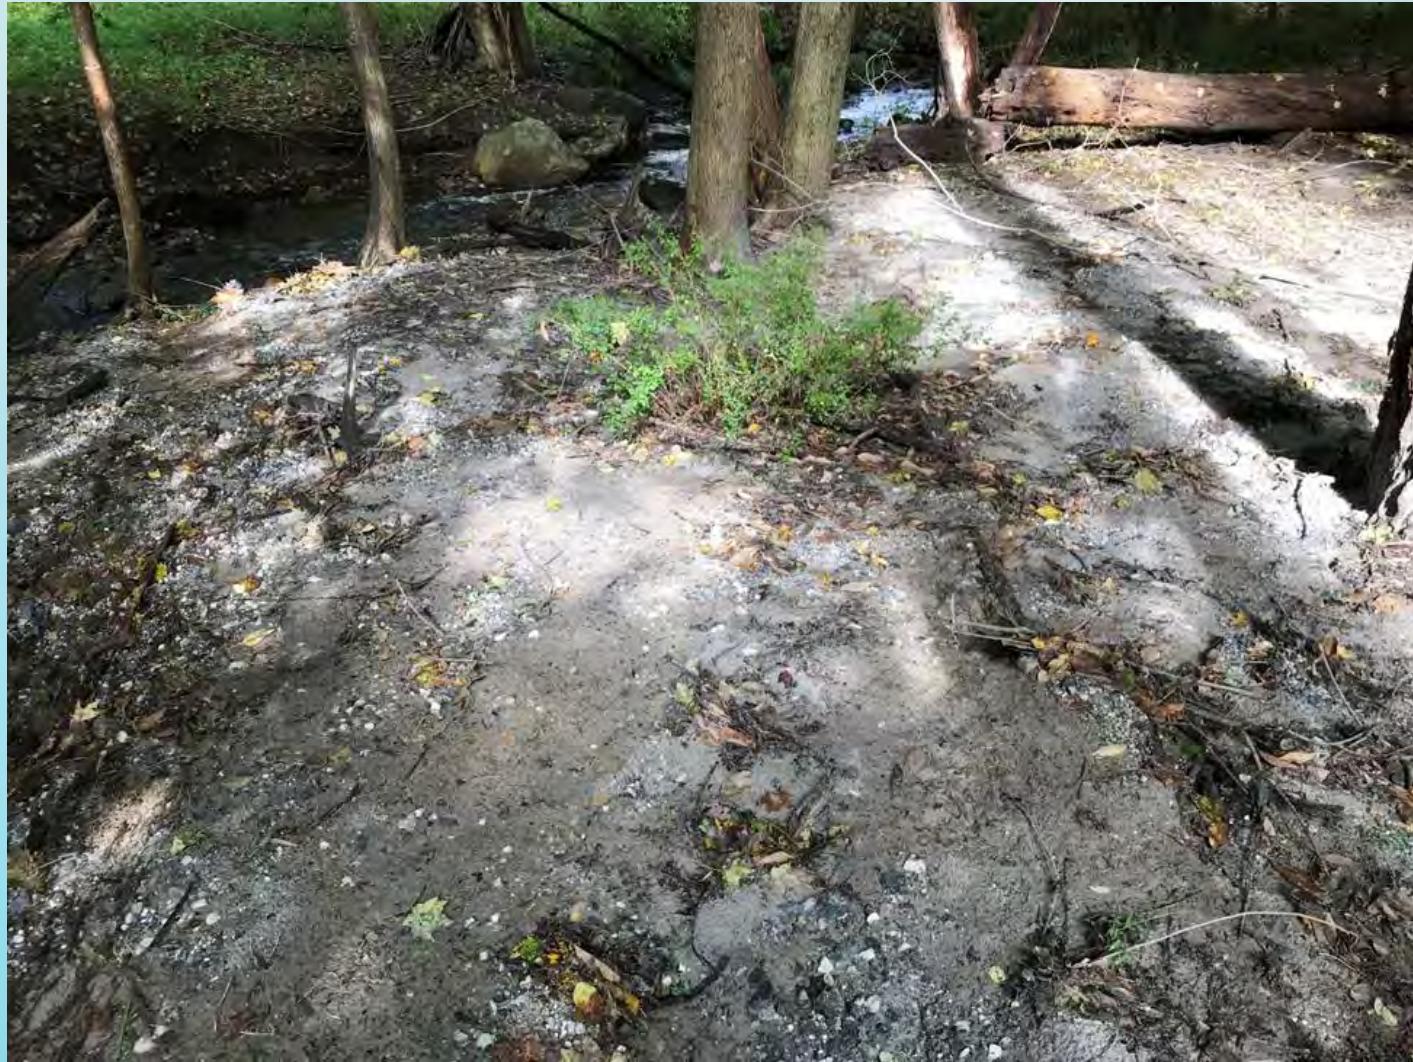
Eroding Gravel Roads

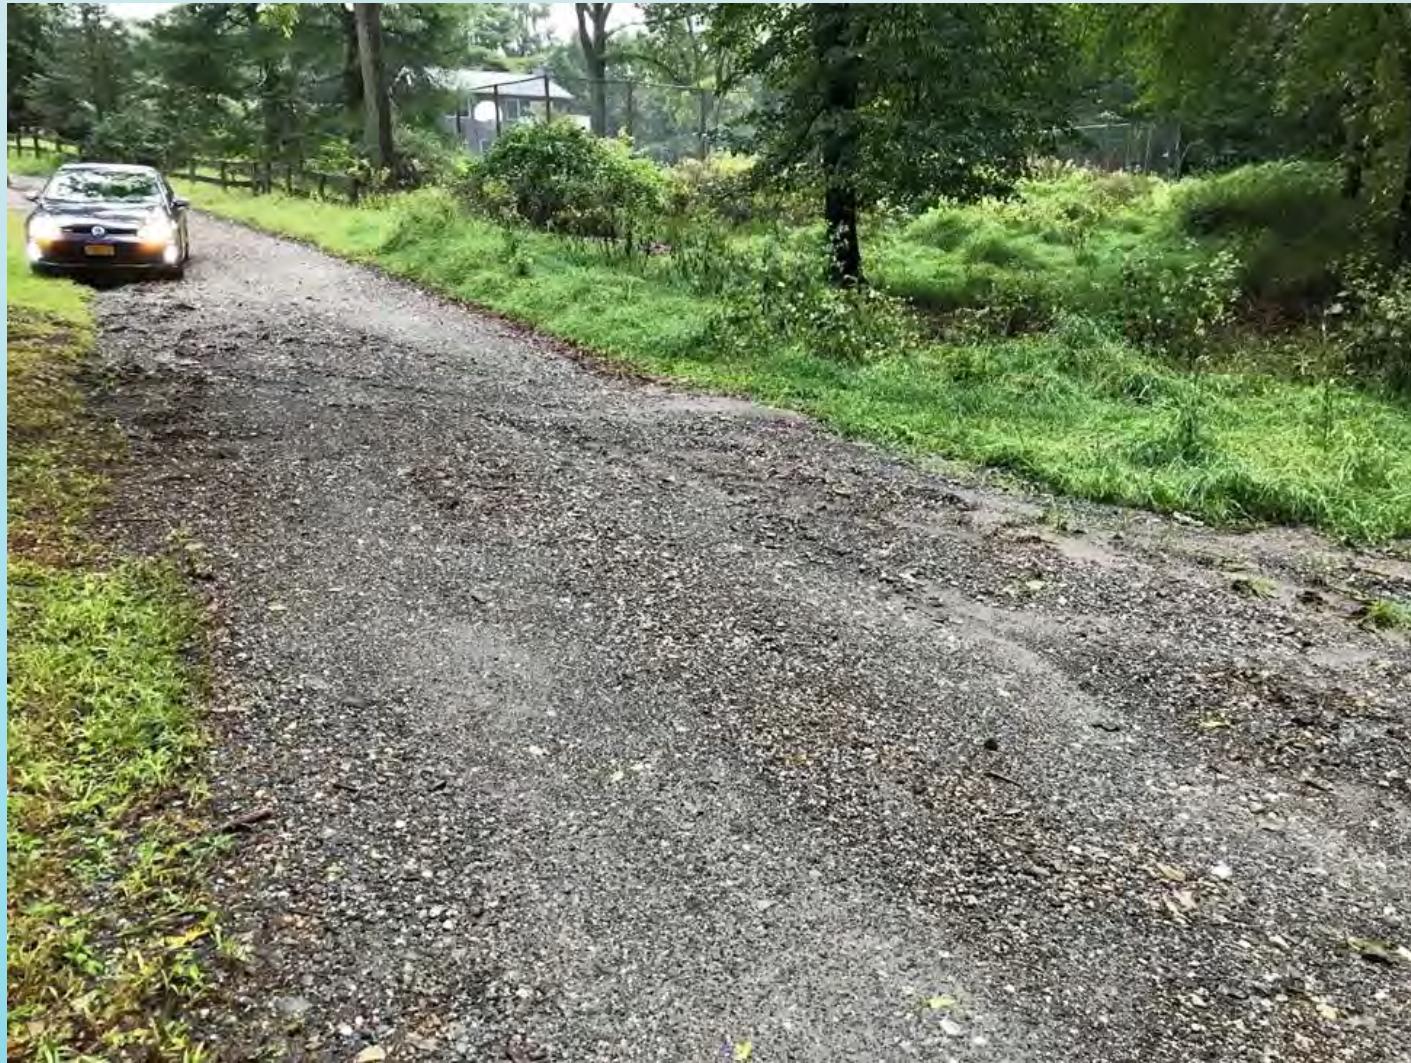
Eroding Gravel Roads

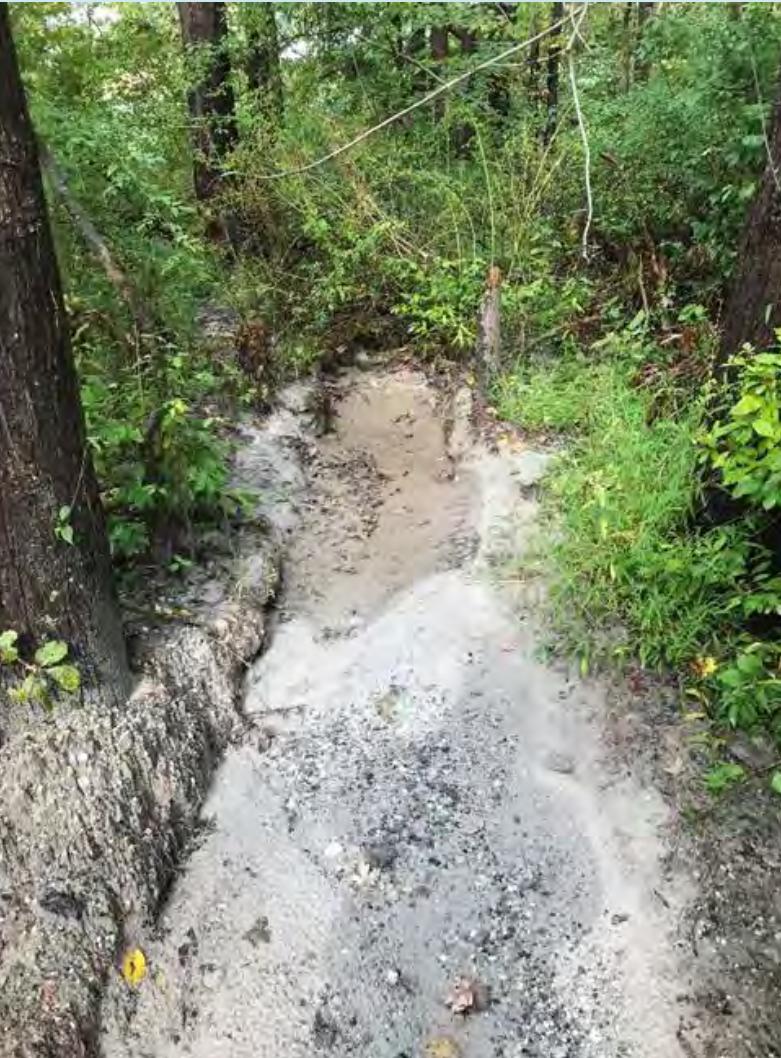
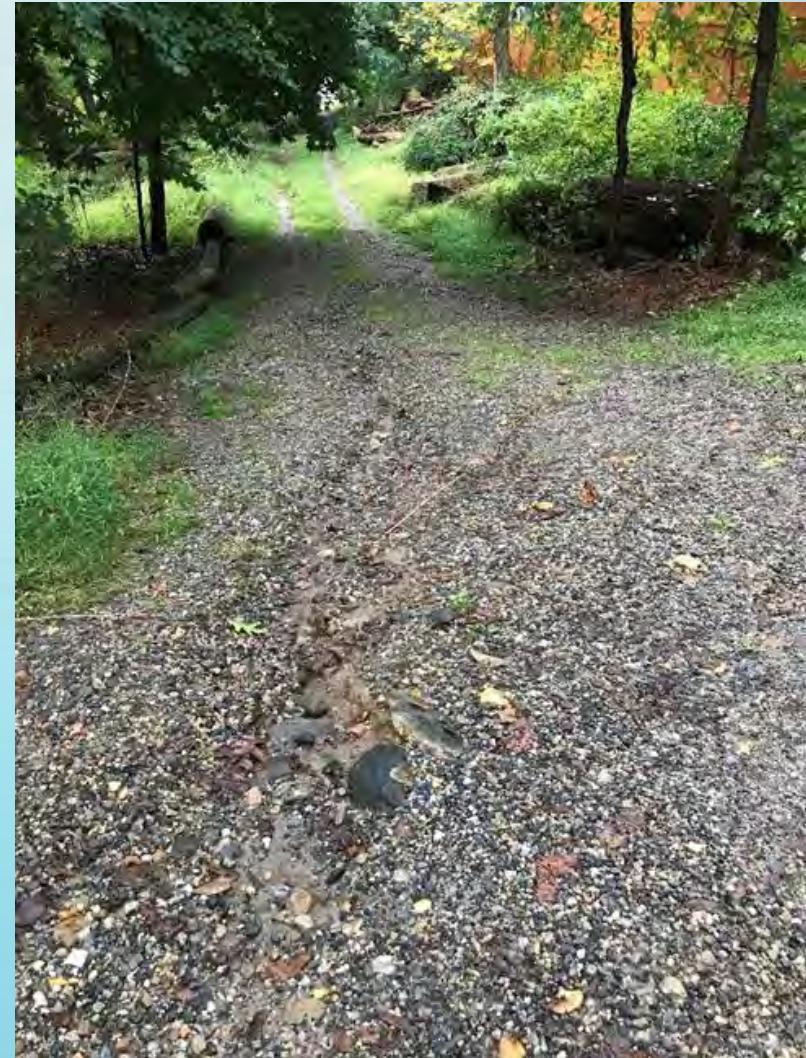
Eroding Gravel Roads

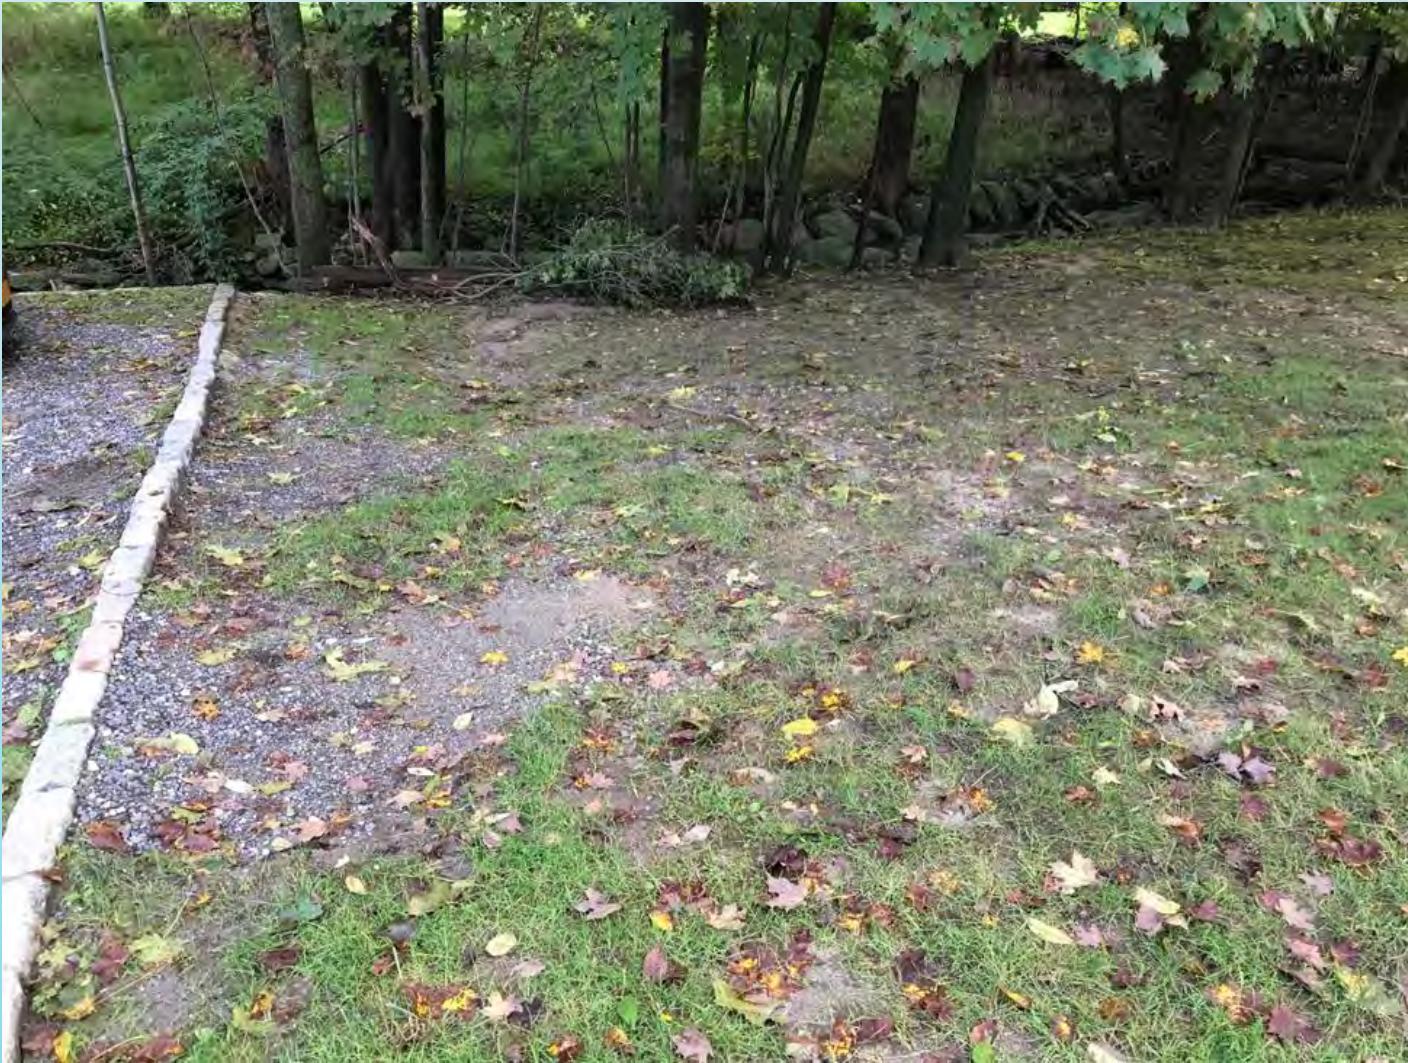
Stormwater Runoff

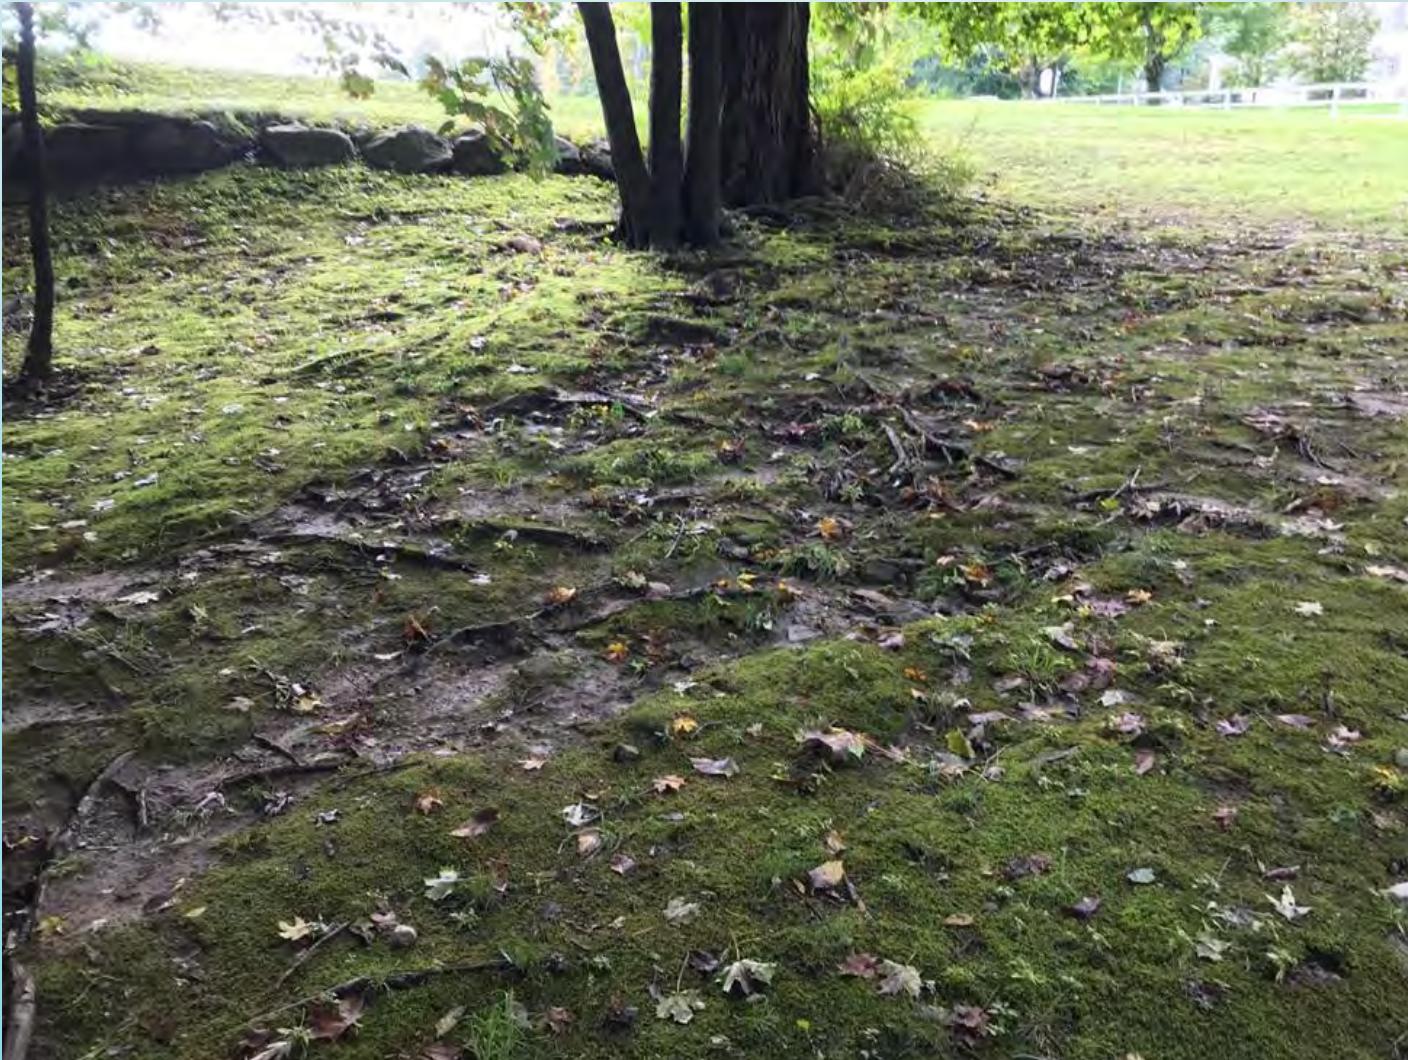
Stormwater Runoff

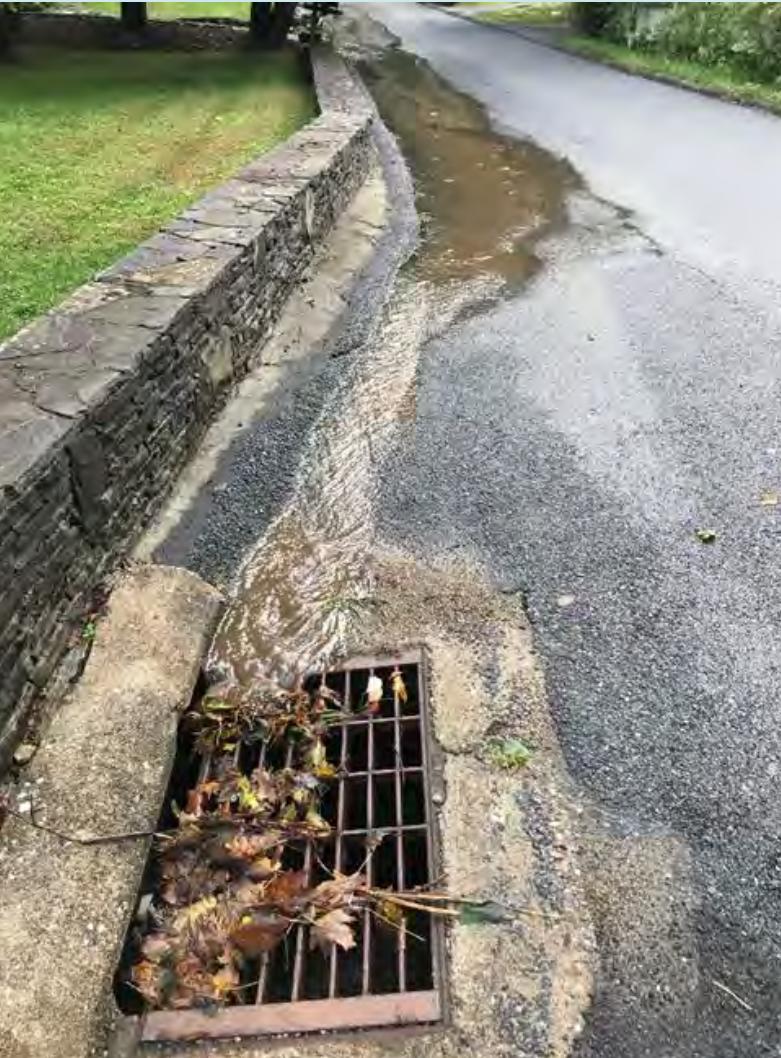
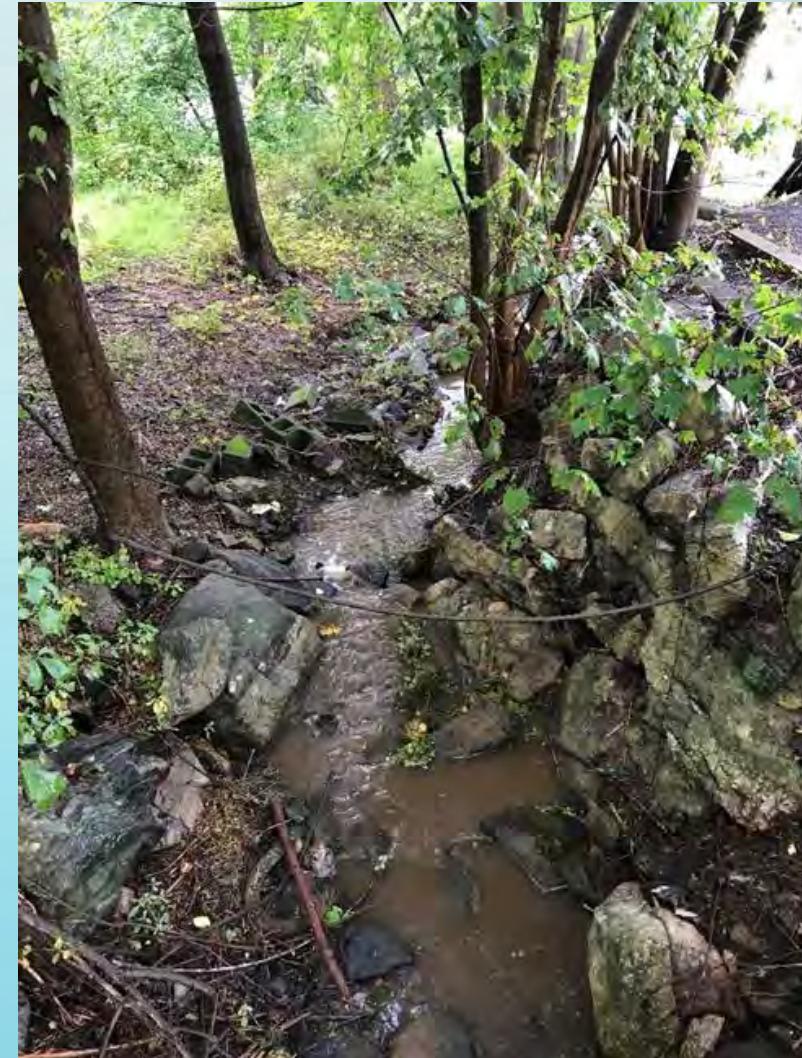
Stormwater Runoff
