Lake & Watershed Management Plan Development for Three Connected Lakes

Town of Lewisboro, Westchester County, NY

Michael R. Martin, CLM

NYSFOLA Annual Conference – May 4, 2019

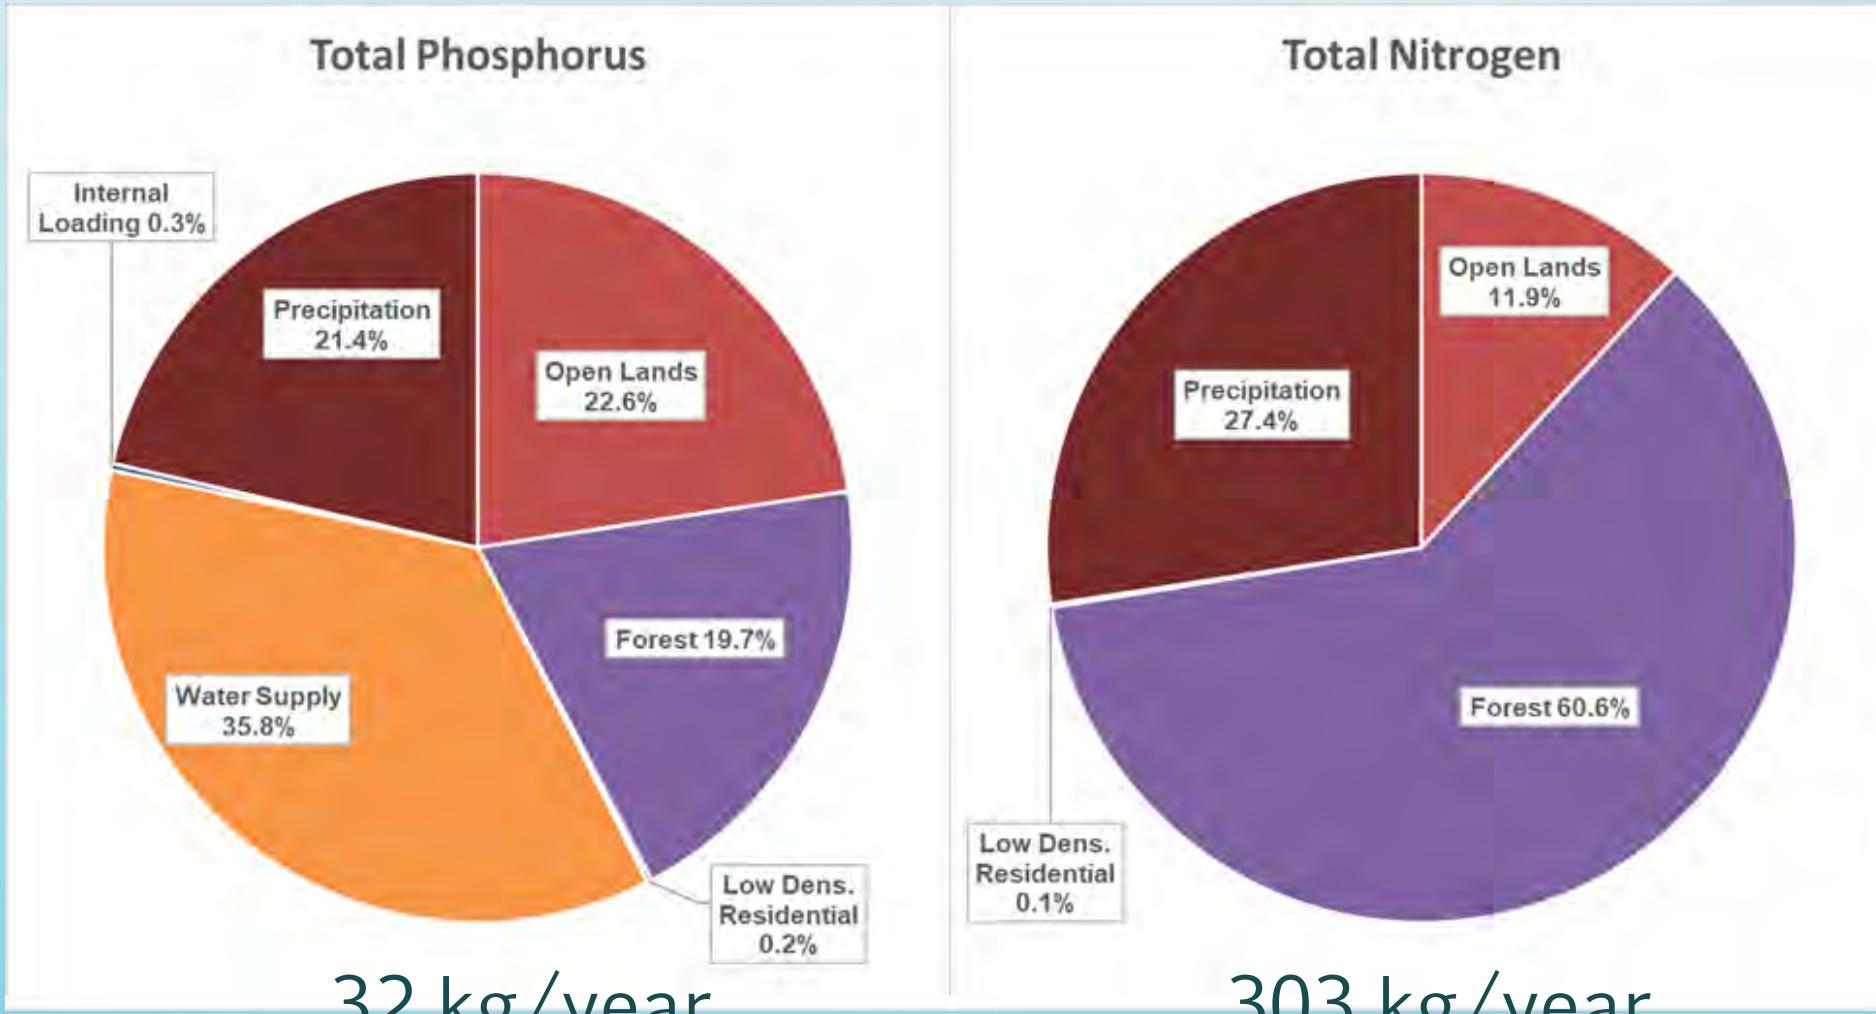
Lake Rippowam Annual Pollutant Budgets

- Lake Rippowam: 12.6 kg/year (39 percent)
 - Switching to alternate water supply anti-corrosion measure (36%)
 - Modest changes in SW management of impervious surface runoff
- Lake Oscaleta: 34.5 kg/year (26 percent)
 - Switching to alternate water supply anti-corrosion measure (27%)
 - Modest changes in SW management of impervious surface runoff
 - Minimizing internal phosphorus load (Aeration, Alum or PhosLock®) (20%)
- Lake Waccabuc: 874 kg/year (88 percent)
 - Minimizing internal phosphorus load (Aeration, Alum or PhosLock®) (76%)
 - Moderately aggressive stormwater management
 - Dirt & gravel roads, Impervious surfaces, Untreated runoff from paved roads

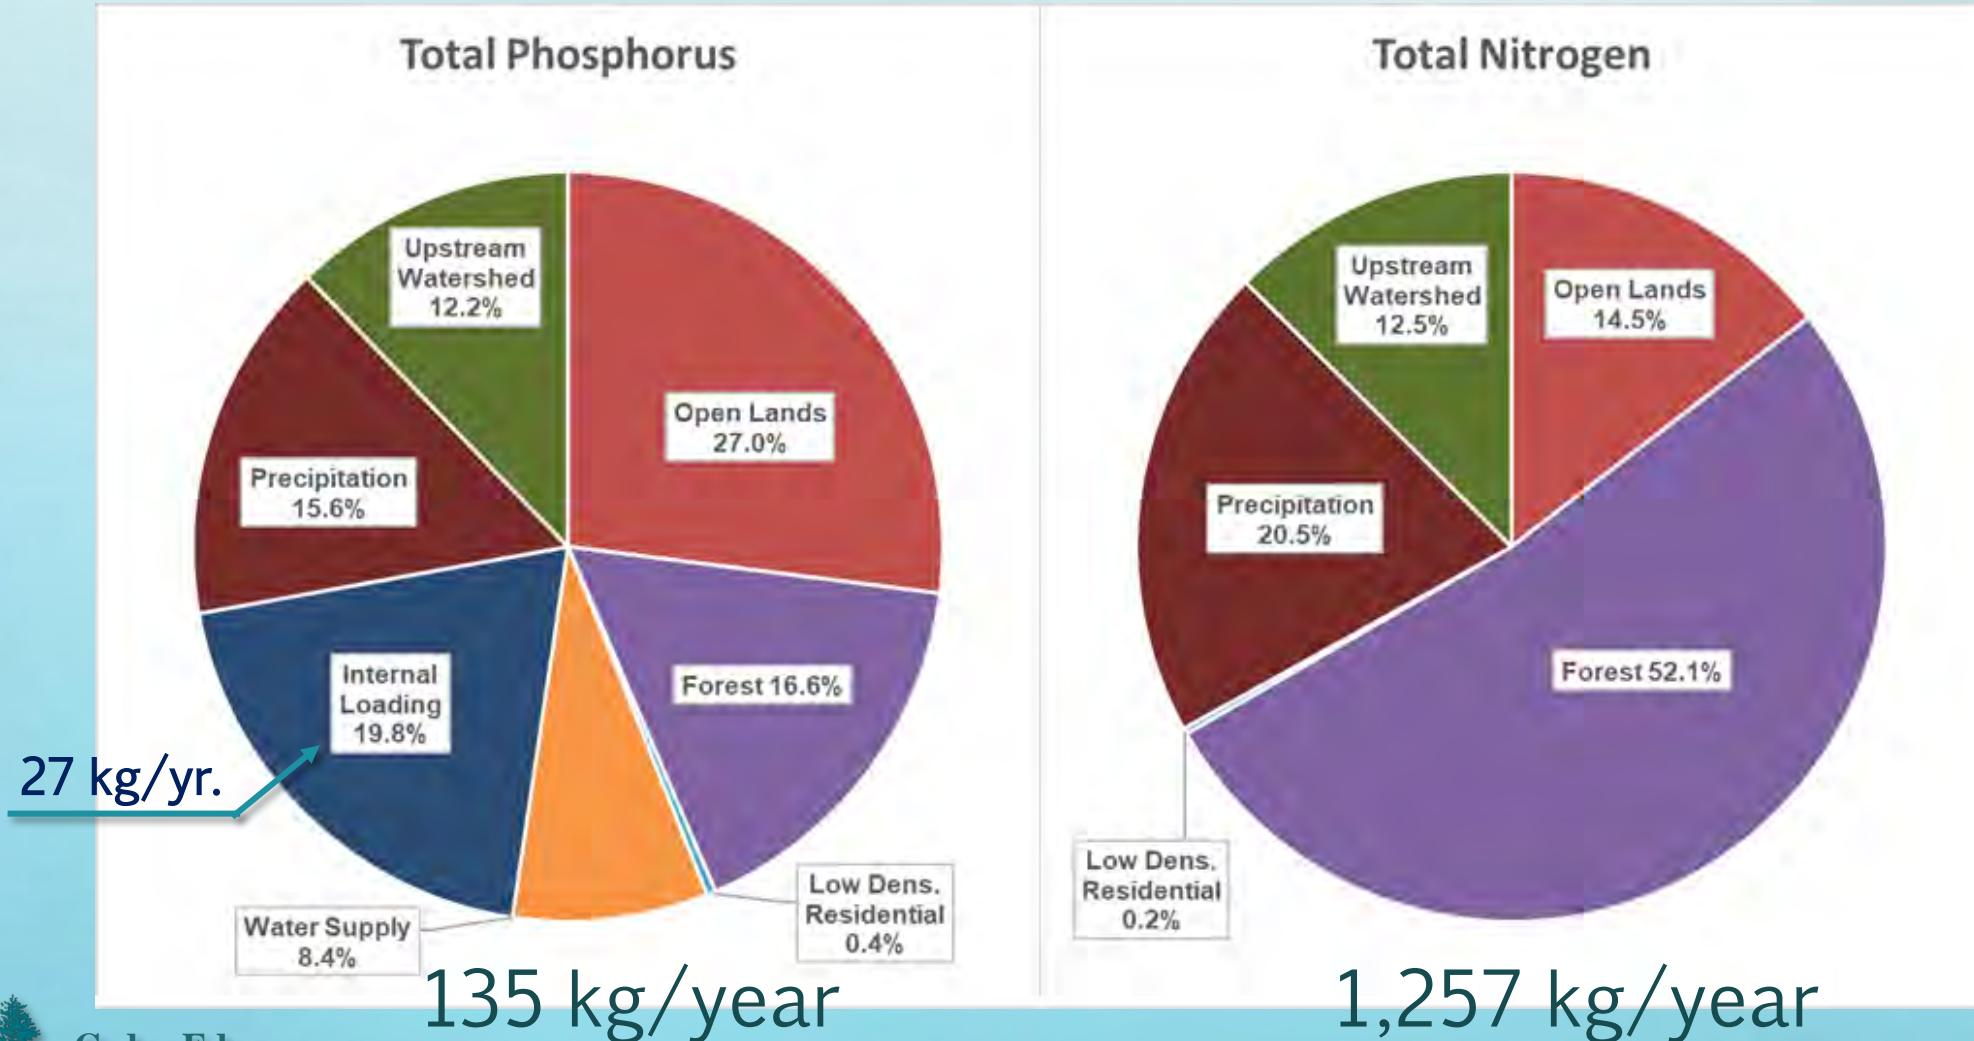
Lake Oscaleta Annual Pollutant Budgets

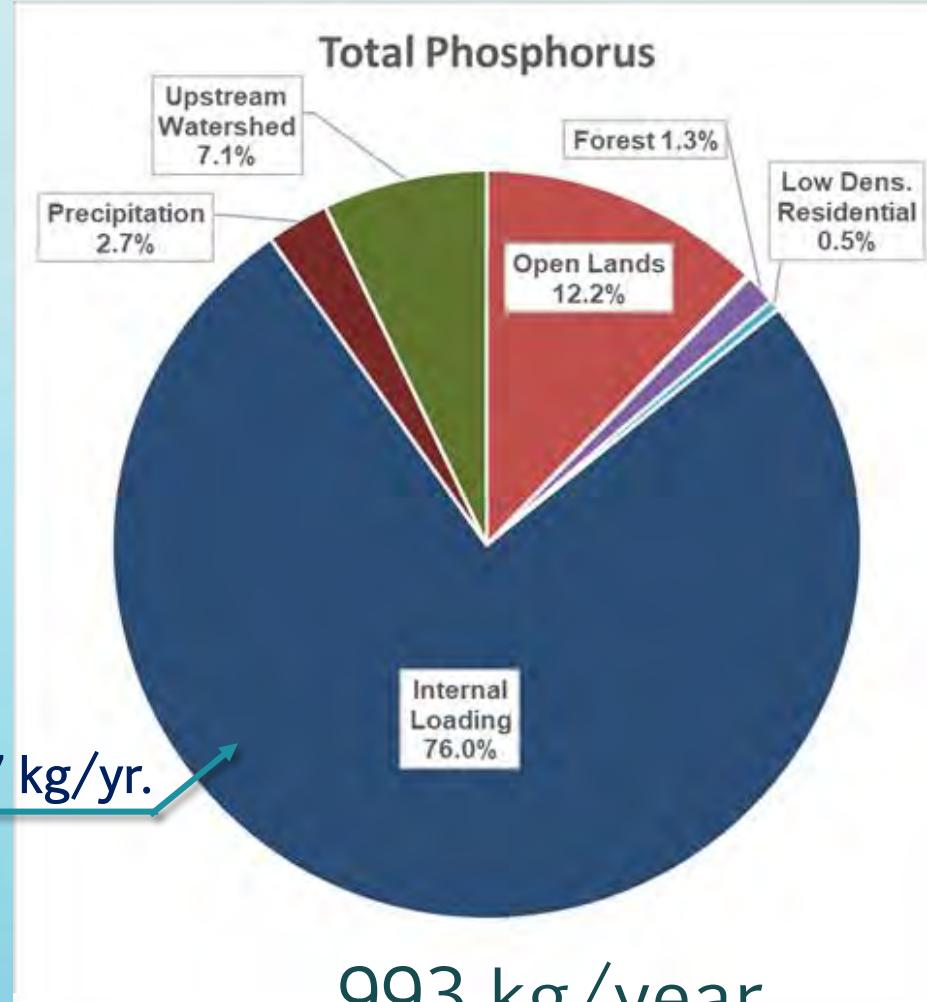
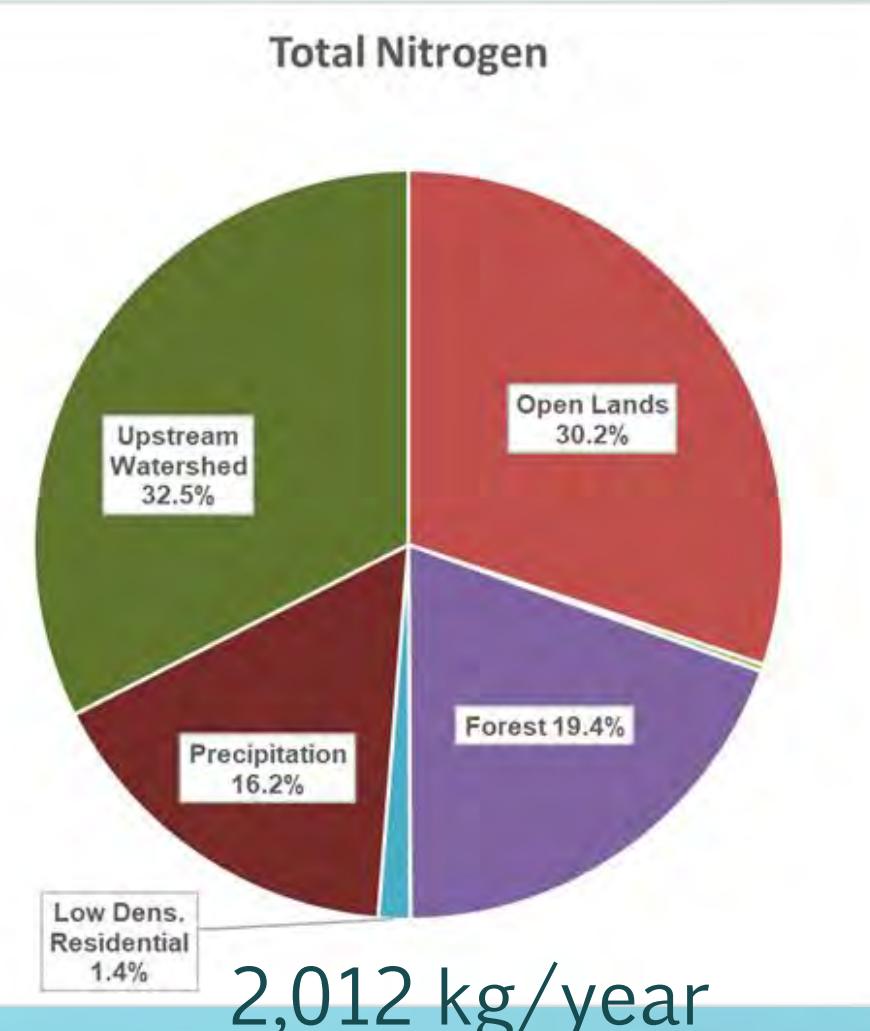
Lake Waccabuc Annual Pollutant Budgets

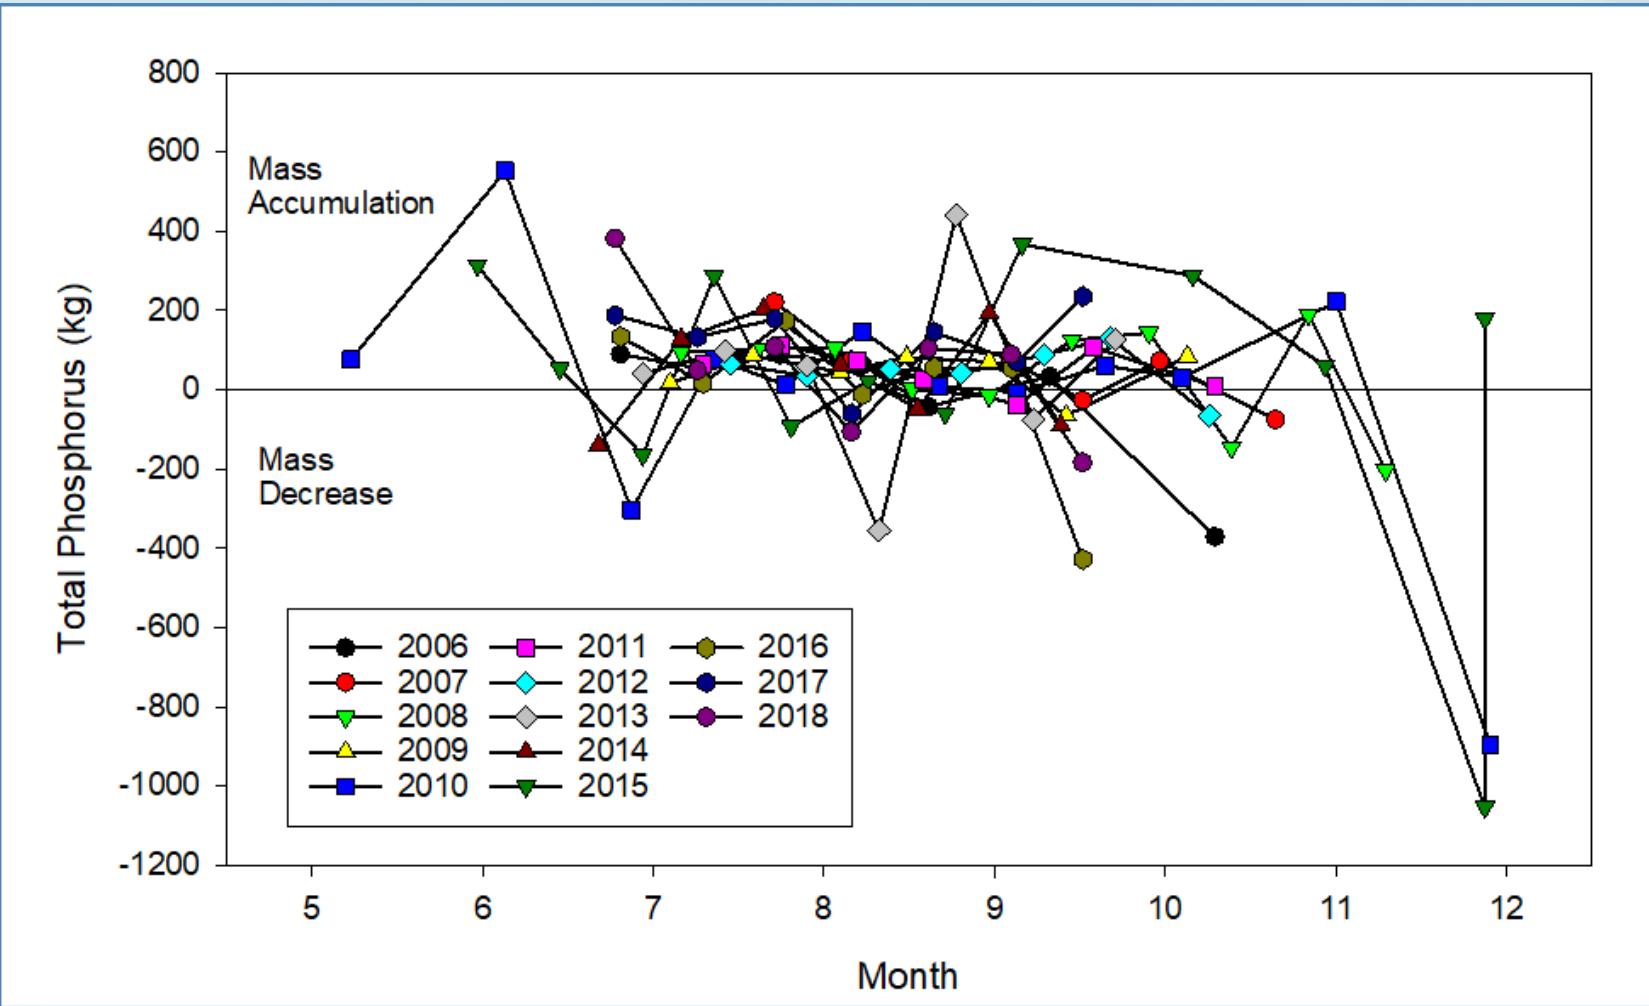
Lake Waccabuc Internal Loading
