LAKE GEORGE TOWN SEPTIC INITIATIVE PROGRAM

New York State Federation of Lake Associations, Inc. 36th Annual Conference May 4, 2019

Chris Navitsky, P.E. - Lake George Waterkeeper

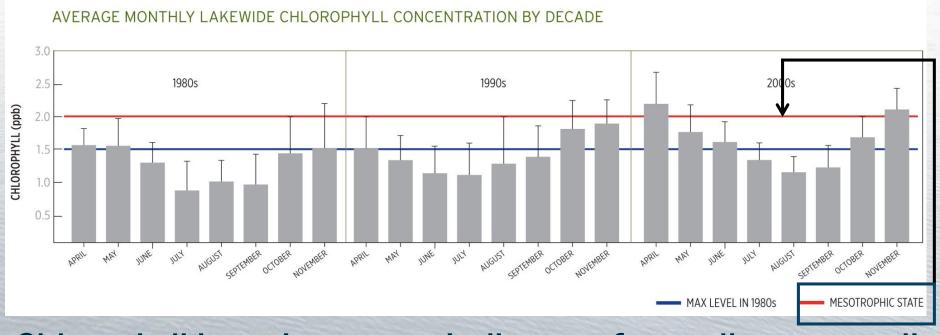
Chlorophyll is an important indicator of overall water quality health because it measures algal growth in the lake. Algal growth is driven by nutrient loading.

CHLOROPHYLL HAS INCREASED 33%

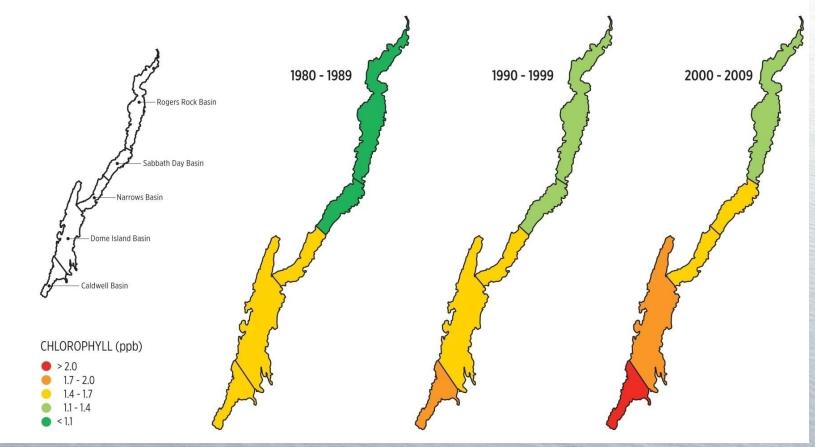
North has oligotrophic levels (outstanding water quality)
South has mesotrophic levels (medium water quality)

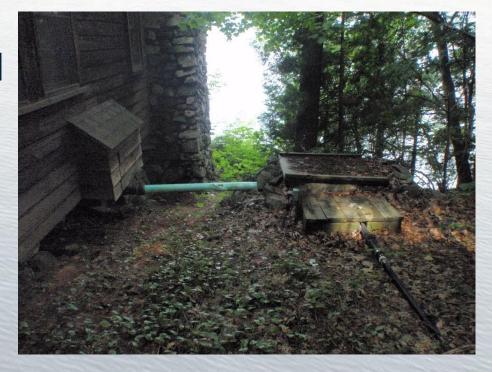
Lake George - Septic Systems (OWTS)

- 6,000 systems within watershed
- Estimated failure rate: 5-15%
- Increased nearshore algal growth
- Multiple studies document water quality impacts

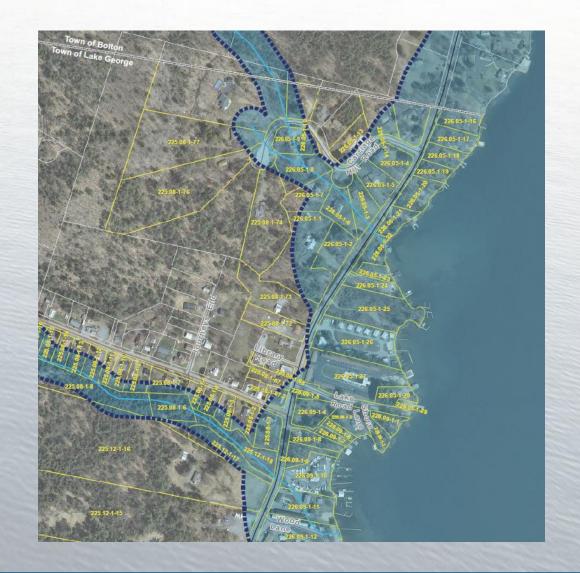
LGSIP Boundaries

- Phase I Diamond Point Area
- Phase II Cannon Point to Hearthstone
- Phase III Hearthstone to **English Brook watershed**
- Phase IV East Side (Plum) Point to Wiawaka/Bloody Pond Road

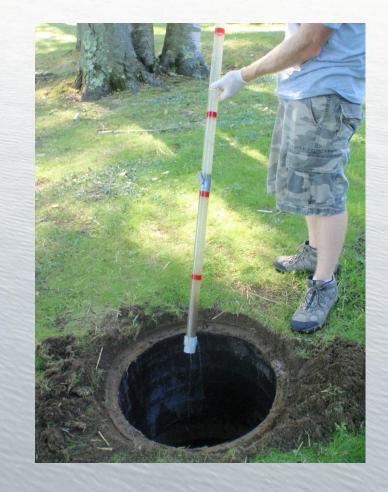
LGSIP Findings

- 34% response rate on surveys.
- Approximately 1/3 of systems are under normal life expectancy (30-40 years), 1/3 are at or exceeding life expectancy and 1/3 no known information.
- 20% of septic tanks are undersized.
- 1/3 of septic tank volumes are unknown.

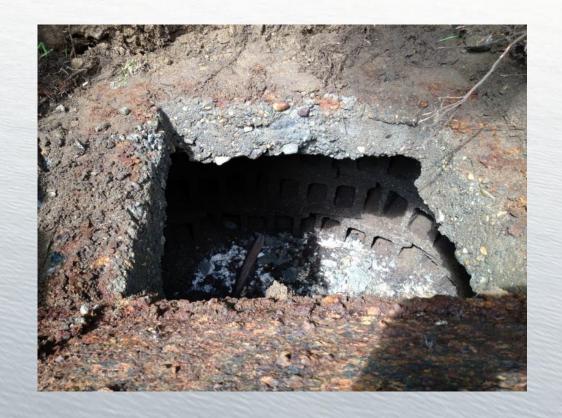
LGSIP Findings

- 20% of septic systems have no known information.
- 20% of septic systems utilize drywells.
- Over 50% of parcels have no record or have never been maintained.

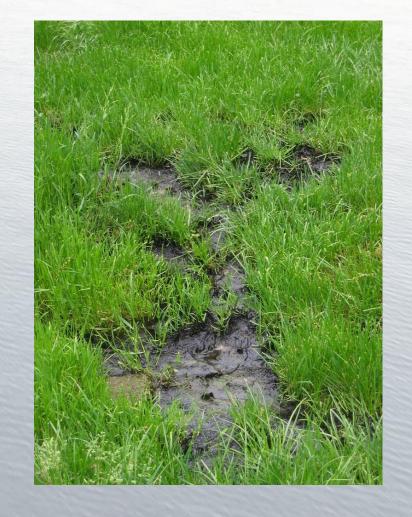
LGSIP Findings

- 1/3 of properties have the highest inspection concern level (Tier 1).
- 14% of algae samples indicate probable organic pollution. (Palmer Pollution Index)
- 50% of the algae samples indicate excessive nutrients. (Trophic Index)

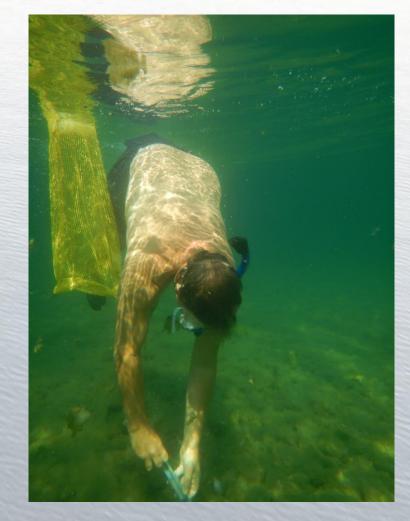
Littoral Algae Biomonitoring

- Sampling based on observed algae, site conditions and land use results
- Single sample is representative assemblage taken from all available substrates and habitats for target reach
- No preservatives added
- Homogenized and identified to lowest taxonomic level possible
