# Water Quality and Habitat Impacts Caused by Common Carp (*Cyprinus carpio*)

# Case Study - Mill Pond, Water Mill (Southampton) NY

# 2018 Princeton Hydro Restoration and Management Project

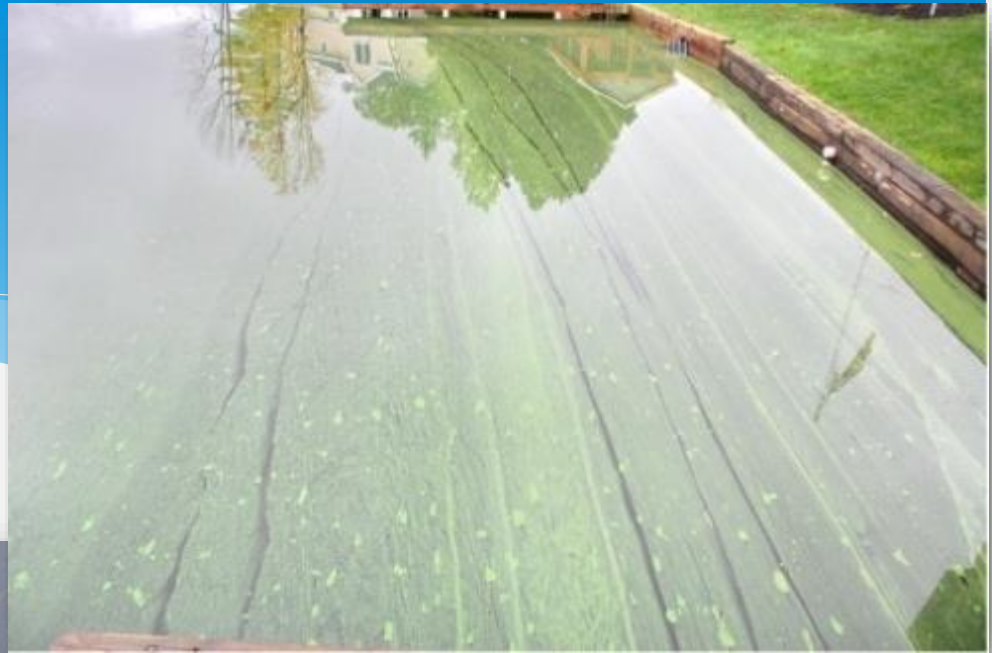
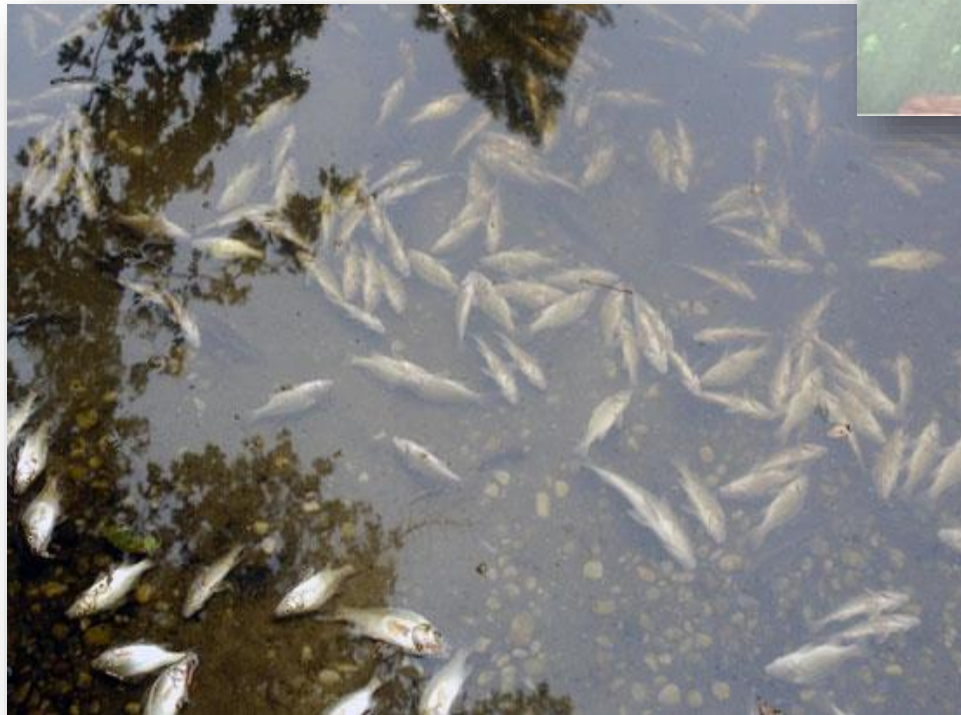
Documented  
HABs

Major Fish Kill 2008

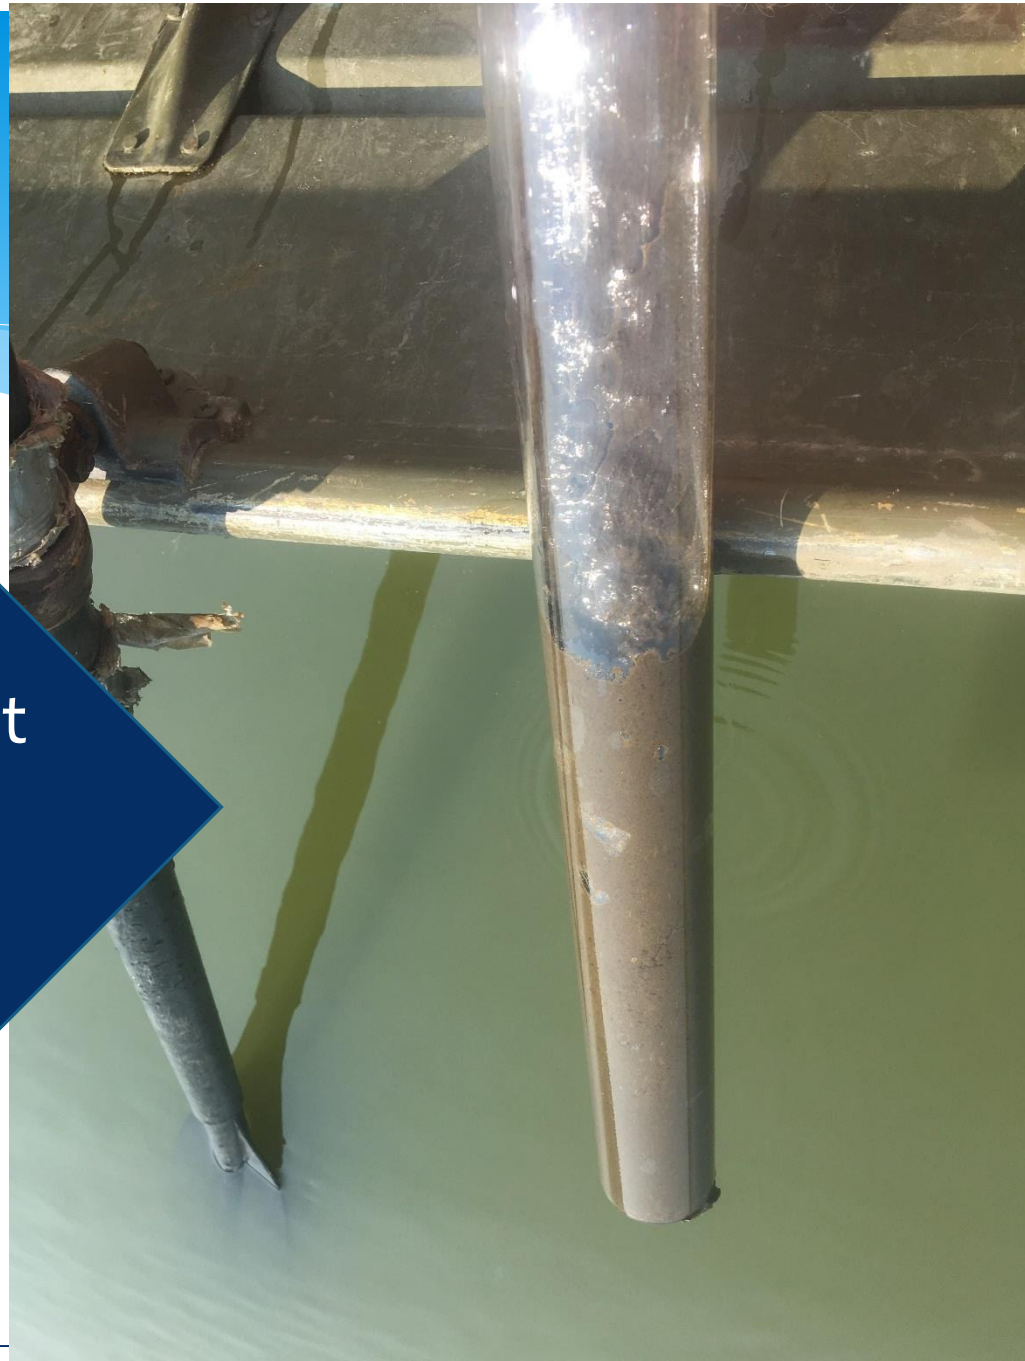
# Sediment Core

- Collected eight (8) sediment cores
  - Cores hand-driven to point of refusal (~ 0.5 - 1m)
  - Retrieved and examined in field for any evidence of striation, odor, reduced organic content, residual macrophyte/leaf detritus
  - Returned to lab for TP and grain size analysis
- Sediments found to be composed mostly of silts/clays, reduced organic material (Org ~30%)
- Sediment TP concs. - 542-1062 mg/kg

What's role of sediment  
resuspension on lake  
eutrophication?

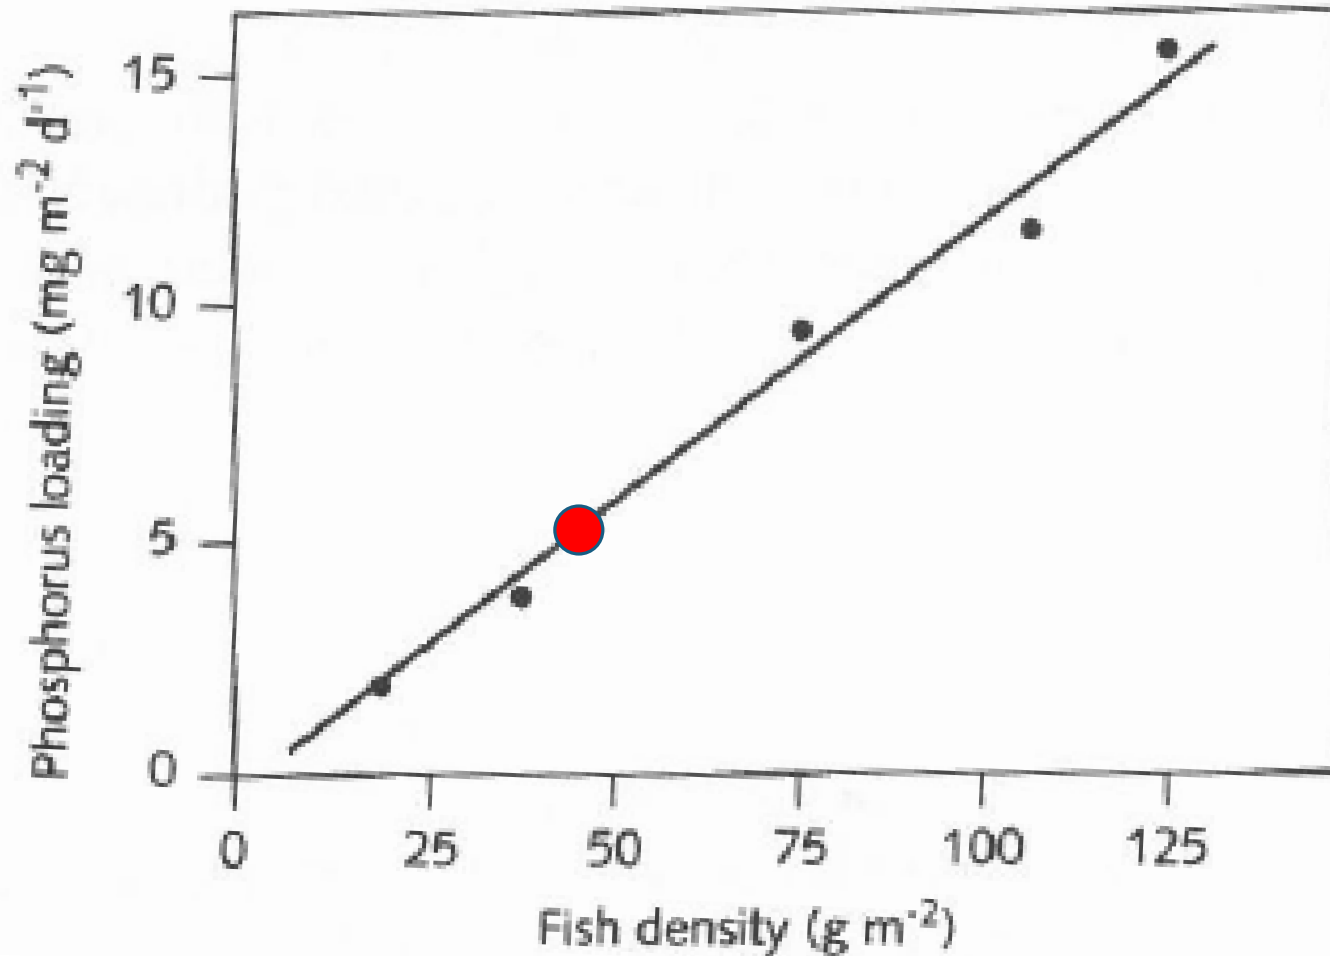
# Carp Bioturbation Impacts, Lamarra, 1974

- Computed P Load due to carp bioturbation only
  - Loading rate 5 mg/m<sup>2</sup>/day
  - Lake bottom area 372,000 m<sup>2</sup>
  - Loading period 245 days
  - Computed load 455.7 kg/yr
  - Adjusted by 50% to account for settling
- Total P load = 227.85 kg/yr

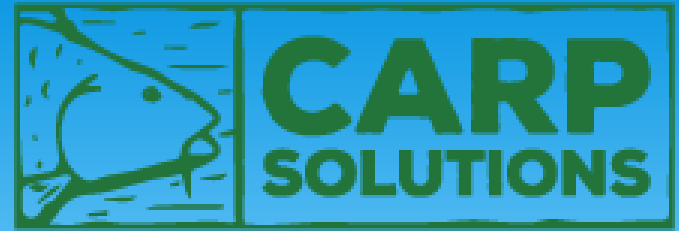
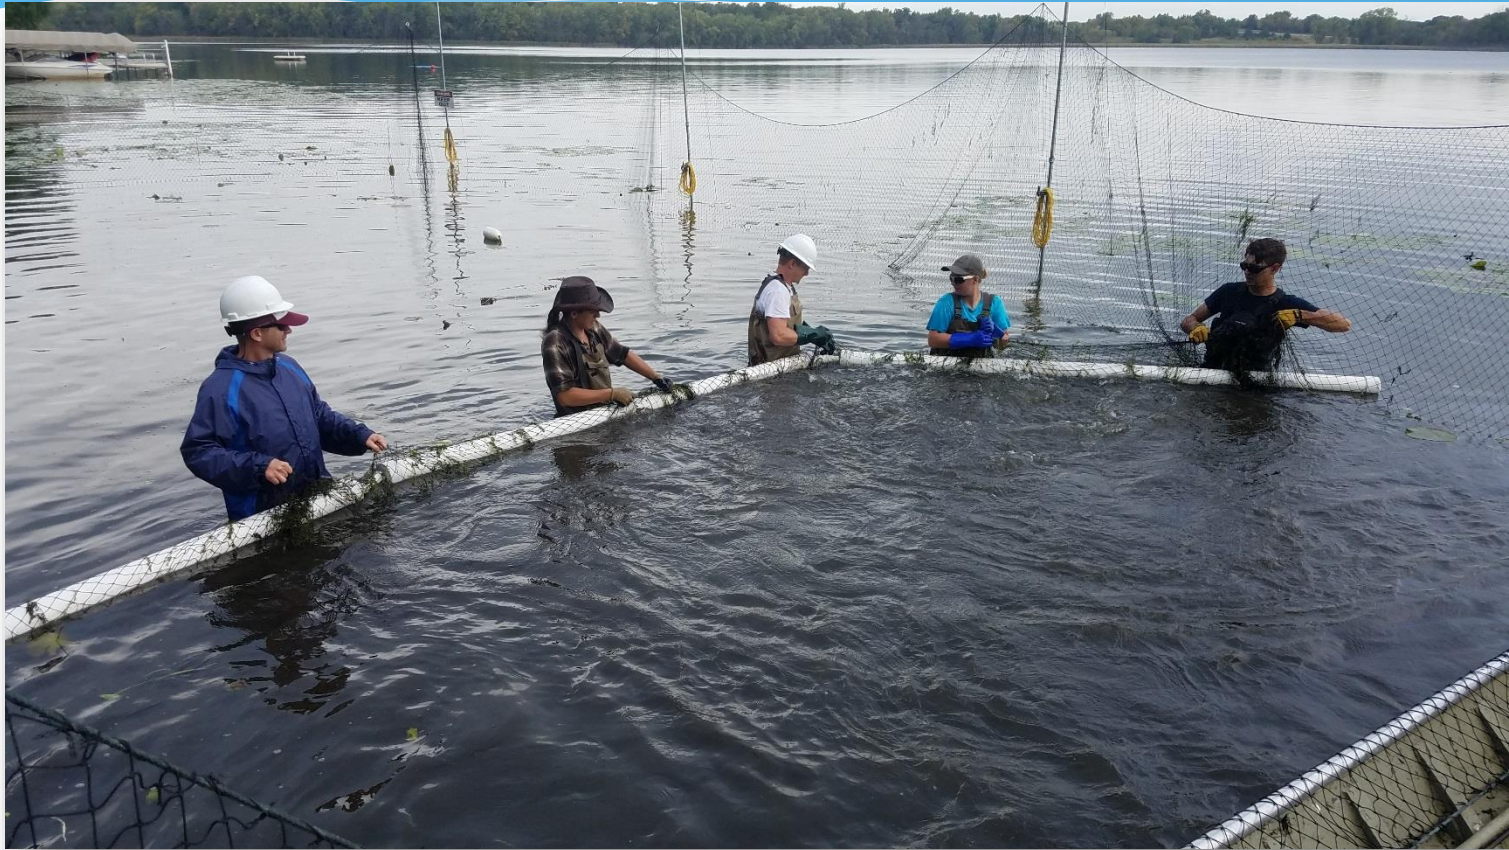
# Baited Box Nets

- Fish come to you!
- Highly selective; by-catch minimal.
- Not size selective.
- High catch per unit effort.
- Relatively cost effective.

- Proposals in place to conduct during summer of 2019 intensive carp removal effort using baited box nets.
- Nets deployed and baited with cracked corn 1 week in advance to entice carp to congregate.
- Conduct fish removal over 1 week period and repeat 2-4 weeks later.
- Collected fish go to commercial fishermen (bait) or organic farmers (fertilizer).

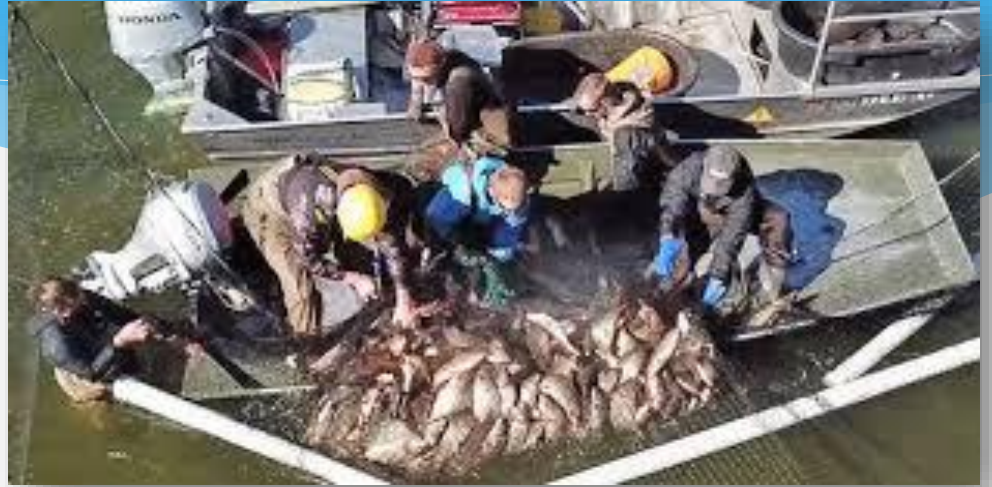
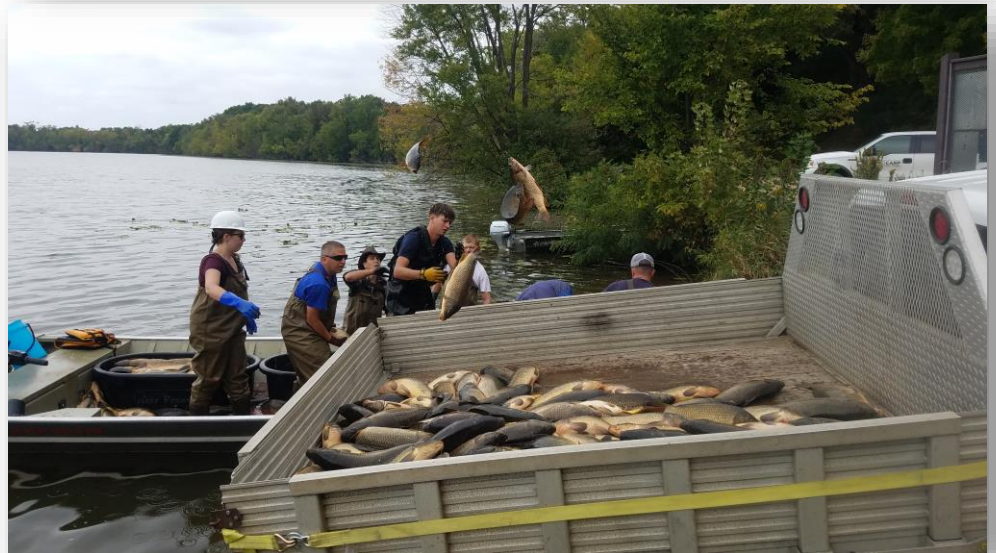
# Advantages of Baited Box Nets

# Mill Pond, NY & Deal Lake, NJ
