# Lake Management Tracker Survey A Citizen Scientist Approach

May 8, 2019

Erin Vennie-Vollrath
AIS Project Coordinator
The Nature Conservancy's APIPP

Leigh Walrath Freshwater Analyst Adirondack Park Agency

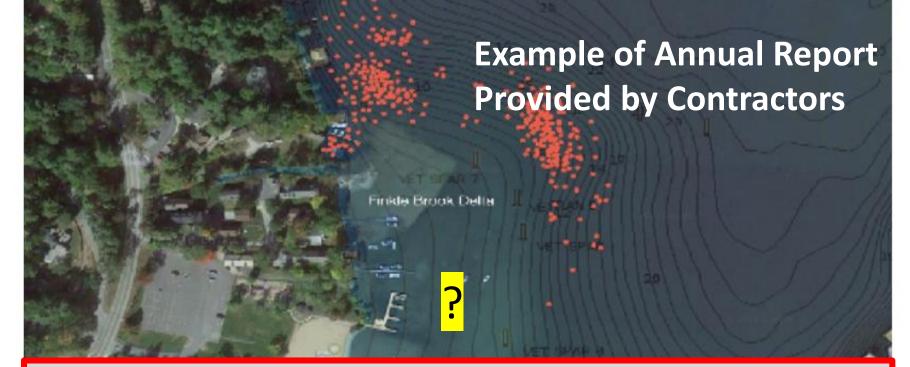
In general, harvest reports only report where activities have occurred and amount of material harvested. Severity, areal extent, and progress in managing an infestation can only be inferred.

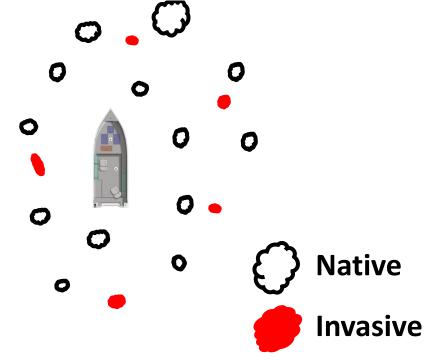
Trace to Sparse Native, Few Plants Widely Scattered Invasive

<u>Trace to Sparse</u>: Individual plants are spaced somewhat close to one another, though there may be large areas between vegetation. Small patches can be present though they should generally be widely spaced. For invasives species ask: "If untreated, could the area easily and/or relatively quickly expand such that it could be classified as Moderate to Dense in the not too distant future?" Trace to Sparse is a combination of the values used in the USACE/Cornell Scale.

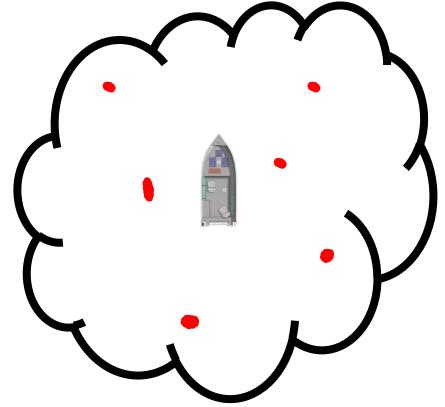
Moderate to Dense Native, Few Plants Widely Scattered Invasive

<u>Moderate to Dense</u>: Individual plants may be almost touching each other. There may be large areas where little or no lake bottom can be observed. For invasives species ask: "Would a reasonable person typically associate the abundance great enough to cause impairments to swimming, boating, or other water contact recreation?" Moderate to Dense is a combination of the values used in the USACE/Cornell Scale.

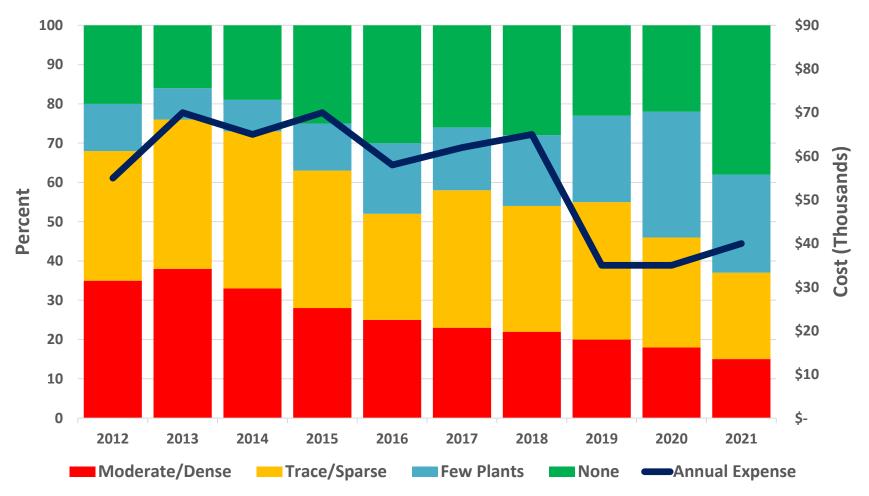
# Hypothetical Example Assessment Over Time – Lake-wide Results

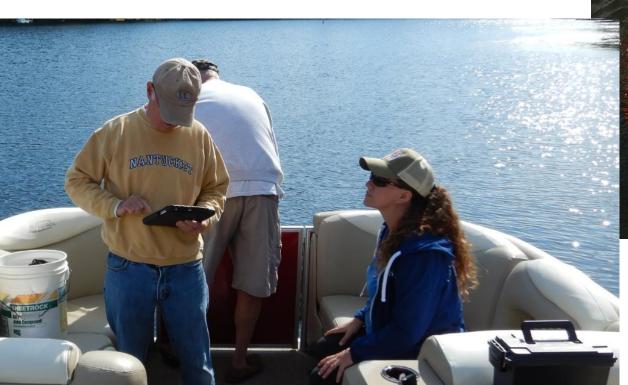
### Survey rapidly assesses invasive and native plant distribution and abundance.

Survey Technique Hierarchy:
Visual Assessment,
Aquascope if Necessary,
Rake Toss as a Last Resort

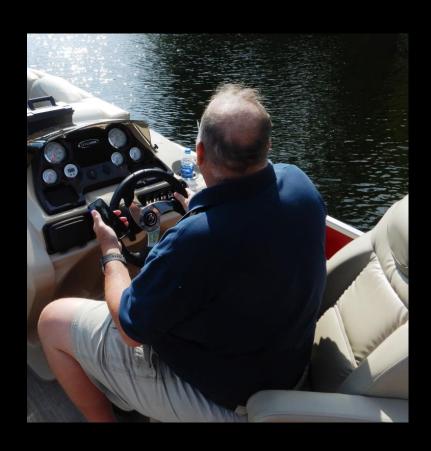
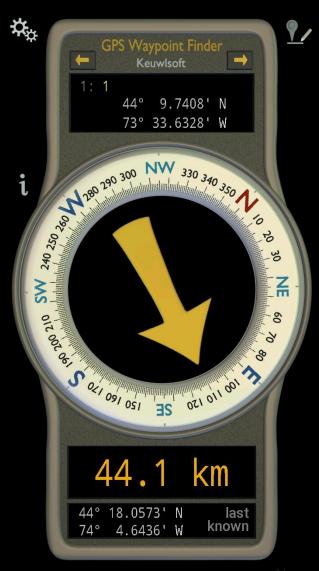
### **GPS Waypoint Finder**

Use GPS Waypoint Finder app to navigate to each site using the boat's lowest throttle setting.

Once you navigate to within 150 feet of the way point observe native and invasive species abundance.
