# Case Studies in Hazard Class Reductions

Implementation of NY's Guidance for Dam Hazard Classification

**Gregory J Daviero, PhD, PE, Principal**  
**Kevin Ruswick, PE, CFM, Associate**

**May 2, 2014**

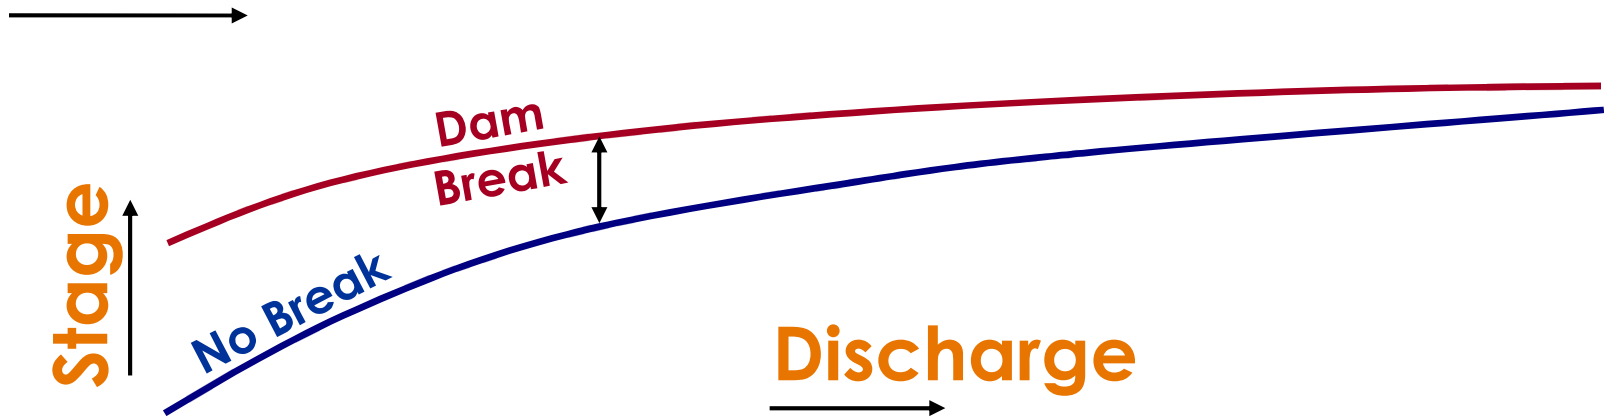
# The incremental concept

Hazard class reduces as incremental difference diminishes

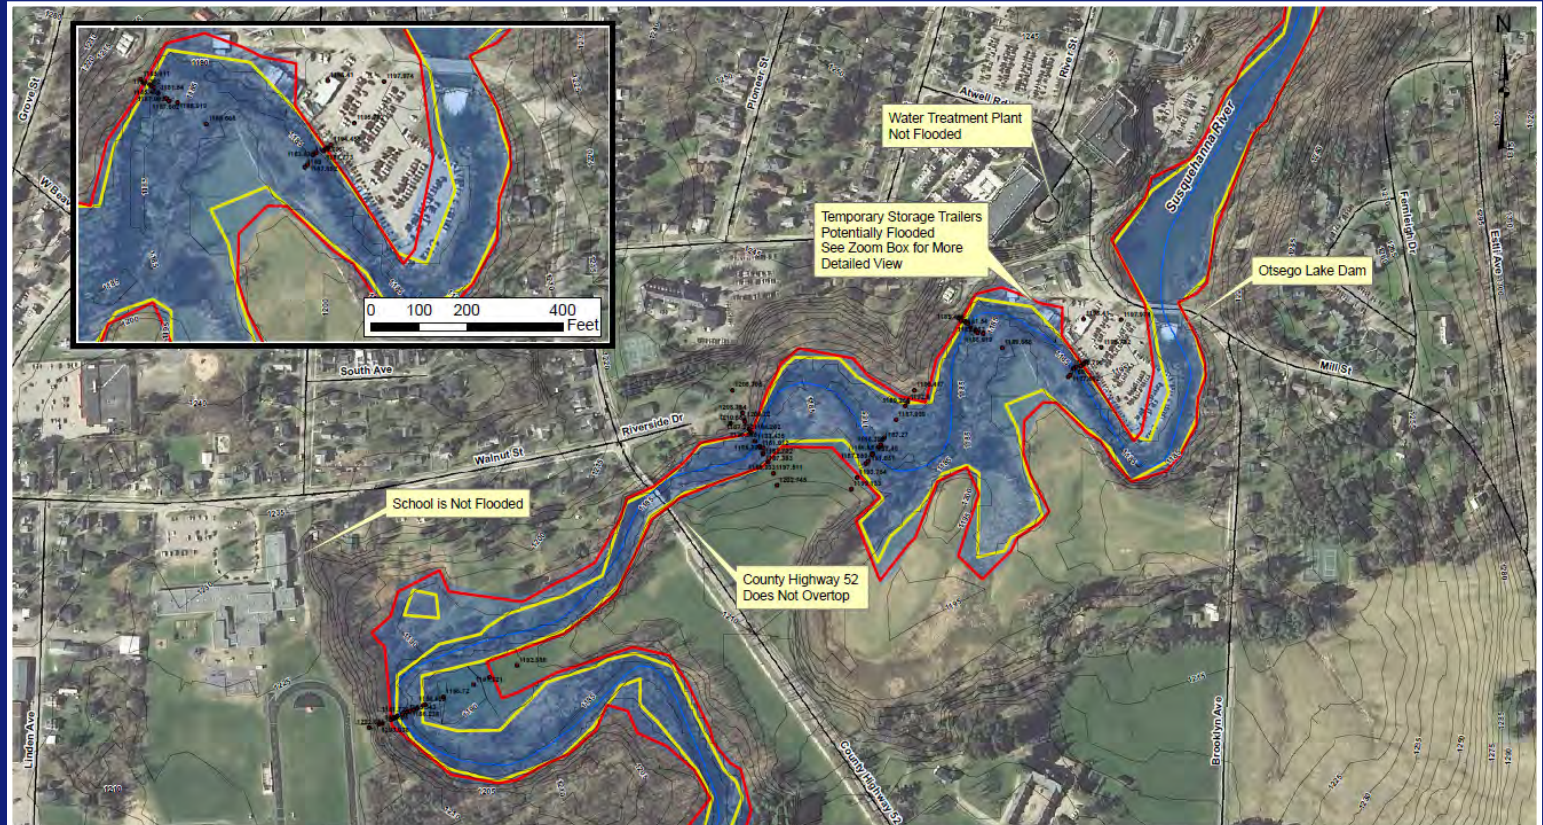
# Typical Inundation Map

Scale: 1 inch equals 300 feet

OTSEGO LAKE DAM  
COOPERSTOWN, NEW YORK  
PROJECT NO. 12025003.00

DAM BREAK  
INUNDATION MAP  
MAY 2013  
Page 1 of 6

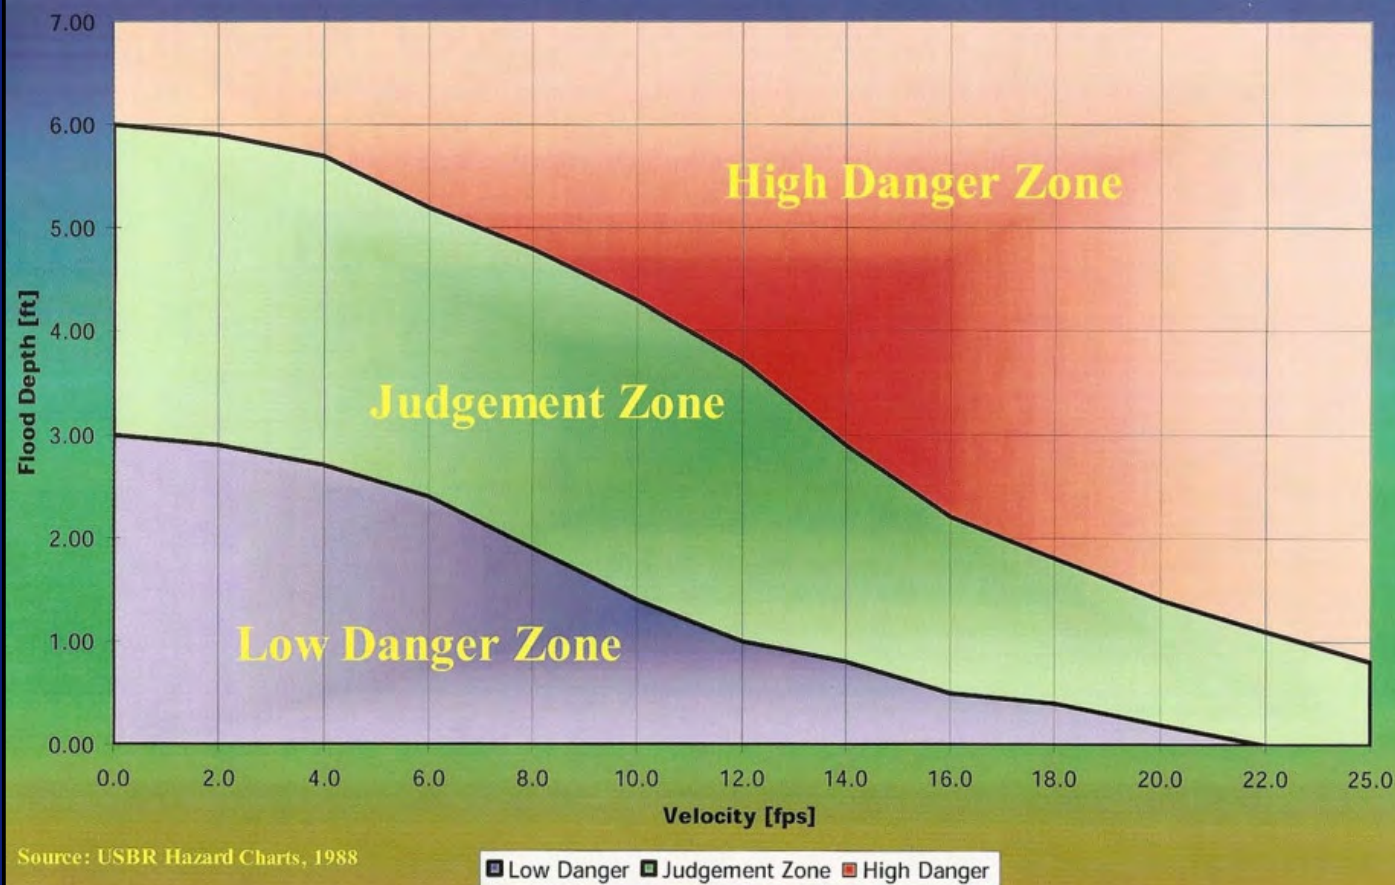
## Flood Danger for Houses

Source: USBR Hazard Charts - 1988

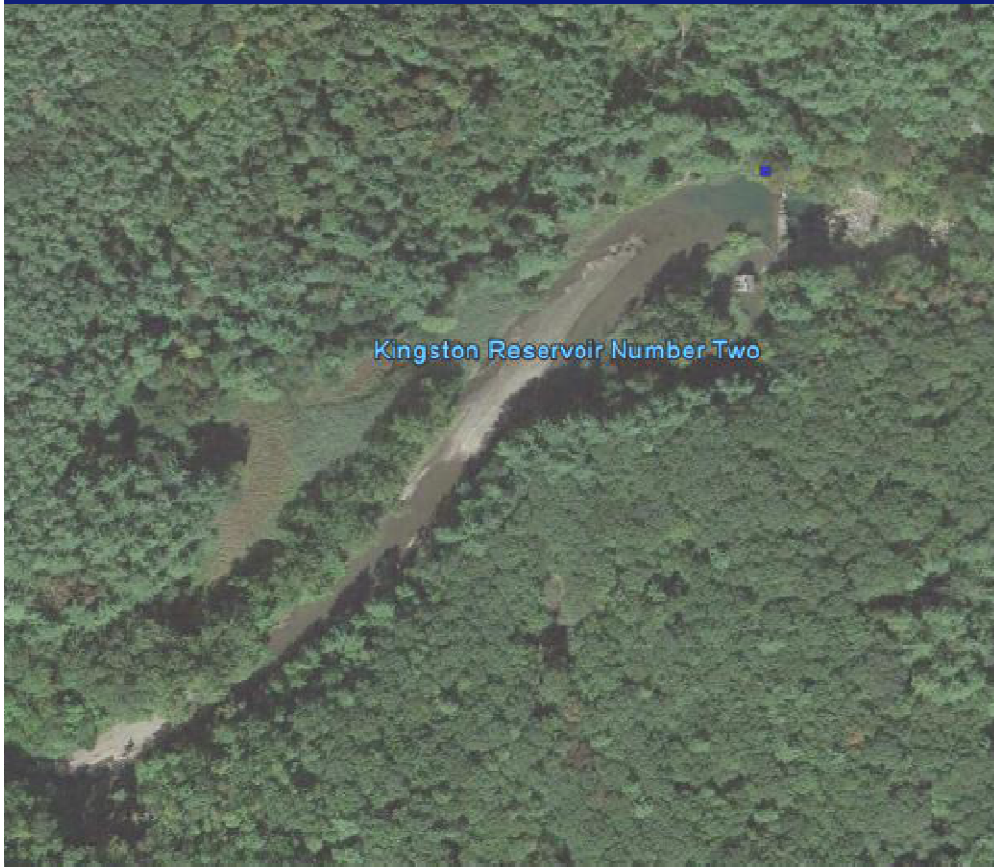
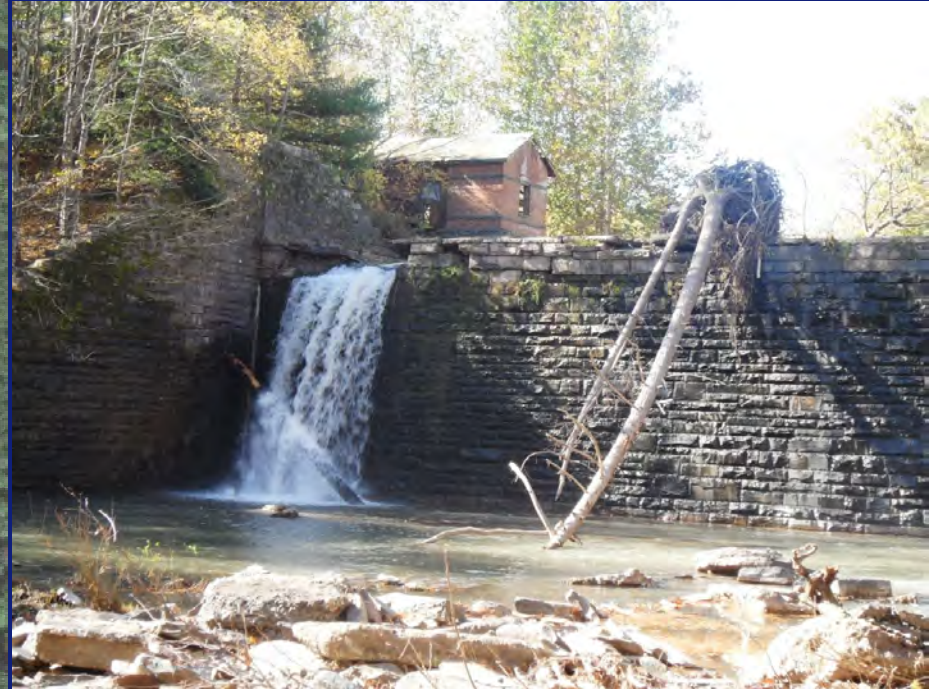
# Case Study – City of Kinston Reservoir #2

- Small Pool – Significant Sedimentation
- Damage From Hurricane Irene

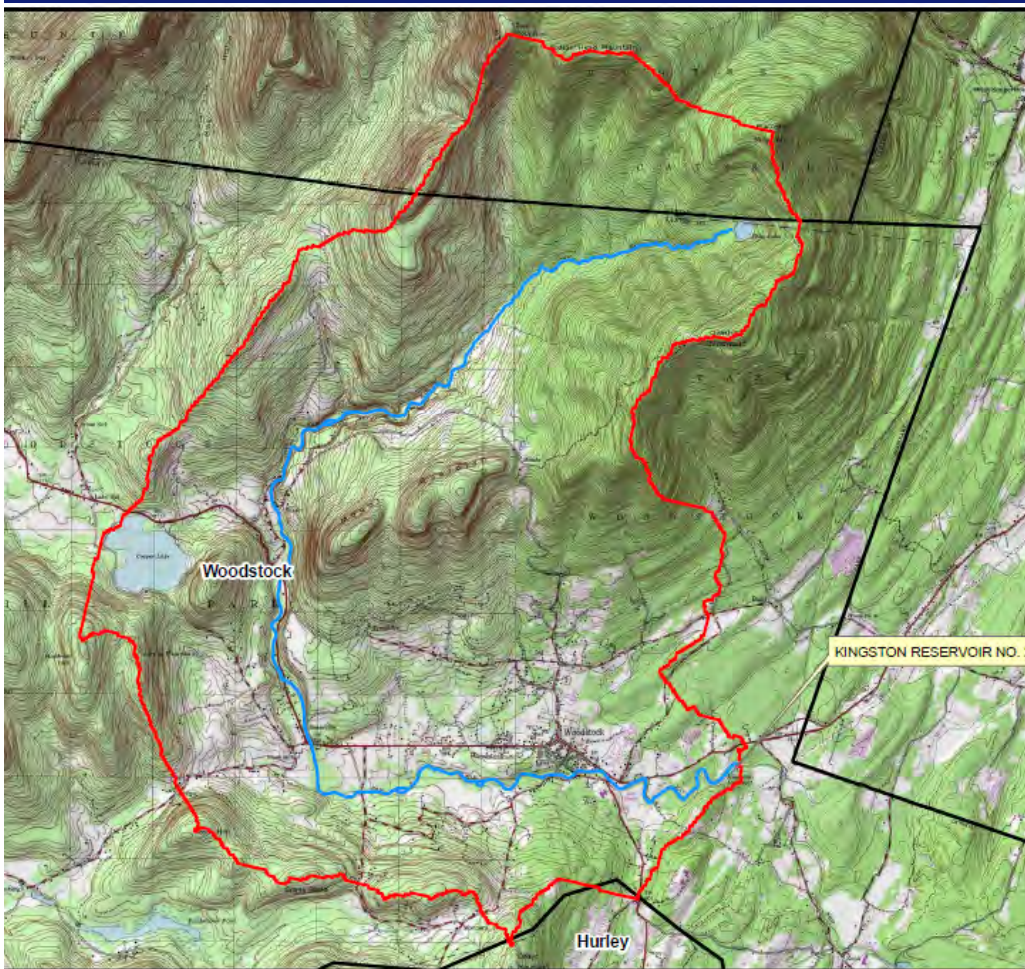
Kingston Reservoir No. 2 Dam - NYSDEC File 192-0908  
HYDROLOGIC AND HYDRAULIC ANALYSIS  
WATERSHED MAP  
Figure 3-1

- 23 sq. mi. watershed
- HEC-HMS
- 50% PMF – 20,400 cfs, EL 461.5
- Embankment Crest – EL 460.0
- 50% PMF overtops by 1.5 ft. for over 4 hours
- Spillway Out of Compliance (Class C)

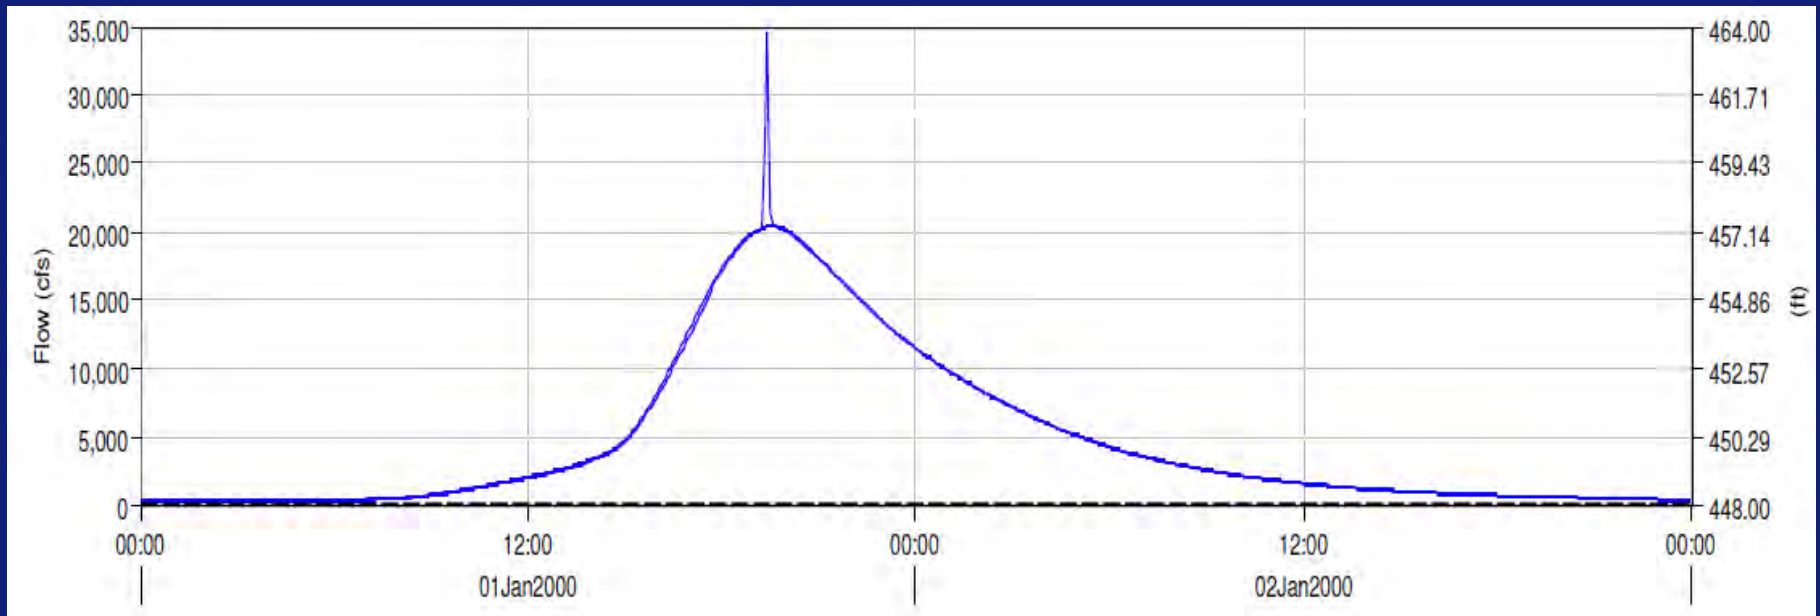
# Breach Hydrograph Generation

- HEC-HMS
- Breach Entire Masonry Spillway Section (130 ft)
- Formation Time – 15 minutes

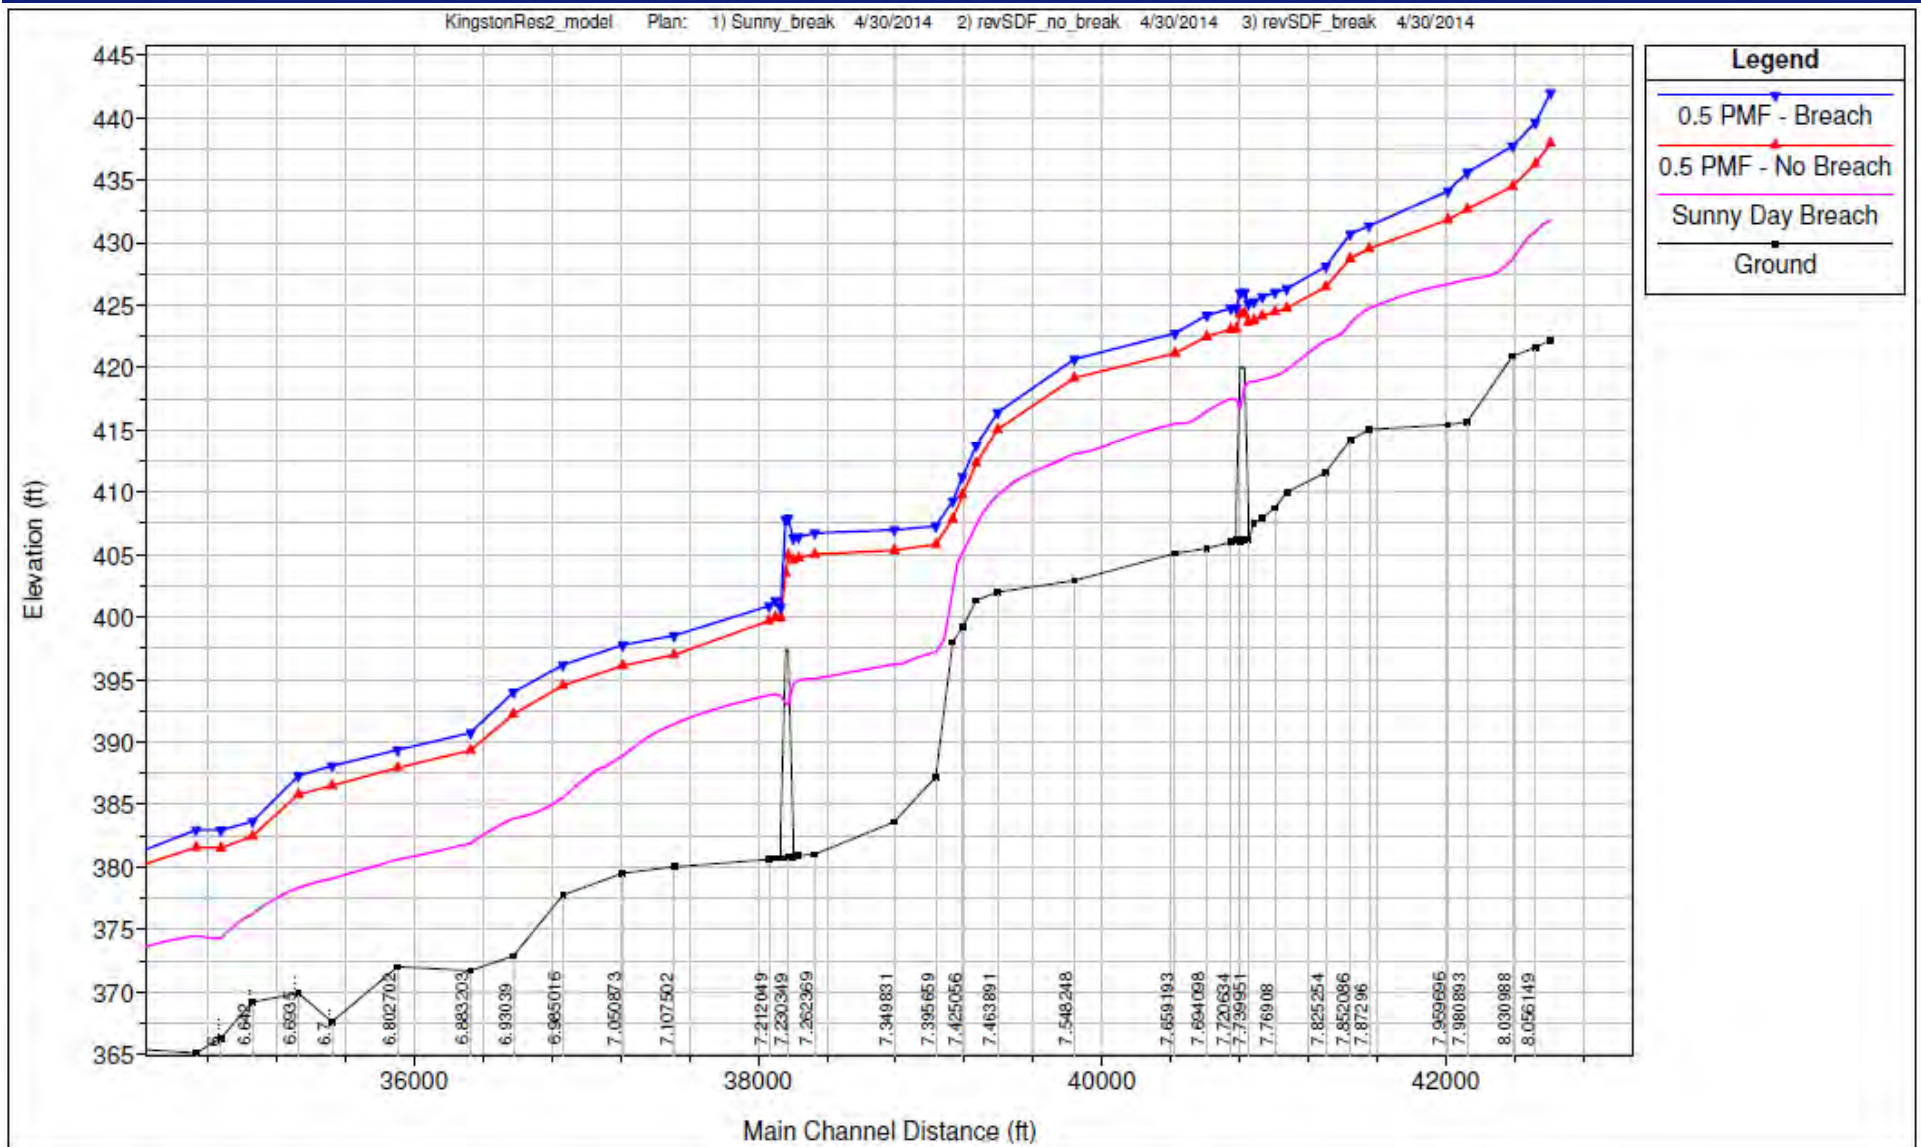
# Peak Flood Profiles

- FEMA FIS HEC-RAS Model
- Refined with LiDAR Based topographic mapping (NYCDEP 2009)
- ~ 8 miles in downstream reach to Esopus
- Sunny Day and Wet Weather dam breach
- FEMA 100-year inflows from D/S Tributaries
- Unsteady Flow Analysis

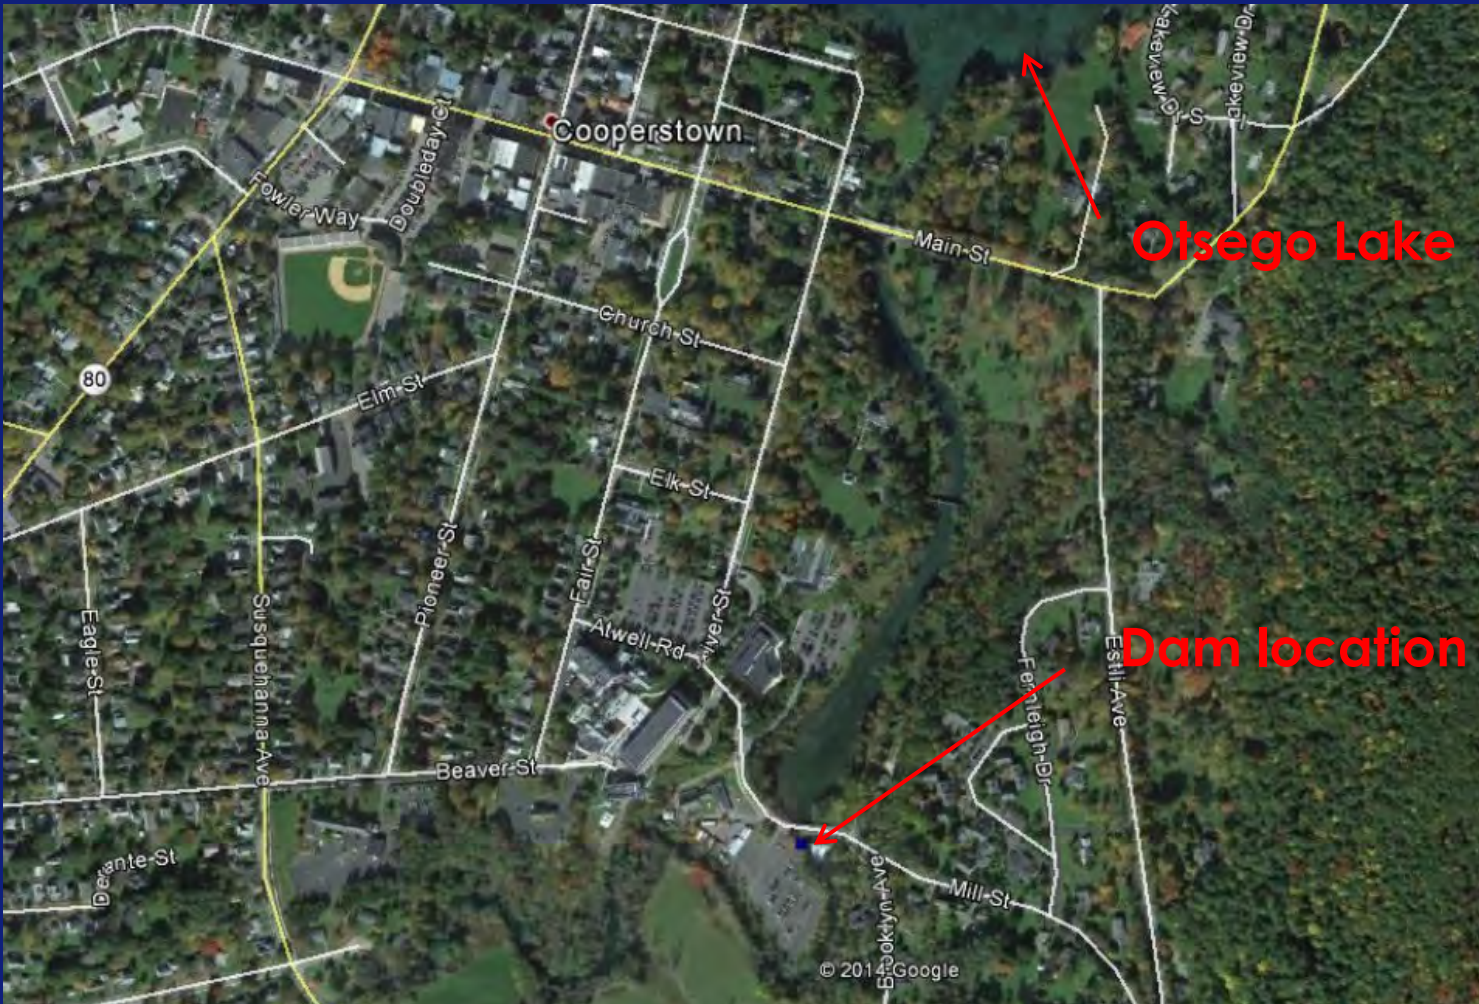
# Channel Between Lake and Dam

- 1/2 Mile Long Upstream Channel

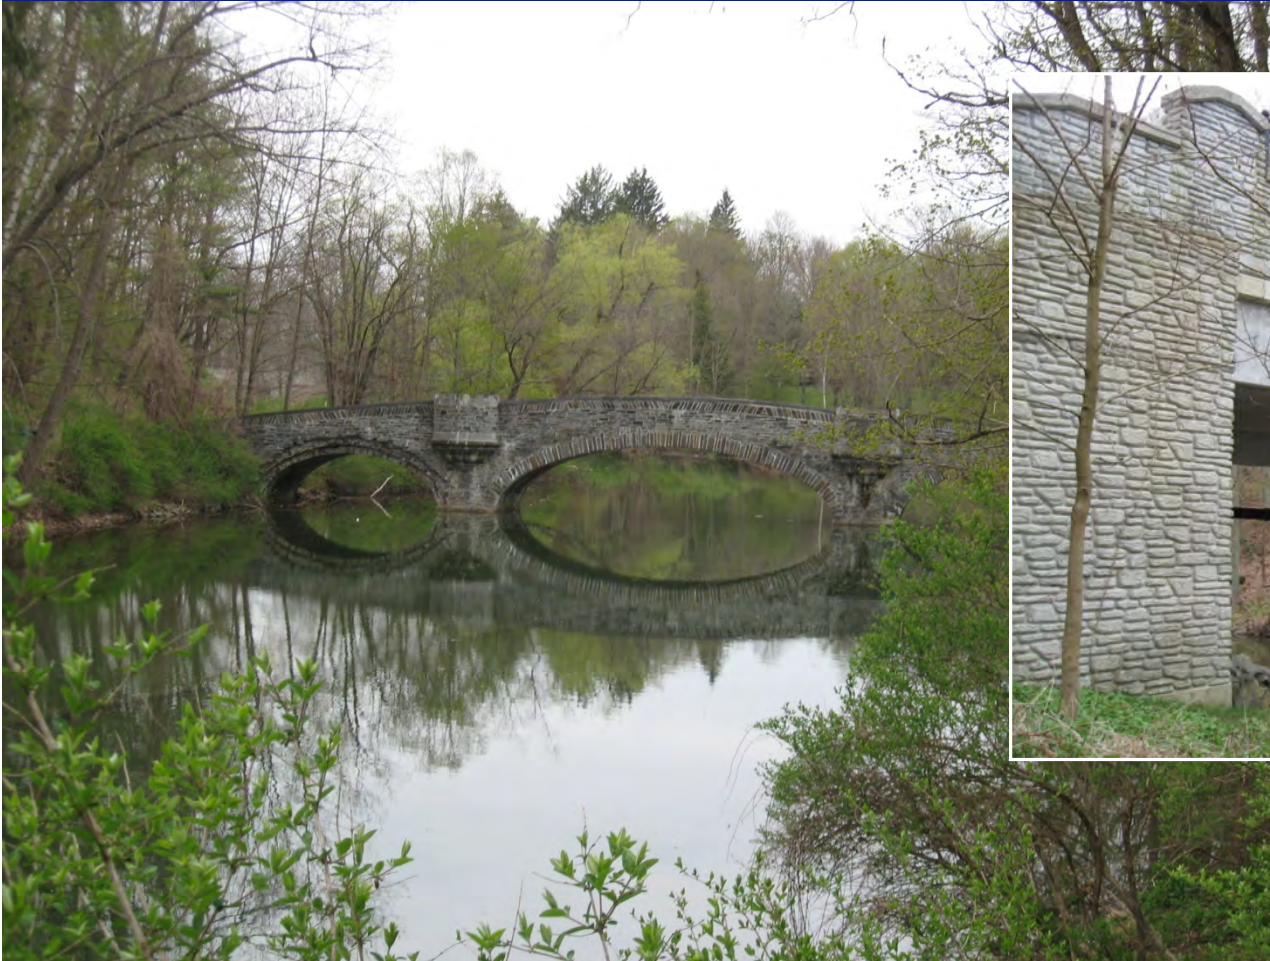
Main St. Bridge

# Constrictions in Upstream Channel

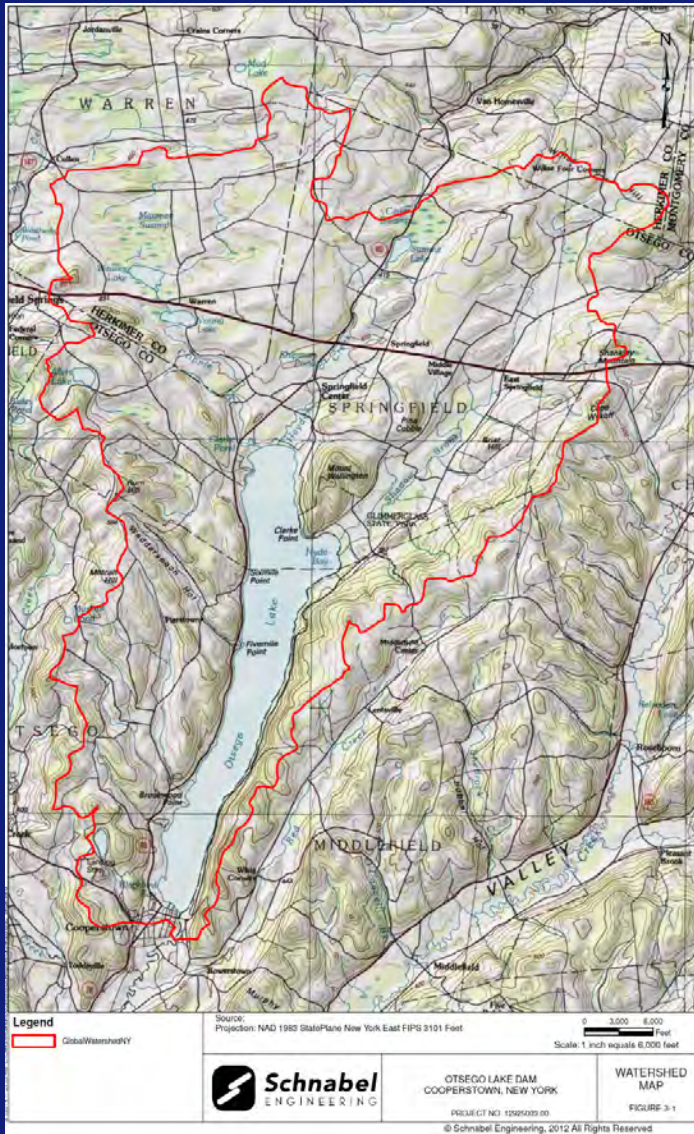
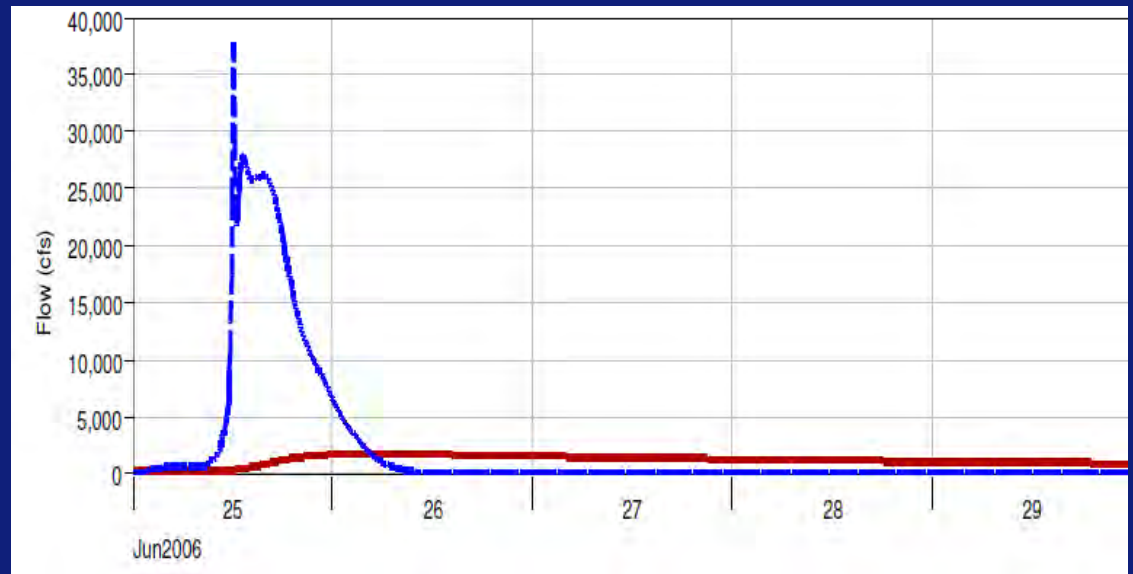
# Otsego Lake Dam Hydrology

- 77.6 sq. mi. watershed
- HEC-HMS Model
- SDF - 150% of 100-Year Storm

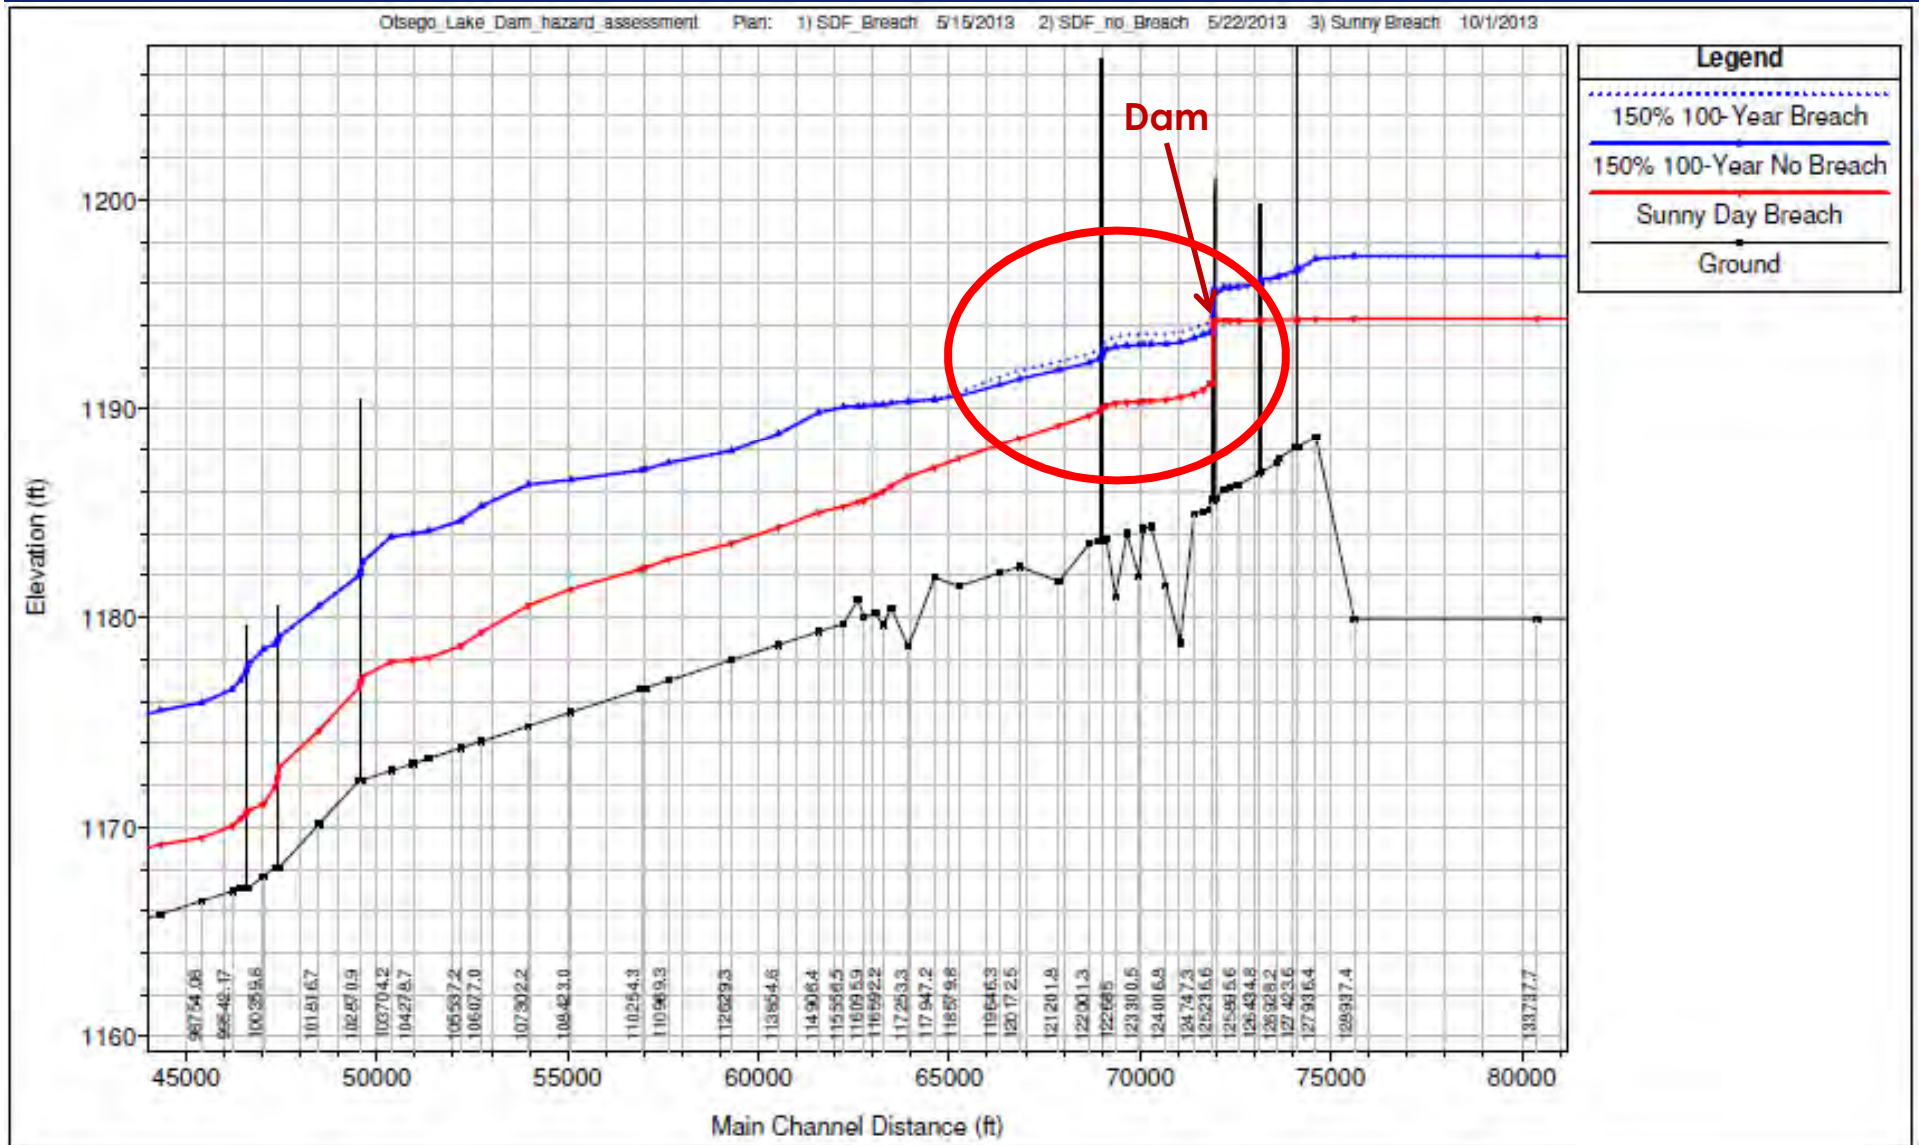
# Dam Break – Peak Flood Profiles

- No FEMA FIS Hydraulic Model
- No LiDAR Topographic Mapping
- 5-ft contour mapping within Village Limits
- NYSDOT drawings for most bridges
- Field measurements of remaining bridges
- Field survey of downstream areas of concern (School, Treatment Plant)

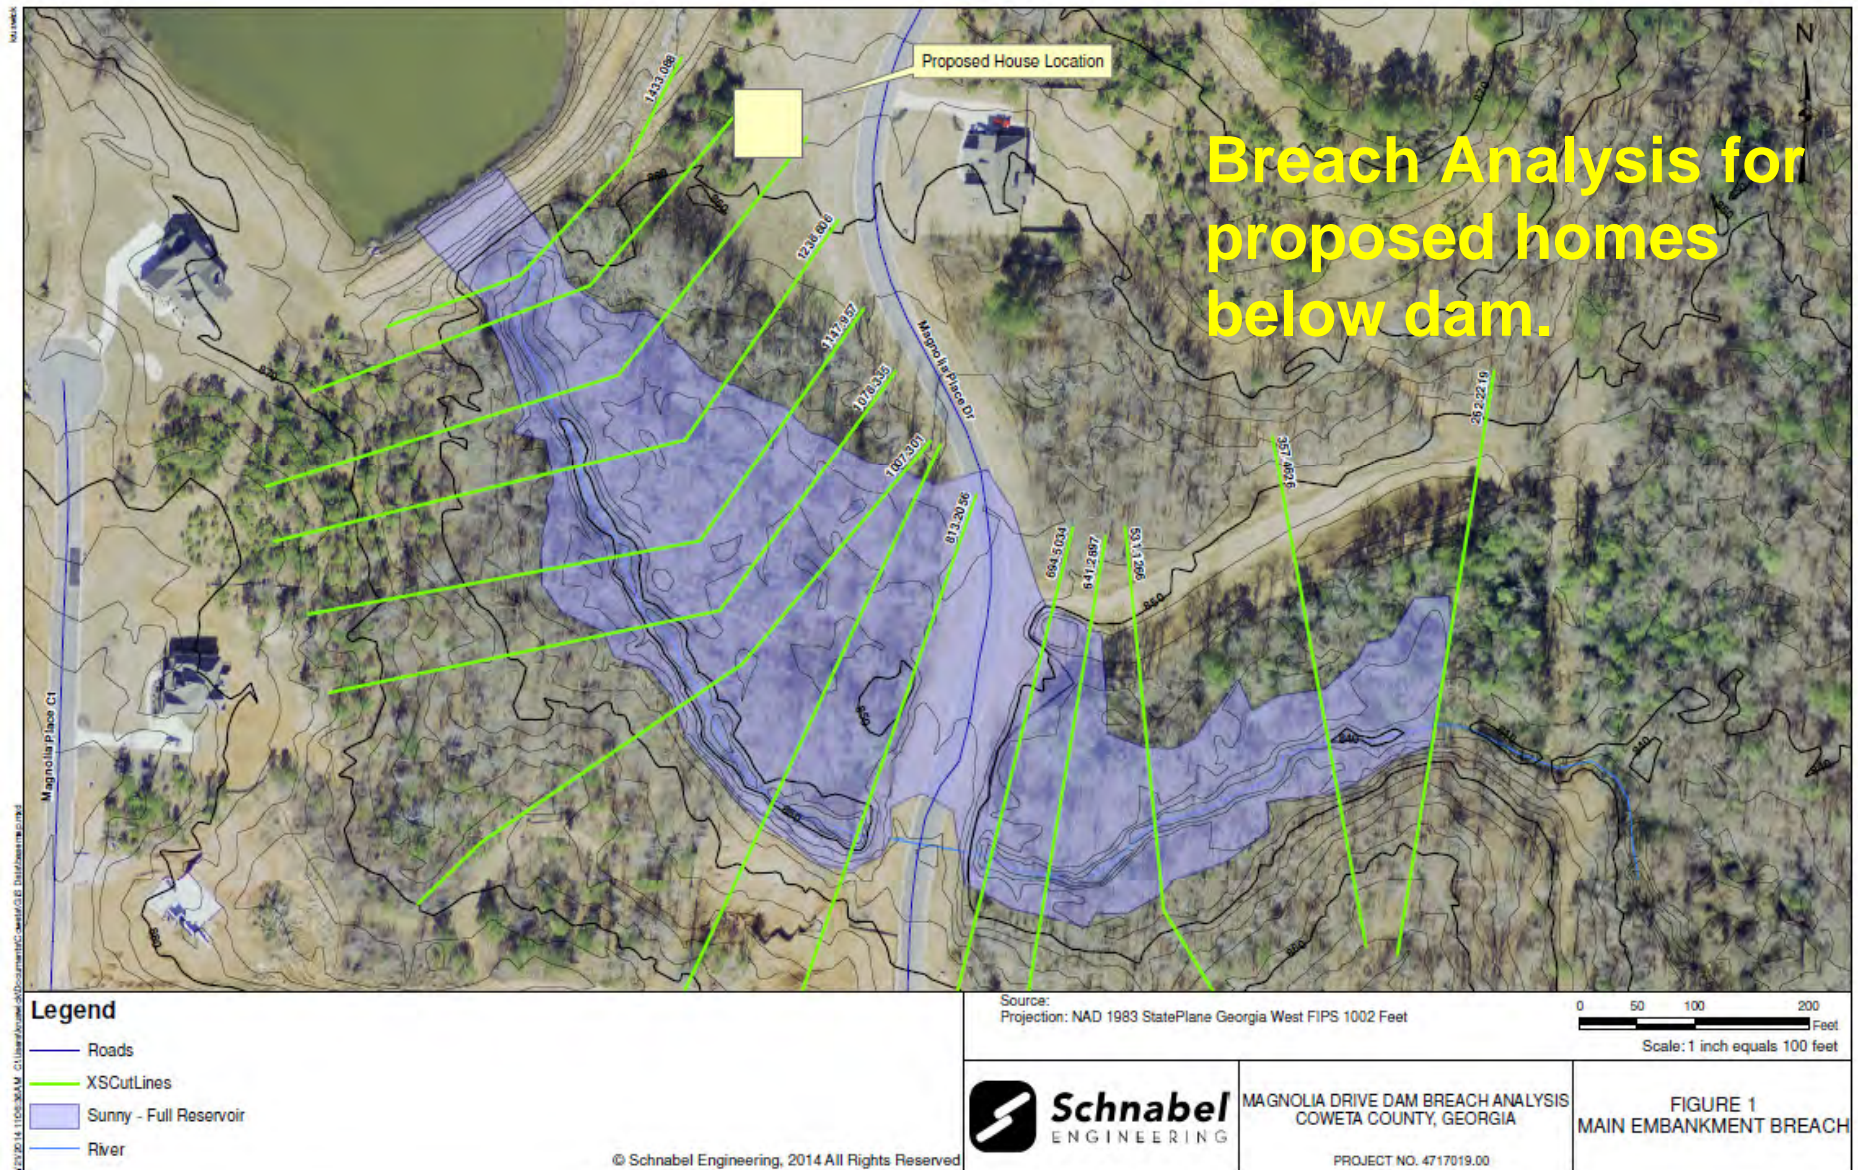
# Magnolia Place Dam (Georgia)

**Breach Analysis for  
proposed homes  
below dam.**
