# Bringing New York Dams into Compliance

May 3, 2019 / PF – Dams and Water Pes

Hans Hasnay, PE – Dams and Water Resources Lead Theresa Chu, EIT – Water Resources Engineer

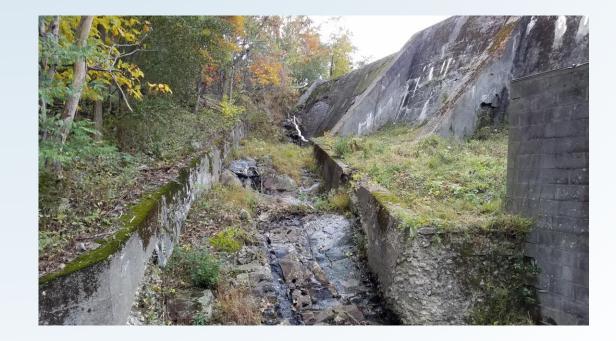
Mount Beacon Dam Spillway (Class C Dam)

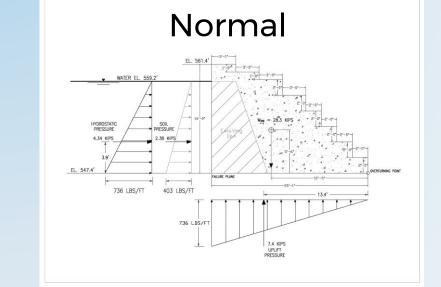
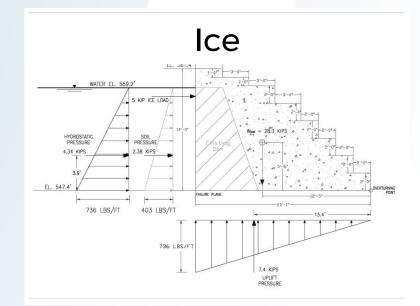
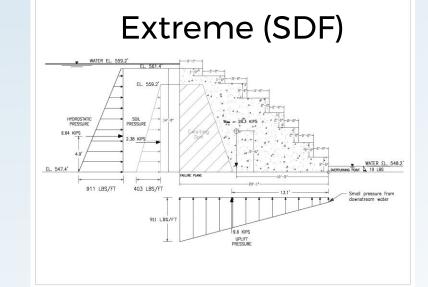
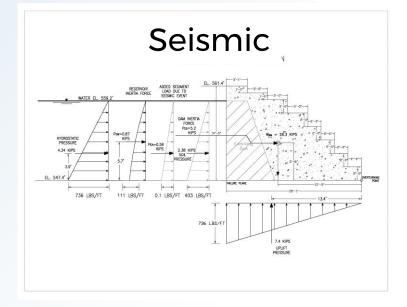
Stability Analysis: Typical Gravity Section

Load Case	Load Condition	Minimum Required Factor of Safety	
Case 1	Normal	1.5	
Case 2	lce	1.25	
Case 3	Spillway Design Flood (SDF)	1.25	
Case 4	Seismic	1.0

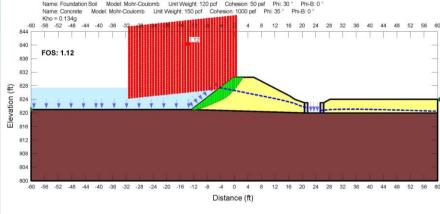
Seismic Upstream

#### Seismic Downstream

-16 -12 -8 -4 0 4 Distance (ft) 12 16 20 24 28 32 36 40 44 48 52 56

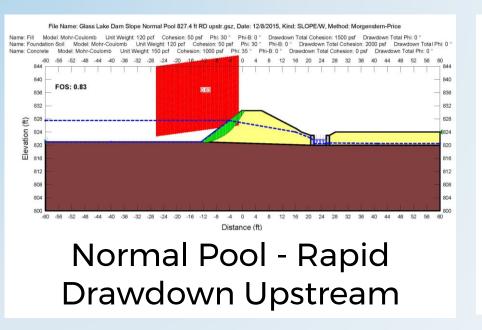
### Stability Analysis: Embankment Section

File Name: Glass Lake Dam Slope Normal Pool 827.4 ft RD downstr.gsz, Date: 12/8/2015, Kind: SLOPE/W, Method: Morgenstern-Price

Name: Fill Model Mohn-Coulomb Unit Weight 120 pcf Cohesion: 50 paf Phi 30 ° Phi-B: 0 ° Drawdown Total Cohesion: 1500 paf Drawdown Total Phi 0 ° Name Foundation Soil Model: Mohn-Coulomb Unit Weight 120 pcf Cohesion: 60 paf Phi 30 ° Phi-B: 0 ° Drawdown Total Cohesion: 2000 paf Drawdown Total Phi 0 ° Name Concrete Model Mohn-Coulomb Unit Weight 150 pcf Cohesion: 60 paf Phi 30 ° Phi-B: 0 ° Drawdown Total Cohesion: 2000 paf Drawdown Total Phi 0 ° Name Concrete Model Mohn-Coulomb Unit Weight 150 pcf Cohesion: 60 paf Phi 30 ° Phi-B: 0 ° Drawdown Total Cohesion: 2000 paf Drawdown Total Phi 0 °

#### Normal Pool - Rapid Drawdown Downstream

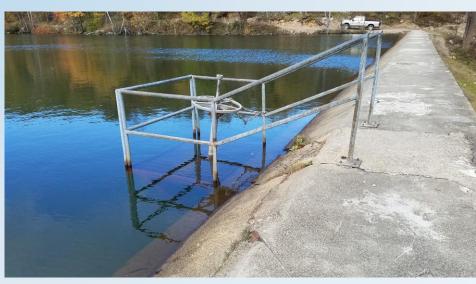
Mount Beacon Reservoir Dam

The low level drain is required to have sufficient capacity to discharge 90% of the storage below the lowest spillway crest within 14 days, assuming no inflow into the reservoir.

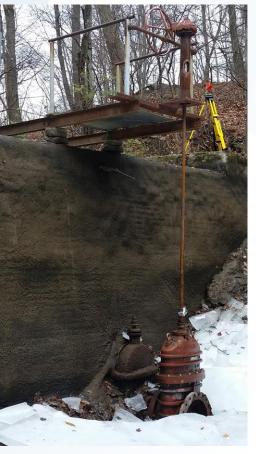
Pocket Dam

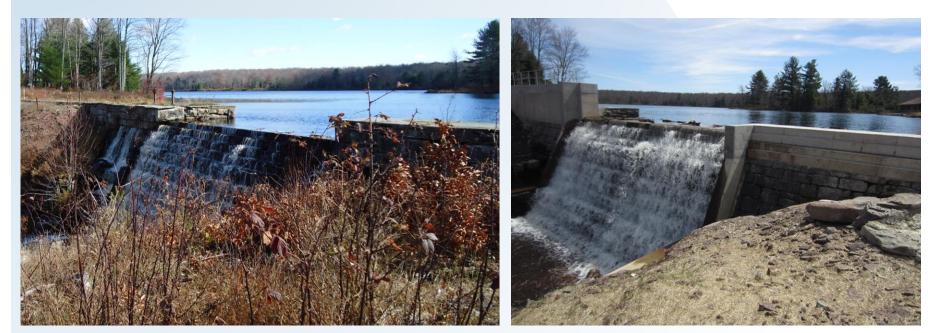
#### Spillway Capacity: St. Joseph's Lake Dam

Increase capacity by raising non-overflow section and adding auxiliary spillway

Before

After

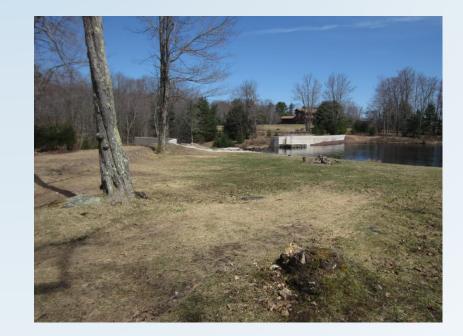
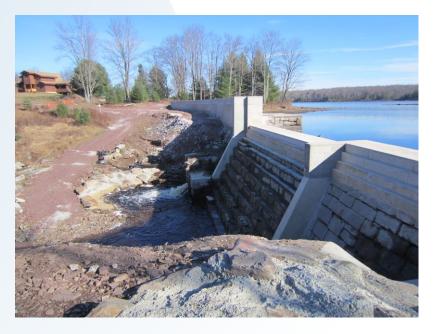
Spillway Capacity: St. Joseph's Lake Dam -After

#### Embankment

Spillway

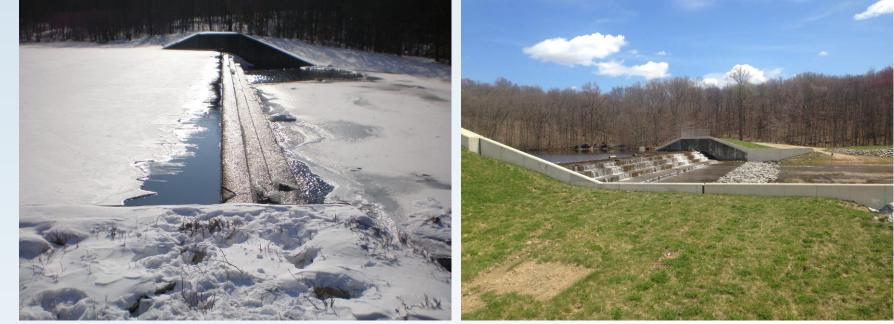
# Spillway Enhancement: Browns Dam

#### Increase capacity by raising non-overflow section

Before

After

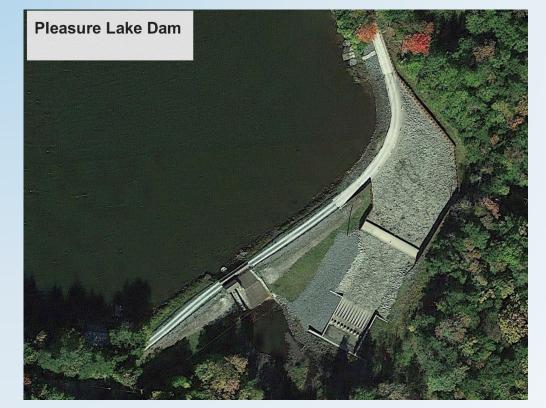
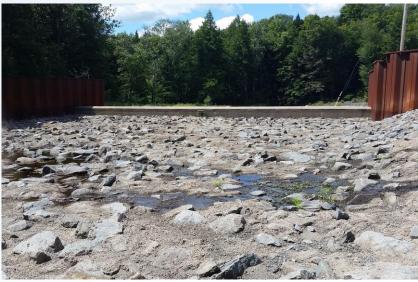
### Spillway Enhancement: Pleasure Lake Dam

#### New emergency spillway

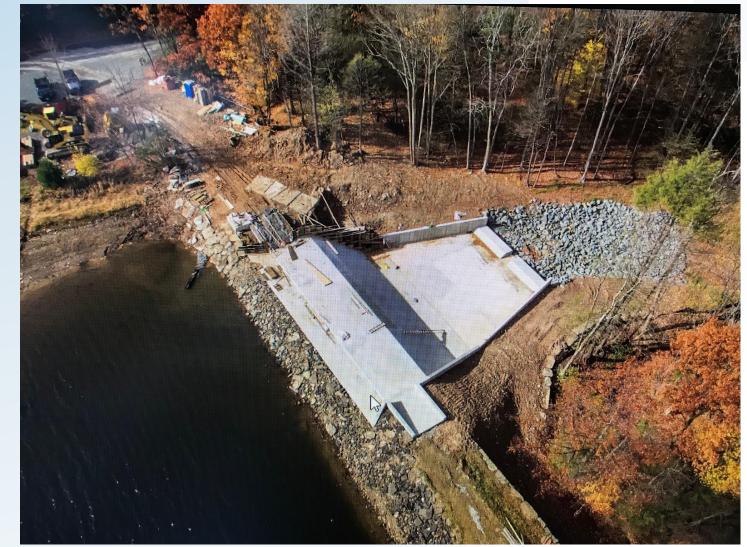
#### Spillway Enhancement: Lake Louise Marie

#### New auxiliary spillway

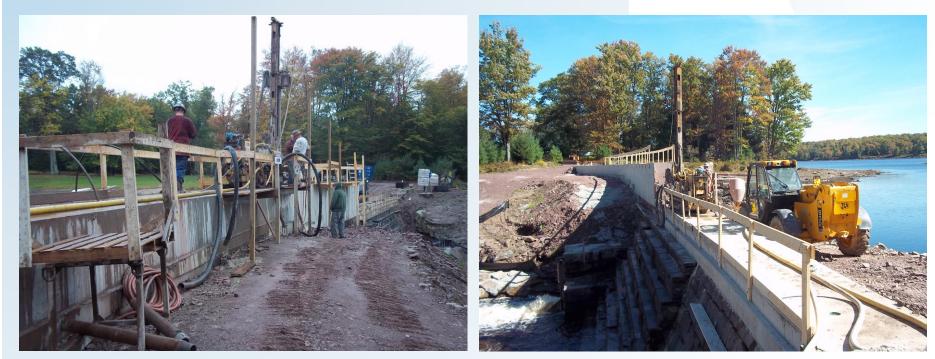
#### Stability Improvements: St. Joseph's Dam

#### Concrete Dam - Anchoring

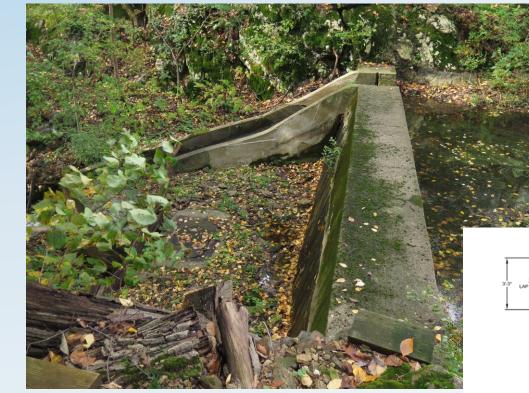
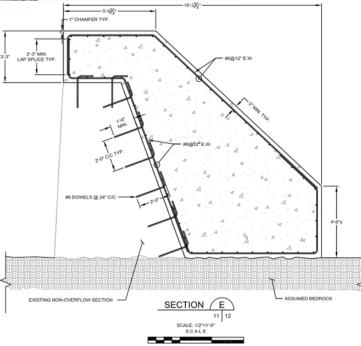
#### Stability Improvements: Chiselhurst Dam

#### Concrete Dam – adding mass

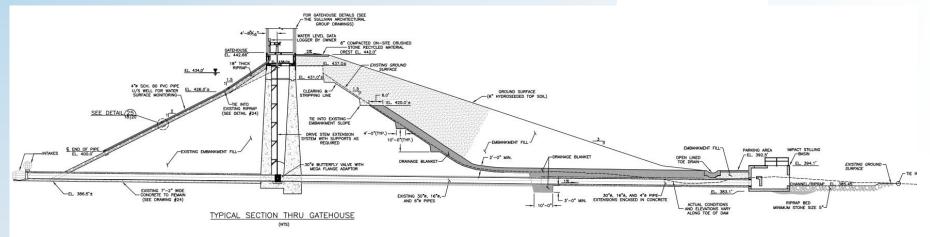
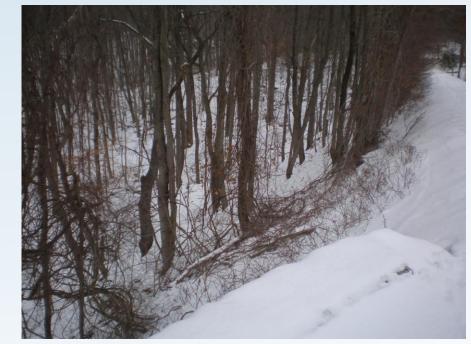
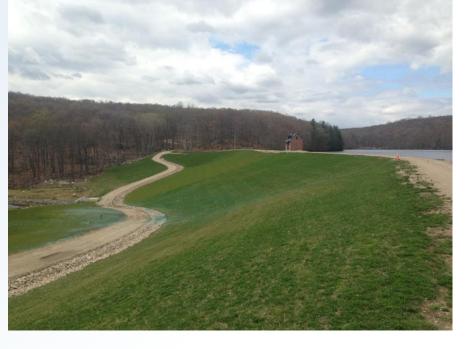
# Stability Browns Dam Embankment Remediation

#### Embankment Dam – flatten downstream slope and seepage blanket

Before

After

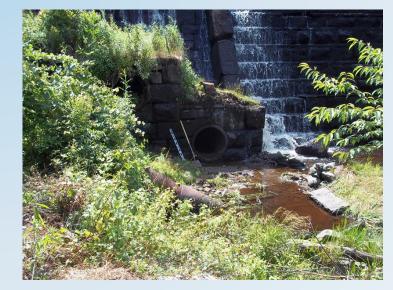
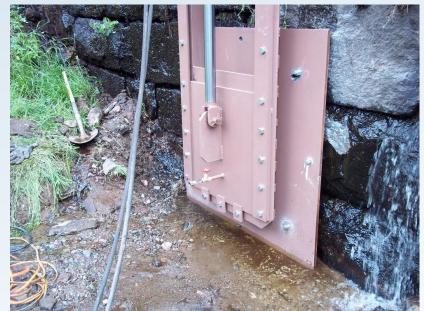
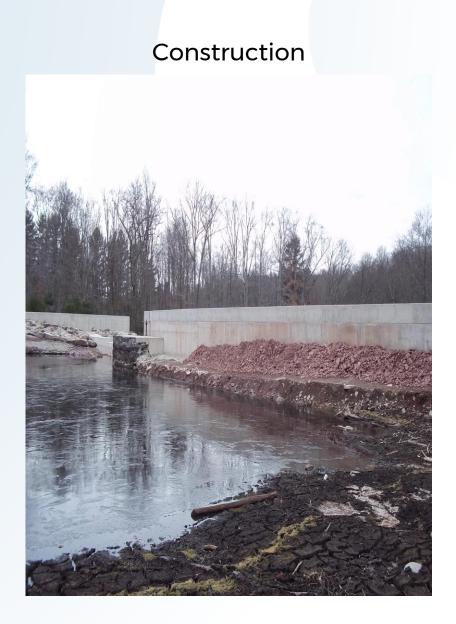
#### Low Level Outlet Repair: St. Joseph's Dam

#### Low Level Outlet

#### **Temporary Valve**

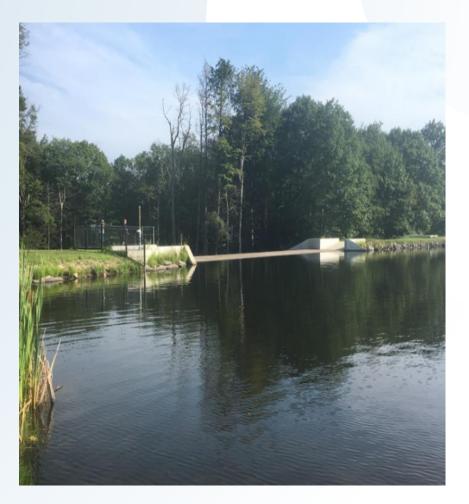
Low Level Outlet: Lake Louise Marie

New LLO drains 40% of Lake

Pumping to assist and drain remainder

- Pumps as supplement (Lake Louise Marie and Wolf Lake)
- Pumps Only (Pleasure Lake)
- Pump sizes must be reasonable and readily available
- Develop a documented plan, get DEC approval, and include in EAP

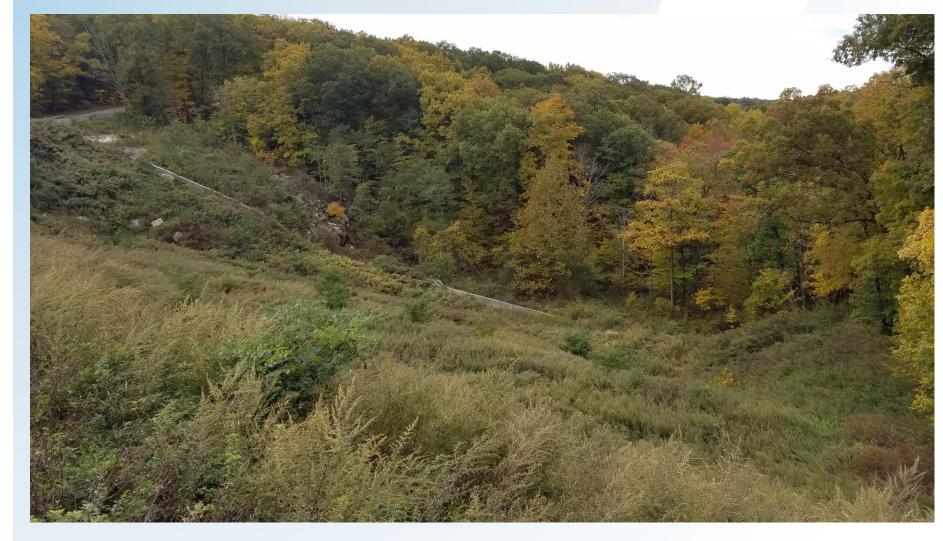
# **Undesirable Vegetation**

- Difficult to inspect hides problems
- Attracts borrowing rodents
- Tree roots create seepage paths

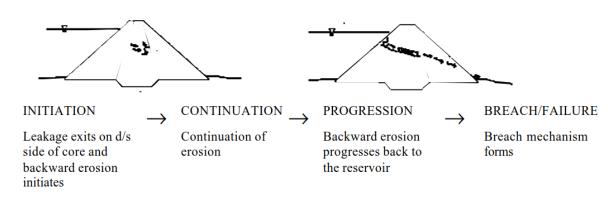
# Potential Piping

(a) Backward erosion piping in the embankment
